Hazardous Materials Survey

Prepared for:	Blue Mountains City Council
Prepared by:	Alex Tam Licensed Asbestos Assessor #001241 Trinitas Group
Site:	Springwood Community Arts Centre
Address:	22 Ferguson Rd, Springwood NSW 2777
Field Work Date:	Wednesday, 1 September 2021
Date of Report:	15/09/2021

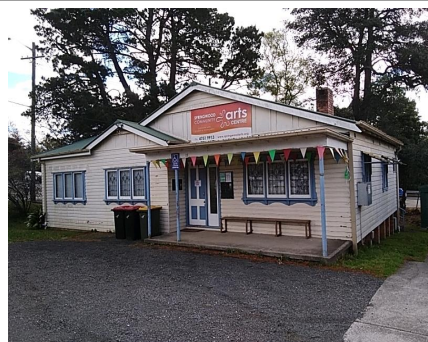
Client Name:	Blue Mountains City Council	Property Number:	NA	Survey Date:	11/08/2021
Site Name:	Springwood Community Arts Centre	Building Age:	N/A	Inspected By:	Alex Tam
Site Address:	22 Ferguson Rd, Springwood NSW 2777	Construction Type:	Fibre Cement Sheeting	Building Size (m2):	160
Building Name:	Springwood Community Centre	Roof Type:	Metal	No. Levels:	1

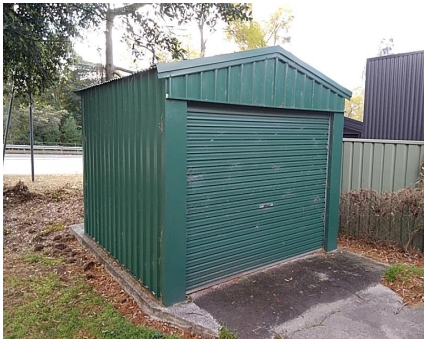
Client Name:	Blue Mountains City Council	Property Number:	NA	Survey Date:	11/08/2021
	Site Name:	Springwood Community Arts Centre	Building Age:	N/A	Inspected By:	Alex Tam
	Site Address:	22 Ferguson Rd, Springwood NSW 2777	Construction Type:	Metal	Building Size (m2):	20
	Building Name:	Garage	Roof Type:	Metal	No. Levels:	1

Item	Location	Level	Room-Specific Location	Hazard Type	Item description	Sample Reference	Sample Status	Photo No	Extent	Condition	Friability	Disturbance Potential	Risk Rating	Current Label	Control Priority	Control Recommendation
nil asbestos identified.
