Asbestos Register

On the 24th June 2018, an Asbestos Audit was conducted on the BMEE Cottage and asbestos containing materials were found to be present at the premises. Please refer Appendix I for results of products that were considered and consequently analysed but did not contain asbestos.

HAZARDOUS MATERIALS REGISTER & MANAGEMENT PLAN

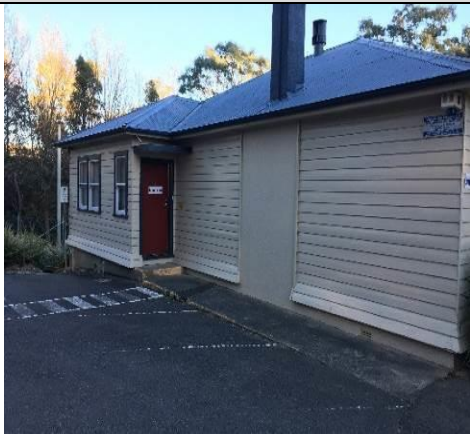
External-Front of Property (Eastern Aspect) Concrete Entrance Path, Rendered Cement and Timber Weatherboard Walls, Timber Window Frames, Aluminium Gutter and Downpipes, Timber Fascia Board.	N/A	N/A	N/A
24 th June 2018

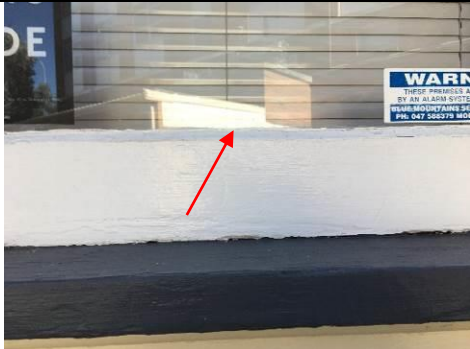
External - All Timber Windows. Mastic 2621	Sample B18167-S9 No Asbestos Detected.	A5	N/A

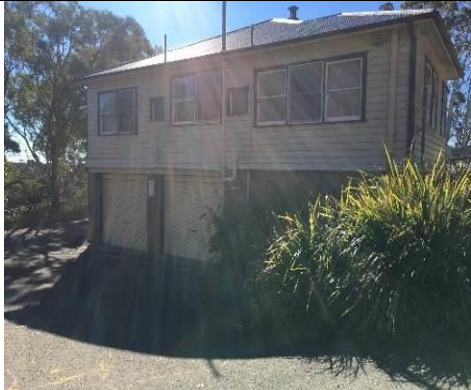
External - Southern Aspect Aluminium Roller Doors, Rendered Cement and Timber Weatherboard Walls, Timber Window Frames, Aluminium Gutter and Downpipes, Timber Fascia Board.	N/A	N/A	N/A
24 th June 2018

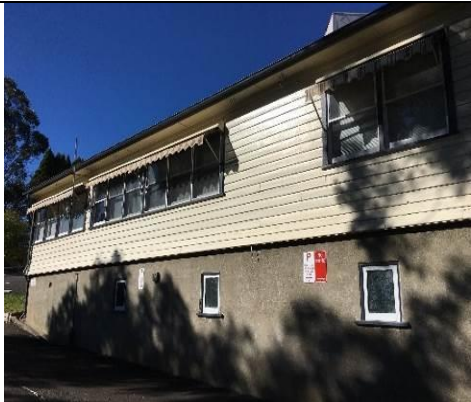
External-Western Aspect Aluminium and Material Awnings, Rendered Cement and Timber Weatherboard Walls, Timber Window Frames, Aluminium Gutter and Downpipes, Timber Fascia Board	N/A	N/A	N/A
24 th June 2018

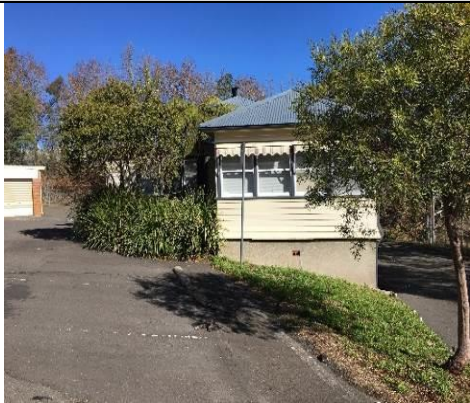
External-Northern Aspect Aluminium and Material Awnings, Rendered Cement and Timber Weatherboard Walls, Timber Window Frames, Aluminium Gutter and Downpipes, Timber Fascia Board.	N/A	N/A	N/A
24 th June 2018

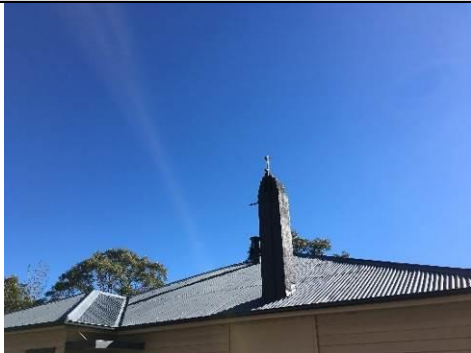
External - Roof (Limited Access) Corrugated Iron Roof with Metal Ridge Capping, Brick Chimney. 2628	No Asbestos Materials Sighted, Limited Access Due to Height of Roof and Sloping Block.	A5	N/A
24 th June 2018

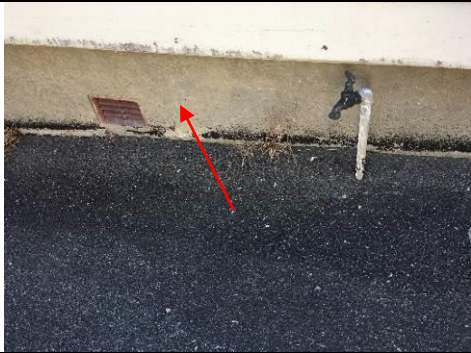
External - Cement Render on Footings. 2629	Sample B18167-S12 No Asbestos Detected.	A5	N/A
24 th June 2018

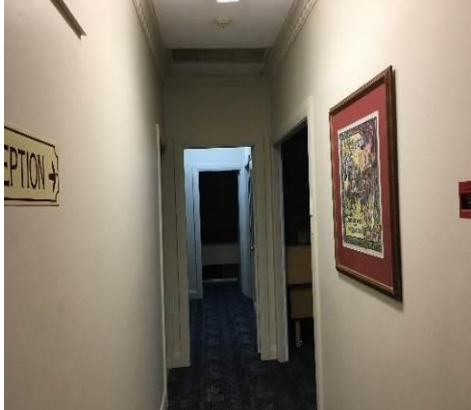
Internal - Entry Hallway running East-West Plasterboard Walls, Timber Skirting Boards and Architraves, Timber Window Frame, Plaster Cornices, Plasterboard Ceilings, Carpet Tiles on Floorboards. 2630	No Sample Taken. No Asbestos Materials Sighted.	A5	N/A

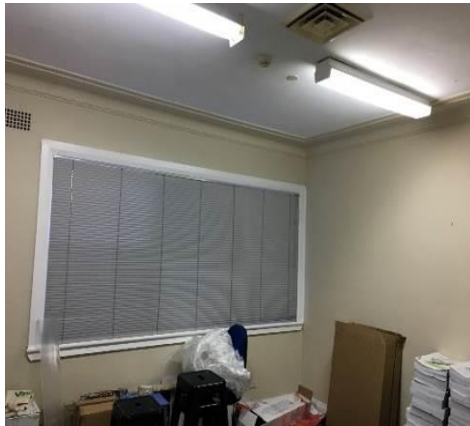
Internal - South-East Office. Plasterboard Walls, Timber Skirting Boards and Architraves, Timber Window Frame, Plaster Cornices, Plasterboard Ceilings, Carpet Tiles on Timber Floorboards.	No Sample Taken. No Asbestos Materials Sighted. 2631	A5	N/A
24 th June 2018

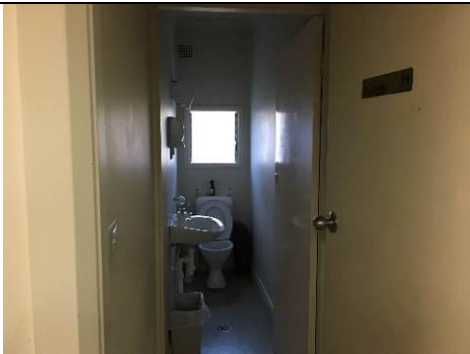
Internal -Eastern Toilet. Plasterboard Walls, Timber Skirting Boards and Architraves, Plaster Cornices, Plasterboard Ceiling Ceramic Cistern and Sink.	No Sample Taken. No Asbestos Materials Sighted. 2632	A5	N/A
24 th June 2018

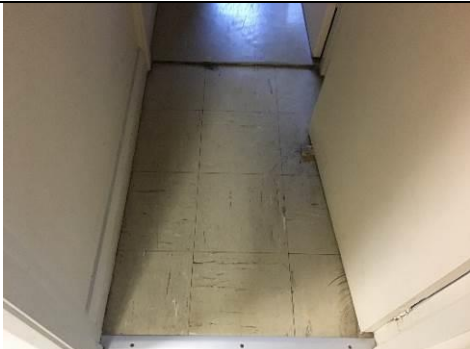
Internal - Eastern Toilet and Toilet Entry Floor Vinyl Tiles Approx. 4m ²	Sample B18167-S2 No Asbestos Detected. 2633	A5	N/A

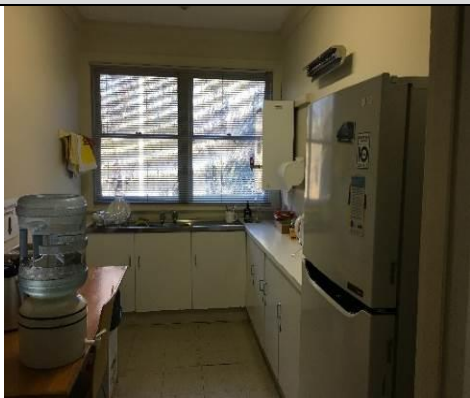
Internal - Kitchen Plasterboard Walls, Plasterboard Ceiling, Plaster Cornices, Composite Timber and Laminate Cupboards, Vinyl Tile Floors on Timber Floor.	Similar to Sample B18167-S02 No Asbestos Detected. 2634	A5	N/A
24 th June 2018

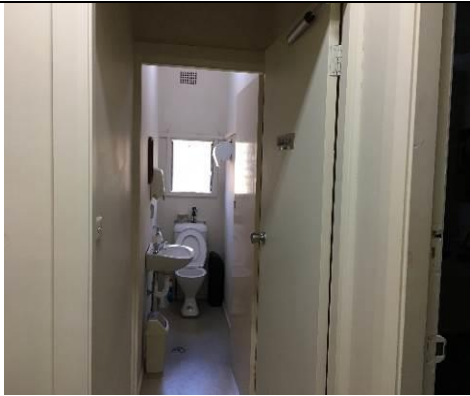
Internal - Western Toilet Plasterboard Walls, Plasterboard Ceiling, Plaster Cornices, Timber Architraves and Skirting, Vinyl Tiles on Timber Floor.	Similar to Sample B18167-S02 No Asbestos Detected. 2636	A5	N/A

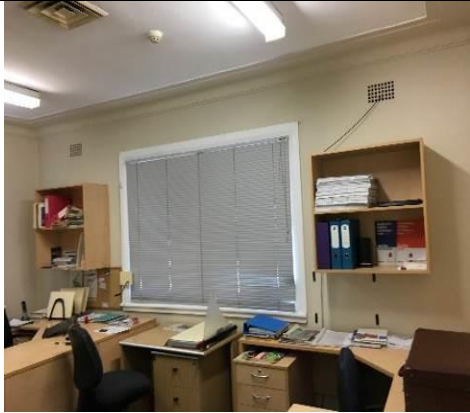
Internal - South-West Office Plasterboard Walls, Plasterboard Ceiling, Plaster Cornices, Timber Skirtings, Architraves and Windows, Carpet Tiles on Timber Floorboards.	No Sample Taken. No Asbestos Materials Sighted. 2638	A5	N/A
24 th June 2018

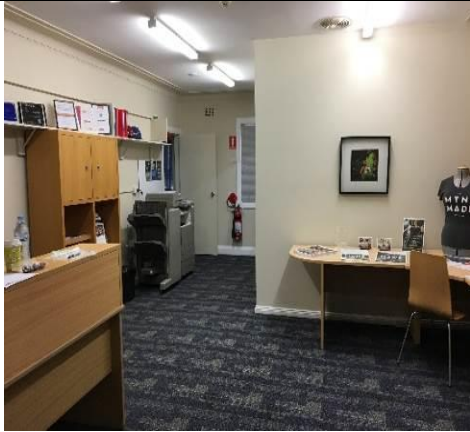
Internal - Foyer Area/Reception Plasterboard Walls, Plasterboard Ceiling, Plaster Cornices, Chipboard Infill Over Rendered Brick Fireplace, Timber Skirtings, Architraves and Windows, Carpet Tiles on Timber Floorboards.	No Sample Taken. No Asbestos Materials Sighted. 2639	A5	N/A

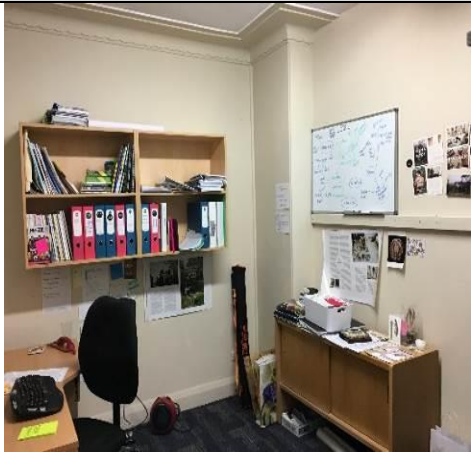
Internal - North-East Office Plasterboard Walls, Plasterboard Ceiling, Plaster Cornices, Chipboard Infill Over Rendered Brick Fireplace, Timber Skirtings, Architraves and Windows, Carpet Tiles on Timber Floorboards.	No Sample Taken. No Asbestos Materials Sighted. 2640	A5	N/A
24 th June 2018

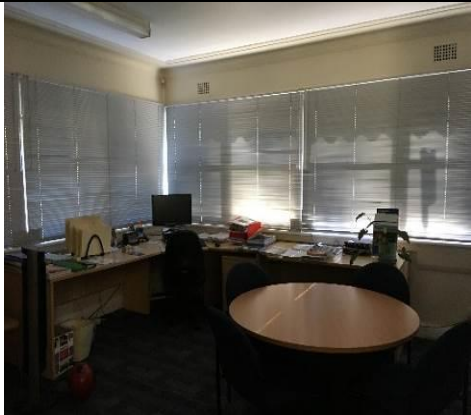
Internal - North-West Office Plasterboard Walls, Plasterboard Ceiling, Plaster Cornices, Timber Skirtings, Architraves and Windows, Carpet Tiles on Timber Floorboards.	No Sample Taken. No Asbestos Materials Sighted. 2641	A5	N/A

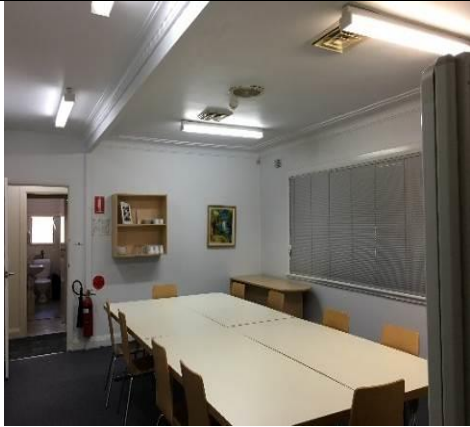
Internal - Meeting Room Plasterboard Walls, Plasterboard Ceiling, Plaster Cornices, Timber Skirtings, Architraves and Windows, Carpet Tiles on Timber Floorboards, Timber Step in North-West Corner, Timber Support Beam.	No Sample Taken. No Asbestos Materials Sighted. 2642	A5	N/A
24 th June 2018

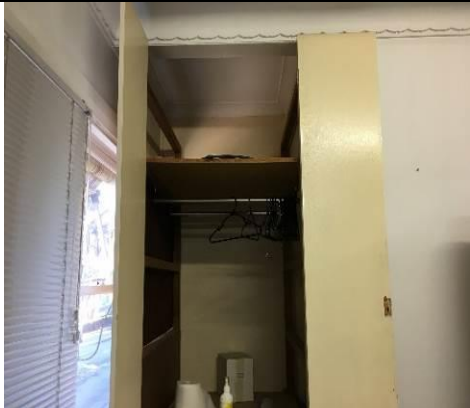
Internal - Cupboard in Meeting Room Masonite and Timber Construction, Plasterboard Ceiling, Plasterboard Walls, Plaster Cornice, Timber Window.	No Sample Taken. No Asbestos Materials Sighted. 2643	A5	N/A

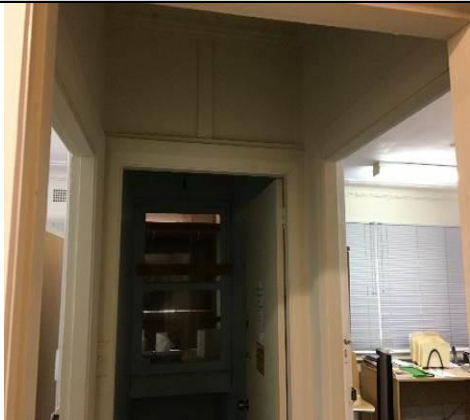
Internal - Void Above Stairwell Plasterboard North and South Walls, Timber with Glass Infills on East and West Walls, Timber Skirting and Architraves, Carpet Tiles on Timber Floor.	No Sample Taken. No Asbestos Materials Sighted. 2644	A5	N/A
24 th June 2018

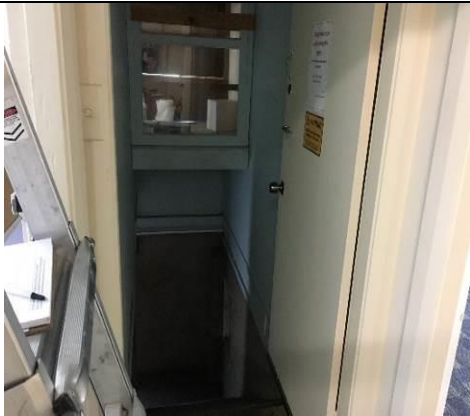
Internal - Upper Stairwell Rendered Brick on Northern Wall To 1500mm, Masonite to 1700mm, Plasterboard Above. Southern Side is Plasterboard With 300mm of Masonite Below. East Wall Glass Window, Carpet on Timber Stairs.	No Sample Taken. No Asbestos Materials Sighted. 2645	N/A	N/A

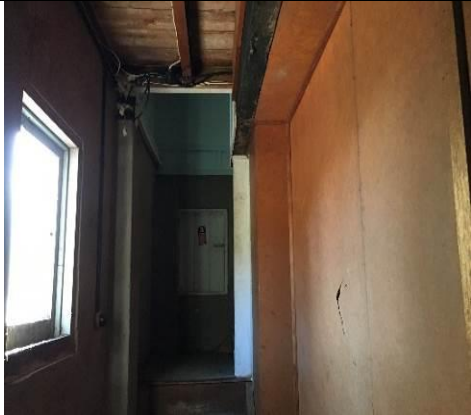
Internal - Lower Stairwell Rendered Brick West Wall, Timber East Wall, Timber Floorboards on Ceiling, Timber Stairs, Concrete Floor. 2650	No Sample Taken. No Asbestos Materials Sighted.	A5	N/A
24 th June 2018

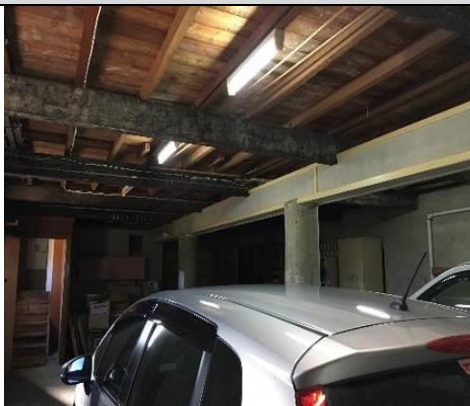
Internal - Garage Rendered Brick Walls, 2 Aluminium Roller Doors, Concrete Supports, Timber Support Beam Running East-West, Concrete Floor, Timber Floorboard Ceiling.	No Sample Taken. No Asbestos Materials Sighted. 2652	A5	N/A
24 th June 2018

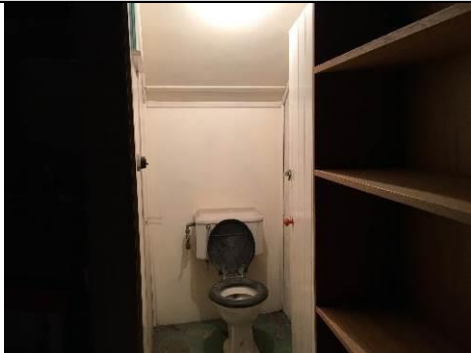
Internal- Toilet in Garage Concrete Floor, Timber Door, Architraves, Cover Strips and Window Frame, Ceramic Cistern, Concrete Northern Wall.	N/A	N/A	N/A
24 th June 2018

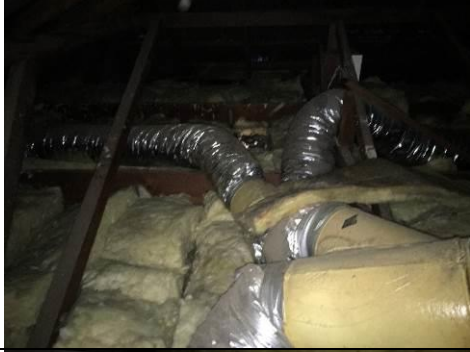
Ceiling Space-Timber Structural Framing, Aluminium Foil Ducting, SMF Insulation. 2662	No Sample Taken. No Asbestos Materials Sighted.	A5	N/A
24 th June 2018

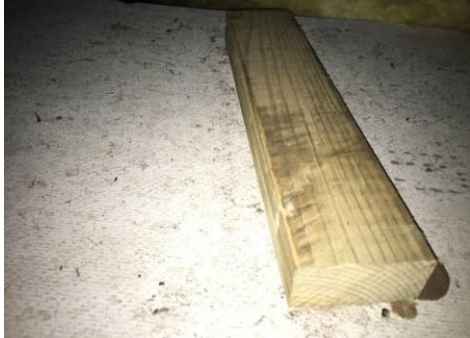
Ceiling Space-Man Hole Cover. Fibre Cement 2663	Sample B18167-S1 No Asbestos Detected.	A5	N/A

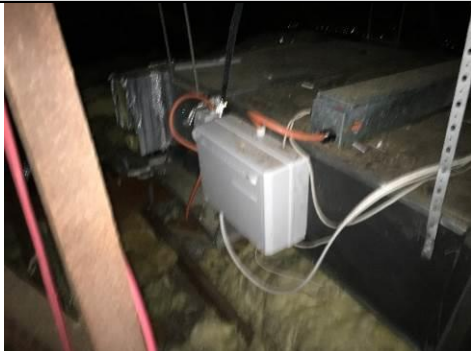
Ceiling Space-A/C System Aluminium Ducting. 2664	No Sample Taken. No Asbestos Materials Sighted.	A5	N/A
24 th June 2018

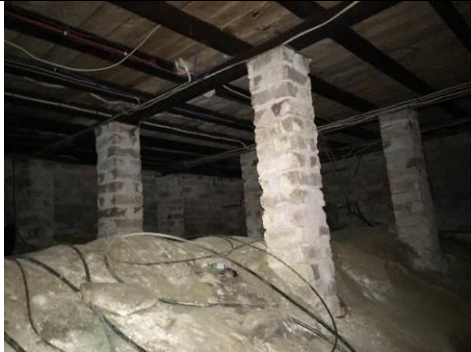
Subfloor-Southern Subfloor Timber Framing and Brick Piers. 2665	No ACM Materials Sighted, However Limited Access Was Available Due to Sloping Subfloor.	N/A	N/A
24 th June 2018

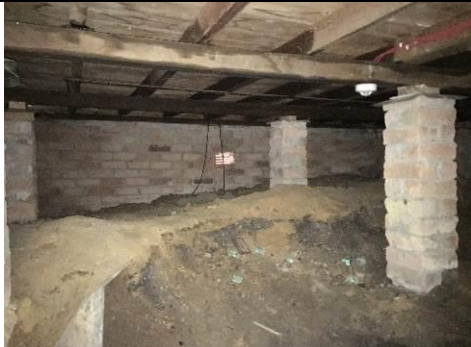
Subfloor-Northern Subfloor Timber Framing and Brick Piers. 3389	N/A	N/A	N/A

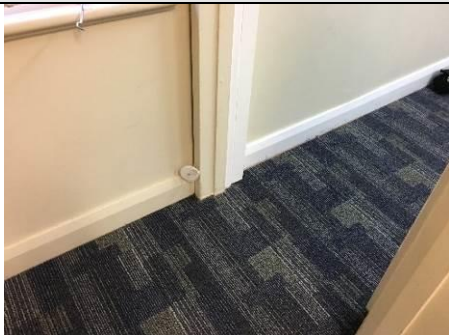
Internal Skirting and Architraves Throughout	0.21% w/w	A4	Paint classified as lead based more than 0.1% w/w
Sample No 2 (194882-2)

Lead based paints were detected at the BMEE Cottage located at 2 Civic Place, Katoomba, NSW, 2780. As good practice all existing paint, even if it is below the recognised standard, should not be sanded and that dust minimisation techniques should be adopted when undertaking renovation/repair works particularly in heritage period buildings. It would be good practice to wear a

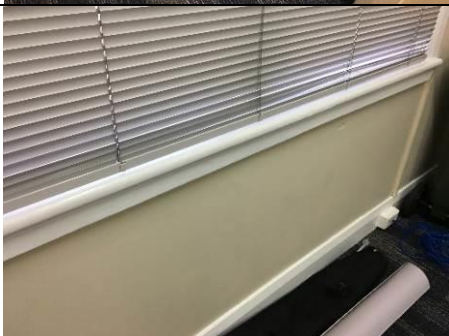
Internal Window Sills Throughout	4.4% w/w	A4	Paint classified as lead based more than 0.1% w/w

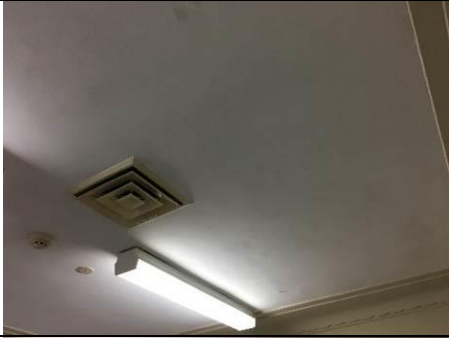
Internal Ceilings Throughout	0.27% w/w	A4	Paint classified as lead based more than 0.1% w/w
Sample No 4 (194882-4)

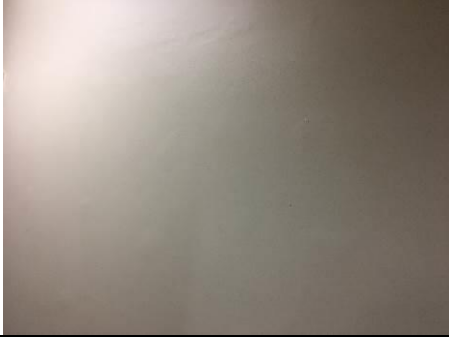
Internal Walls Throughout	0.08% w/w	A5	Paint not classified as lead based as less than or equal to 0.1% w/w
Sample No 5 (194882-5)

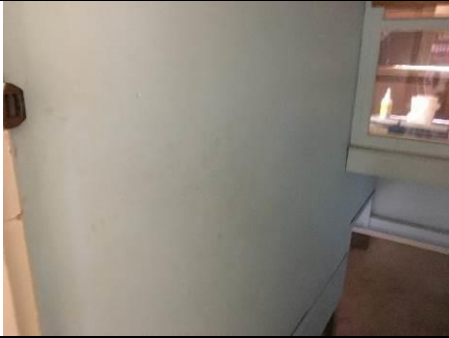
Internal Blue Paint in Stairwell	7.7% w/w	A4	Paint classified as lead based more than 0.1% w/w
Sample No 6 (194882-6)

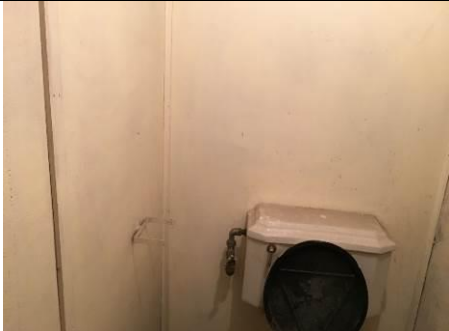
Internal Yellow Paint Garage Toilet	0.97% w/w	A4	Paint classified as lead based more than 0.1% w/w

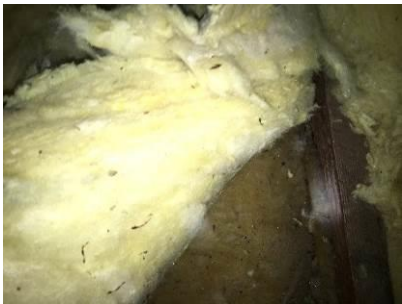
Ceiling Space-Old Yellow Batt Insulation	Visual Inspection	A4	Good Bonded, Not High Risk
24 th June 2018

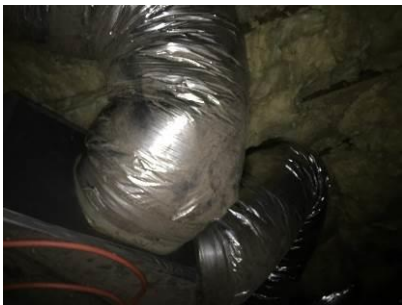
Ceiling Space- Insulation inside A/C Ducting	Visual Inspection	A4	Good Bonded, Not High Risk

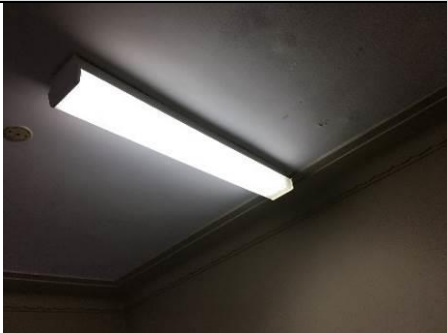
South-East Office Double Light x2 Fluorescent Lights No PCB's Observed	Visual Inspection	A5	N/A
24 th June 2018

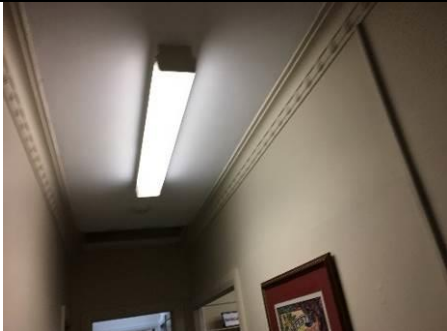
East to West Hallway, Double Long Light Fluorescent Lights No PCB's Observed	Visual Inspection	A5	N/A

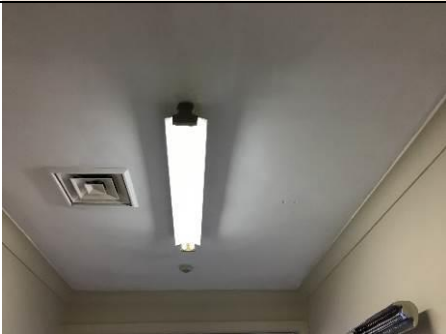
Kitchen Double Light Fluorescent Lights No PCB's Observed	Visual Inspection	A5	N/A
24 th June 2018

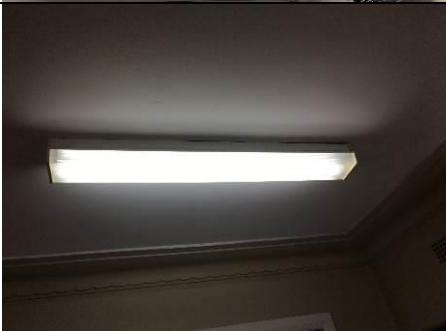
South West Office Double Light x 2 Fluorescent Lights No PCB's Observed	Visual Inspection	A5	N/A

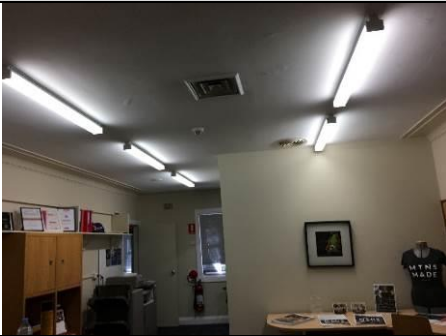
Reception/Foyer Fluorescent Lights x5 No PCB's Observed	Visual Inspection	A5	N/A
24 th June 2018

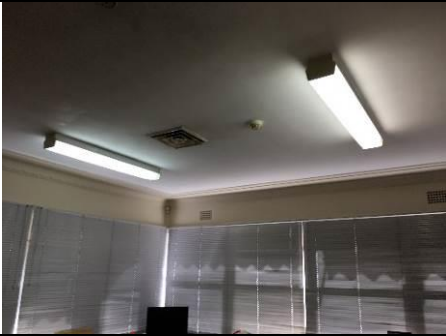
North-West Office Double Light x 2 Fluorescent Lights No PCB's Observed	Visual Inspection	A5	N/A
24 th June 2018

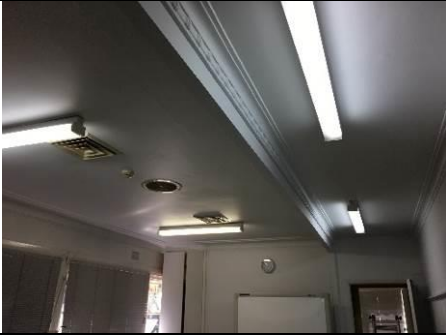
Meeting Room x 4 Fluorescent Lights No PCB's Observed	Visual Inspection	A5	N/A
24 th June 2018

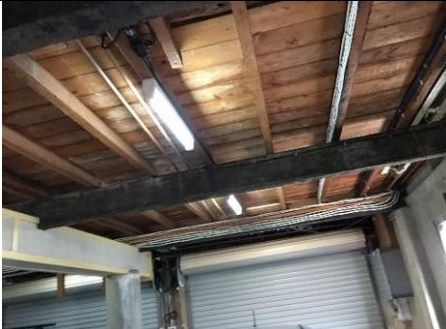
Garage Small Single Light x 5 Fluorescent Lights No PCB's Observed	Visual Inspection	A5	N/A

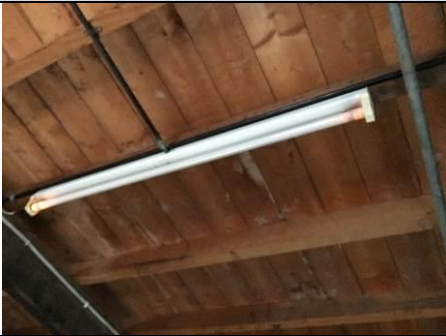
Garage Long Single Light x 2 Fluorescent Lights No PCB's Observed	Visual Inspection	A5	N/A
24 th June 2018

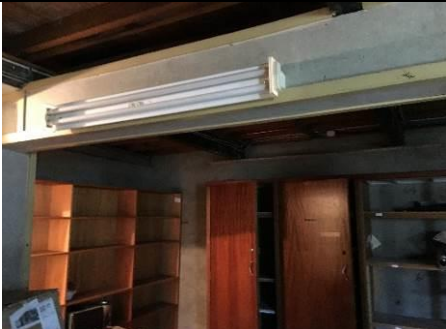
Garage Long Double Light x 2 Fluorescent Lights No PCB's Observed	Visual Inspection	A5	N/A

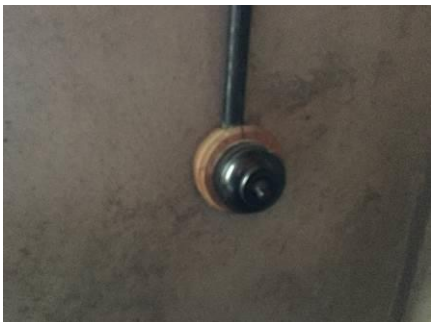
Bakelite Switch in Stairwell	Assume Contains Phenols, Visual Inspection	A4	Good Condition, Refer to Management Plan
24 th June 2018

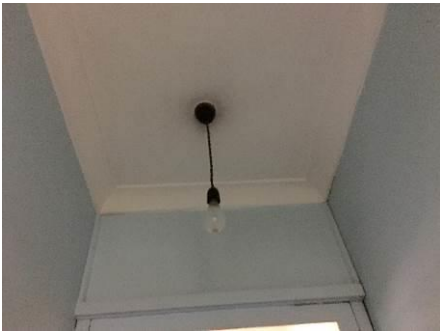
Bakelite Light Fitting in Stairwell	Assume Contains Phenols, Visual Inspection	A4	Good Condition, Refer to Management Plan
24 th June 2018

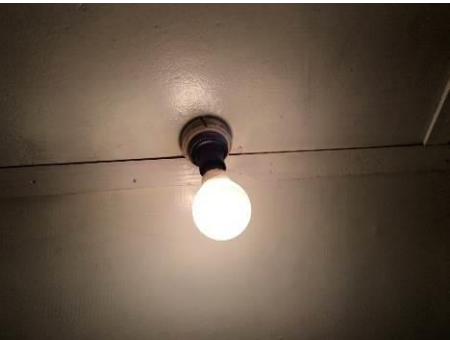
Bakelite Light Fitting in Garage Toilet	Assume Contains Phenols, Visual Inspection	A4	Good Condition, Refer to Management Plan
24 th June 2018

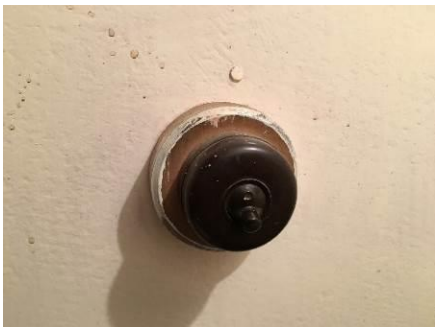
Bakelite Switch in Garage Toilet	Assume Contains Phenols, Visual Inspection	A4	Good Condition, Refer to Management Plan

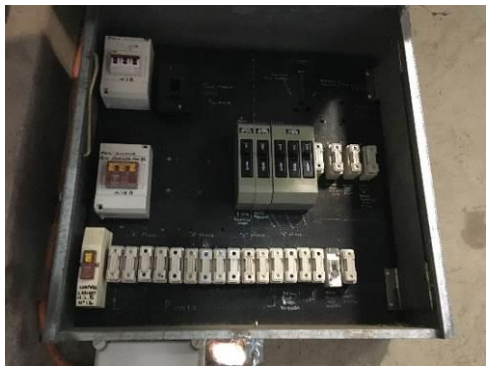
Bakelite Backing Board and Switches on Meter board in Garage	Assume Contains Phenols, Visual Inspection	A4	Good Condition, Refer to Management Plan
