Asbestos Register

HAZARDOUS MATERIALS REGISTER

Regional EnviroScience Pty Ltd was requested by Mr. Jason Adams of Blue Mountains City Council to undertake a Hazardous Building Materials Register and to prepare a Hazardous Materials Management Plan of the property known as the Blue Mountains City Council Headquarters, 2-6 Civic Place, Katoomba, NSW, 2780. The purpose of the audit was to locate and identify asbestos based building materials and product within the building in accordance with the *NSW Work Health and Safety Act 2011* and *NSW Work Health and Safety Regulation 2017* and the *Code of Practice: How to Manage and Control Asbestos in the Workplace [Safe Work Australia: 2016]* and the *Code of Practice: How to Safely Remove Asbestos [Safe Work Australia: 2016]*.

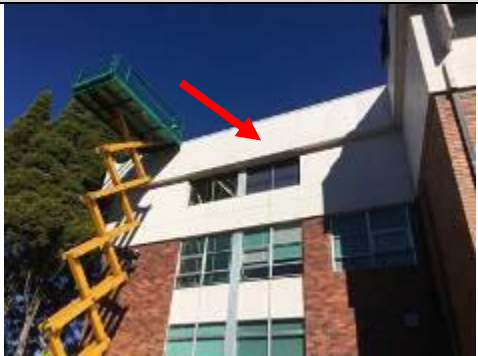
External-Fascia Boards. Surrounding the Top Level Fibre Cement Approx. 200m ² 2278	Sample B18780-S1 Chrysotile and Amosite Asbestos Detected Non-Friable	A4	Good Condition, Accessible to Tradespeople Refer to Management Plan
24 th June 2018

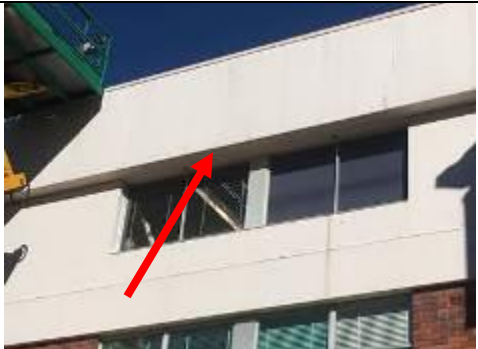
External-Soffit. Surrounding the Top Level Fibre Cement Approx. 40m ² 2279	Sample B18780-S2 Chrysotile Asbestos Detected Non-Friable	A4	Good Condition, Accessible to Tradespeople Refer to Management Plan

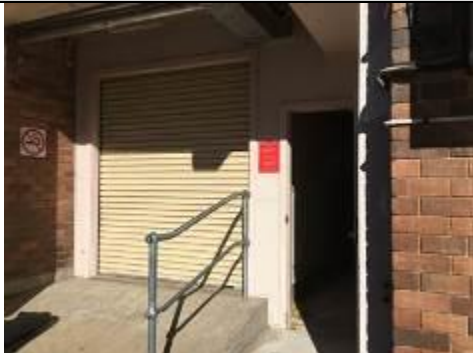
External-North-West Aspect Wall Infills Around Exit and Roller Door Fibre Cement 2280	Sample B18780-S3 No Asbestos Detected	A5	N/A
24 th June 2018

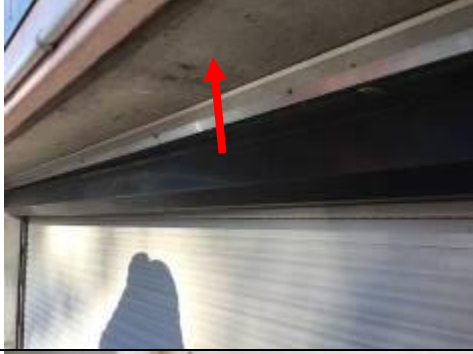
External-Northern Aspect Infills Above Roller Doors Fibre Cement 2281	Sample B18780-S4 No Asbestos Detected	A5	N/A
24 th June 2018

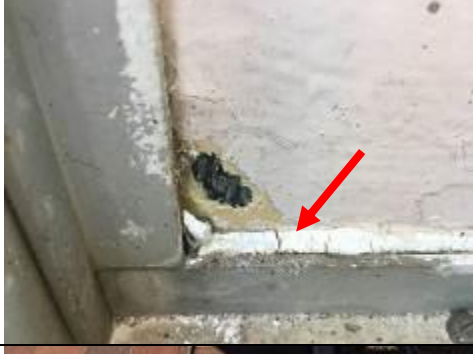
External-Northern Aspect Mastic in Spandrel Panels 2282	Sample B18780-S5 No Asbestos Detected	A5	N/A
24 th June 2018

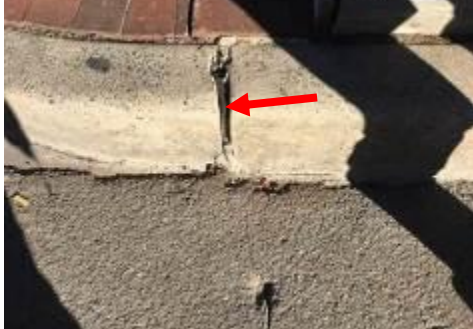
External-Carpark Expansion Joints in Carpark Kerbing 2283	Sample B18780-S6 No Asbestos Detected	A5	N/A

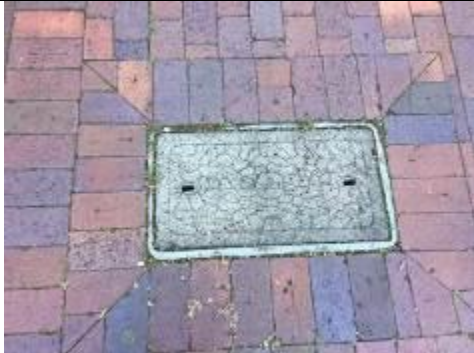
External- Eastern Aspect Telstra Pit 1m ² 2284	No Sample Taken, Assume Contains Asbestos Non-Friable	A4	Good Condition, Accessible to Tradespeople Refer to Management Plan
24 th June 2018

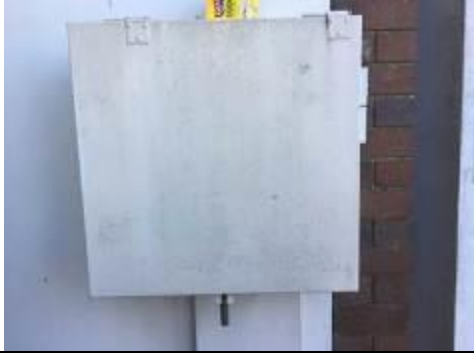
External-South-East Aspect Electrical Meter Board Nil Access 2285	No Sample Taken, Assume Contains Asbestos Non-Friable	A4	Good Condition, Accessible to Tradespeople Refer to Management Plan
24 th June 2018

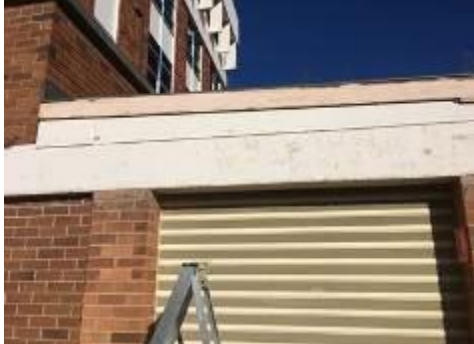
External-North-West Aspect Fascia on External Garage Fibre Cement Approx. 1m ² 2286	Sample B18780-S7 Chrysotile and Amosite Asbestos Detected Non-Friable	A4	Good Condition, Accessible to Tradespeople Refer to Management Plan

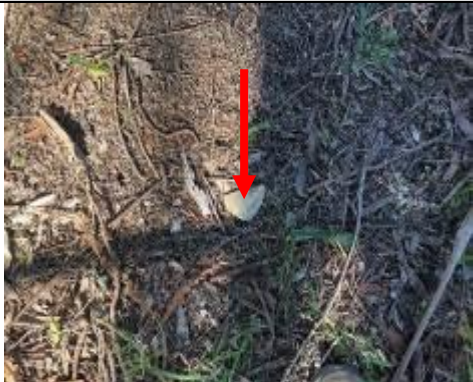
External- Lower Carpark in North-West Corner Fibre Cement Debris 2287	Sample 18780-S8 Chrysotile Asbestos Detected Non-Friable	A3	Piece of Debris removed during Sampling, no other Debris sighted, area to be periodically checked Refer to Management Plan
24 th June 2018

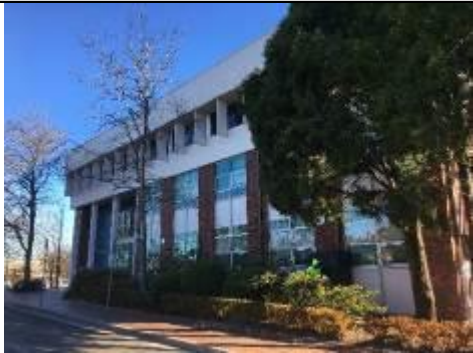
<p style="color: red; text-align: center;">2290</p>	External-Eastern Aspect Fibre Cement Fascia, Fibre Cement Soffit, Fibre cement Shade Panels, Brick walls, Aluminium Framed Windows, Concrete Fascia Below Second Story Windows, Tiled Wall at Entrance, Cement Pillars, Metal Spandrel Panels	Similar to Sample B18780-S1 & B18780-S2 Chrysotile and Amosite Asbestos Detected Non-Friable	A4	Good Condition, Accessible to Tradespeople Refer to Management Plan
24 th June 2018

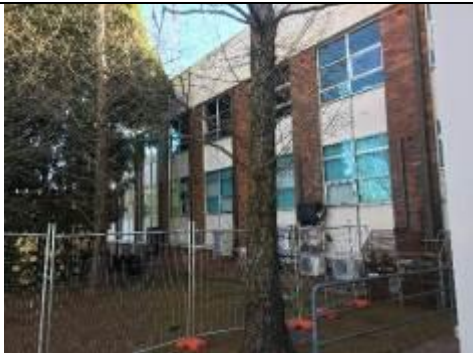
<p style="color: red; text-align: center;">2291</p>	External-Southern Aspect Fibre Cement Fascia, Fibre Cement Soffit, Metal Spandrel Panels, Brick Walls, Aluminium Windows, Concrete Fascia Below Level 2	Similar to Sample B18780-S1 & B18780-S2 Chrysotile and Amosite Asbestos Detected Non-Friable	A4	Good Condition, Accessible to Tradespeople Refer to Management Plan

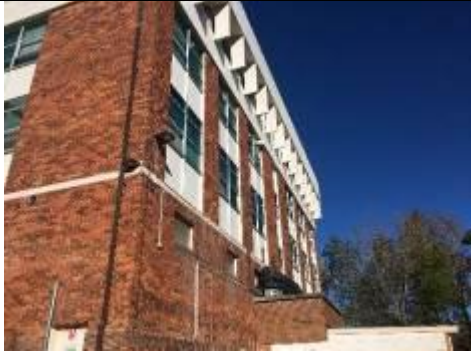
2292	External-Western Aspect Fibre Cement Fascia, Fibre Cement Soffit, Fibre Cement Shade Panels, Brick and Concrete Construction, Metal Spandrel Panels	Similar to Sample B18780-S1 & B18780-S2 Chrysotile and Amosite Asbestos Detected Non-Friable	A4	Good Condition, Accessible to Tradespeople Refer to Management Plan
24 th June 2018

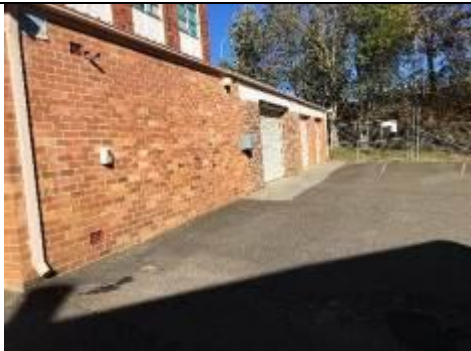
2293	External-Garages Brick Walls, Aluminium Roller Doors, Timber Fascia Board	No Sample Taken No Asbestos Containing Materials Sighted	A5	N/A

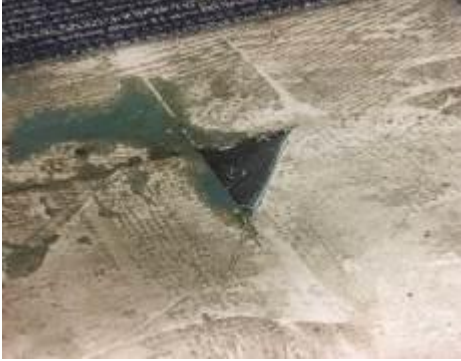
Lower Ground Floor Manager Information & Customer Service Green Vinyl Tiles Below Carpet Approx. 25m ²	Sample B18780-S12 Chrysotile Asbestos Detected Non-Friable 2294	A4	Poor Condition, Encapsulated by Carpet Tiles Accessible to Tradespeople Refer to Management Plan
24 th June 2018

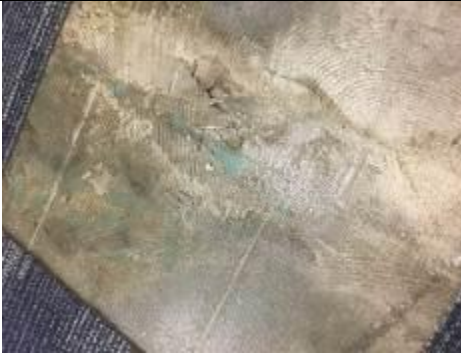
Lower Ground Floor First Aid Room Green Vinyl Tiles Below Carpet. Vinyl Coverage to be Determined Once Carpet is Removed.	Similar to Sample B18780-S12 Chrysotile Asbestos Detected Non-Friable 2295	A4	Poor Condition, Encapsulated by Carpet Tiles Accessible to Tradespeople Refer to Management Plan
24 th June 2018

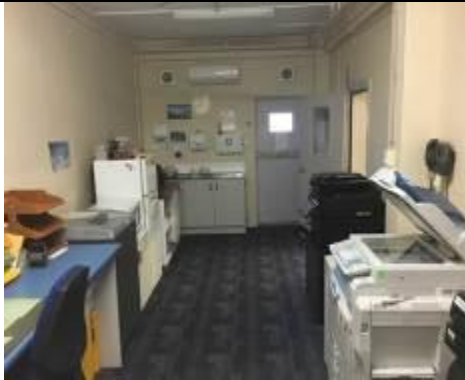
Lower Ground Floor Mail Room Concrete Render Ceiling, Concrete Render and Plasterboard Walls, Green Vinyl Under Carpet Tiles. Approx. 45m ²	Similar to Sample B18780-S12 Chrysotile Asbestos Detected Non-Friable 2298	A4	Poor Condition, Encapsulated by Carpet Tiles Accessible to Tradespeople Refer to Management Plan

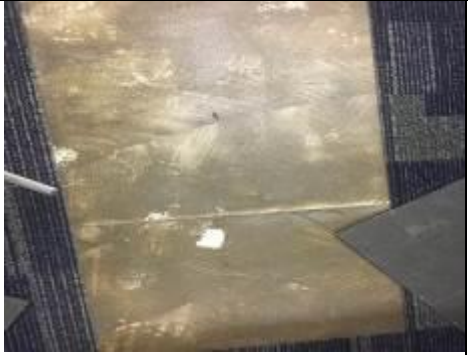
Lower Ground Floor- Help Desk Cream Vinyl Under Carpet Vinyl Coverage to be Determined Once Carpet is Removed	Sample B18780-S13 Chrysotile Asbestos Detected Non-Friable 2300	A4	Good Condition, Encapsulated by Carpet Tiles Accessible to Tradespeople Refer to Management Plan

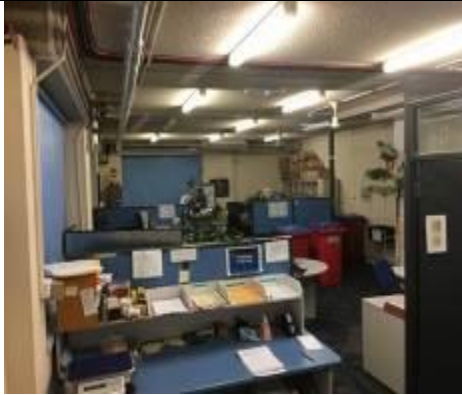
Lower Ground Floor-Records and Archives Vermiculite Ceiling, Concrete Render Walls, Timber Doors and Architraves, Aluminium Windows, Cream Vinyl Tiles Under Carpet. Vinyl Coverage to be Determined Once Carpet is Removed	Similar to Sample B18780-S13 Chrysotile Asbestos Detected Non-Friable 2302	A4	Good Condition, Encapsulated by Carpet Tiles Accessible to Tradespeople Refer to Management Plan
24 th June 2018

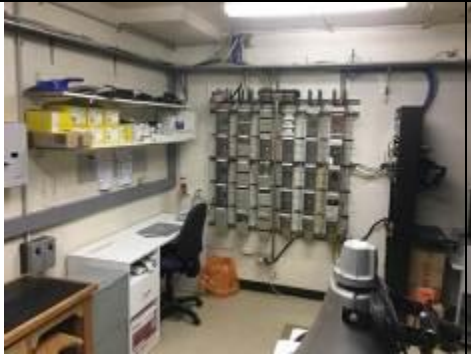
Lower Ground Floor-PABX Room Concrete Render / Brick Ceiling / Walls, Cream Vinyl Tiles. Approx. 20m ²	Similar to Sample B18780-S13 Chrysotile Asbestos Detected Non-Friable 2303	A4	Good Condition, Encapsulated by Carpet Tiles Accessible to Tradespeople Refer to Management Plan

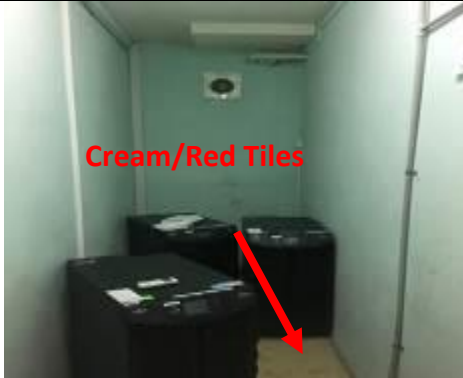
Lower Ground Floor UPS Room Rendered Concrete Ceiling and Walls Cream / Red Vinyl Tiles Approx. 15m ²	Sample B18780-S14 Chrysotile Asbestos Detected Non-Friable 2306	A4	Good Condition, Encapsulated by Carpet Tiles Accessible to Tradespeople Refer to Management Plan
24 th June 2018

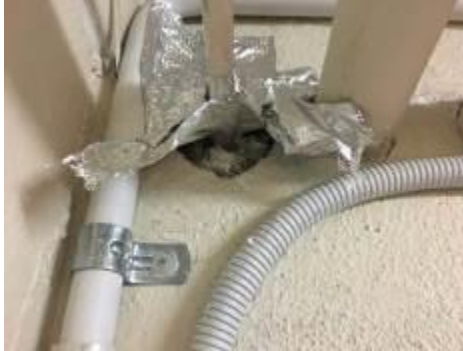
Lower Ground Floor Hall to Female Bathroom Pipe Lagging Friable	Sample B18780-S18 Amosite Asbestos Detected Friable 2307	A2	Poor Condition, Arrange for Removal Accessible to Tradespeople Refer to Management Plan
24 th June 2018

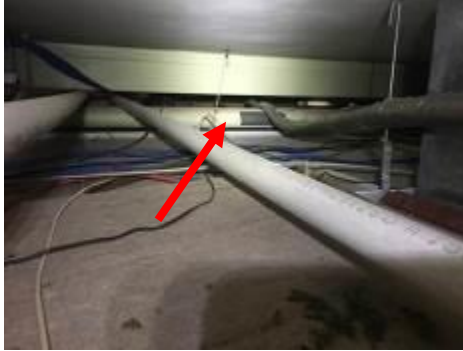
Lower Ground Floor Ceiling Space Above First Aid Room Assumed Lagged Pipe Information Provided by Jason Adams	Similar to Sample B18780-S18 Amosite Asbestos Detected Friable 2308	A3	Good Condition, Accessible to Tradespeople. Refer to Management Plan

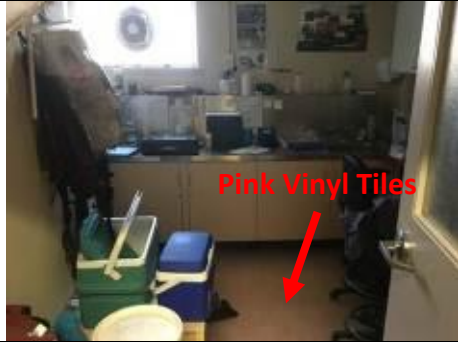
Lower Ground Floor Environmental Branch Floor Pink Vinyl Floor Covering Approx. 15m ²	Sample B18780-S19 Chrysotile Asbestos Detected Non-Friable 2309	A4	Good Condition, Accessible to Tradespeople Refer to Management Plan
24 th June 2018

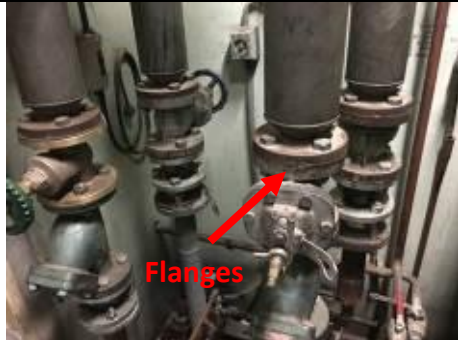
Lower Ground Floor Boiler Room Flanges Approximately 0.5m ²	Sample B18780-S21 Chrysotile Asbestos Detected Non-Friable 2310	A4	Good Condition, Accessible to Tradespeople Refer to Management Plan
24 th June 2018

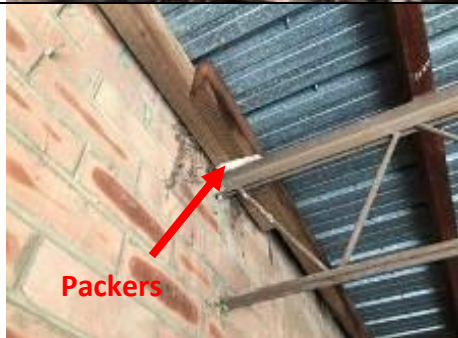
Lower Ground Floor Generator Garage Fibre Cement Packers. 2311	Sample B18780-S26 Chrysotile & Amosite Asbestos Detected. Non-Friable	A4	Good Condition Accessible to Tradespeople Refer to Asbestos Management Plan

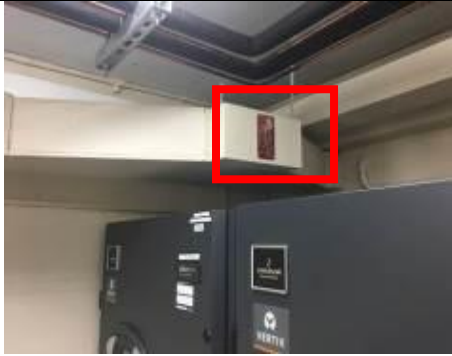
Lower Ground Floor Main Computer Room Heater Bank 2312	No Sample Taken, Assume Contains Asbestos, Could Not Sample as it Was in Use at Time of Inspection Friable	A3	Good Condition, No Damage Accessible to Tradespeople Refer to Management Plan
24th June 2018

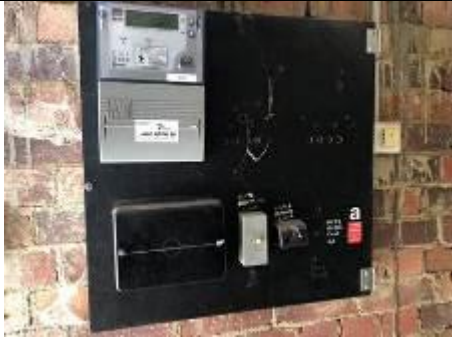
Lower Ground Floor Main Switchboard Room Bakelite Electrical Board on Northern Wall Adjacent Door.	No Sample Taken. Assume Contains Asbestos. Non-Friable. 2313	A4	Good Condition Accessible to Tradespeople Refer to Asbestos Management Plan.
24th June 2018

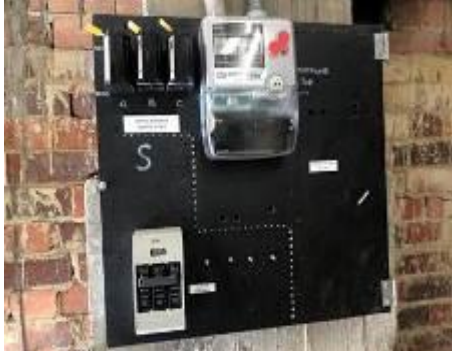
Lower Ground Floor Main Switchboard Room Bakelite Vodafone Meter Board on Northern Wall.	No Sample Taken. Assume Contains Asbestos. Non-Friable. 2314	A4	Good Condition Accessible to Tradespeople Refer to Asbestos Management Plan.

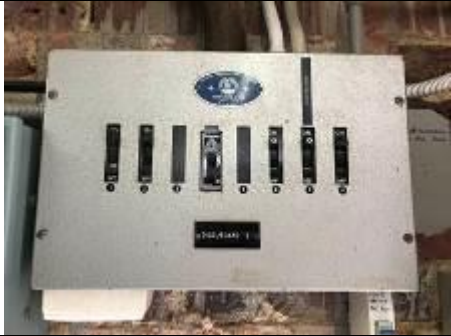
Lower Ground Floor Main Switchboard Room Distribution Board "E" Bakelite Fuse Switches. 2315	No Sample Taken. Assume Contains Asbestos. Non-Friable.	A4	Good Condition Accessible to Tradespeople Refer to Asbestos Management Plan.
24th June 2018

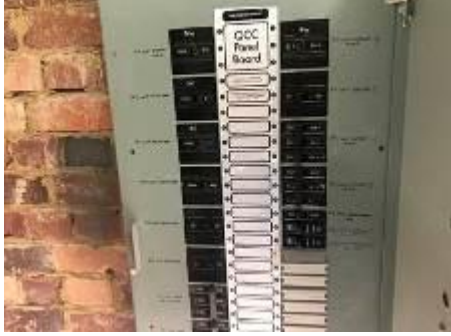
Lower Ground Floor Main Switchboard Room QCC Air Conditioning Switchboard Bakelite Switches. 2316	No Sample Taken. Assume Contains Asbestos. Non-Friable. 2316	A4	Good Condition Accessible to Tradespeople Refer to Asbestos Management Plan.
24th June 2018

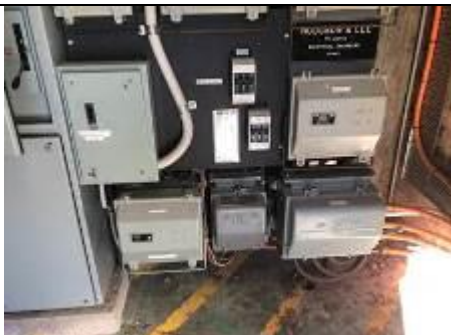
Lower Ground Floor Main Switchboard Room Section 2 Fuse Switches Bakelite Backing Board. 2317	No Sample Taken. Assume Contains Asbestos. Non-Friable. 2317	A4	Good Condition Accessible to Tradespeople Refer to Asbestos Management Plan.

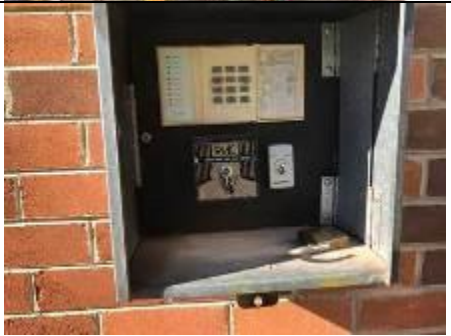
Lower Ground Floor Garage Adjacent Generator Garage Roller Door Access Point with Bakelite Backing Board. 2318	No Sample Taken. Assume Contains Asbestos. Non-Friable. 2318	A4	Good Condition, Accessible to Tradespeople Refer to Asbestos Management Plan.

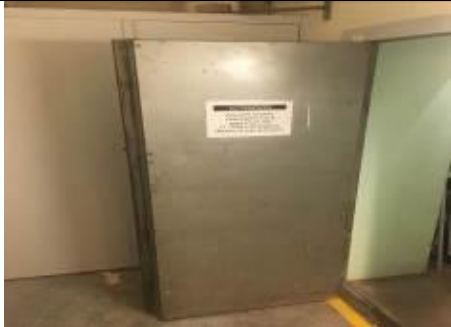
Lower Ground Floor Vault Door Insulation 2319	Sample B18780-S9 No Asbestos Detected	A5	N/A
24 th June 2018

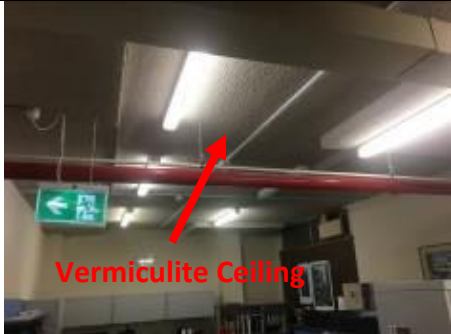
Lower Ground Floor IT Help Desk Ceiling Vermiculite 2320	Sample B18780-S10 No Asbestos Detected	A5	N/A
24 th June 2018

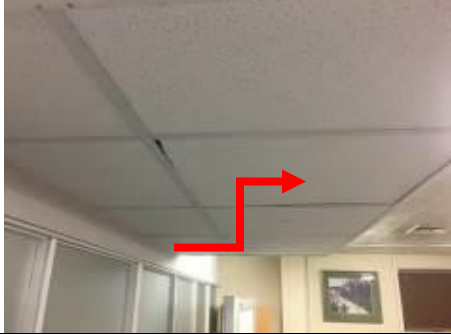
Lower Ground Floor Manager Information & Customer Service Suspended Ceiling 2321	Sample B18780-S11 No Asbestos Detected	A5	N/A
24 th June 2018

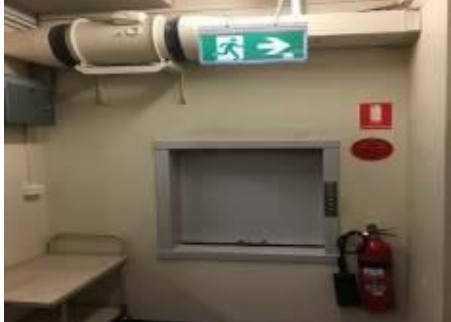
Lower Ground Floor Void to Hoist Concrete Render Walls, Vermiculite Ceiling, Carpet on Cream Tile Floor 2322	Similar to Sample B18780-S10 No Asbestos Detected	A5	N/A

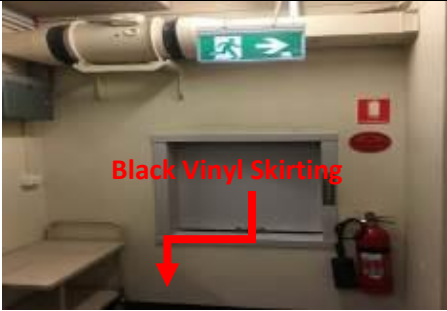
Lower Ground Floor Void to Hoist Black Vinyl Skirting 2323	Sample B18780-S15 No Asbestos Detected	A5	N/A
24 th June 2018

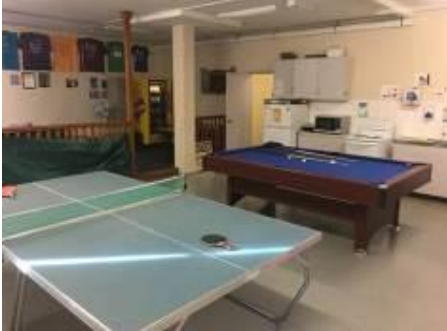
Lower Ground Floor Recreation Room Concrete Render Ceiling / Walls, East Wall Plasterboard Vinyl Floor	Sample B18780-S16 No Asbestos Detected 2324	A5	N/A
24 th June 2018

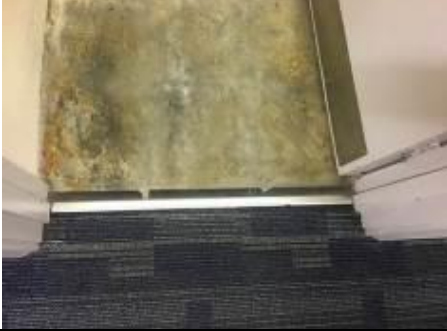
Lower Ground Floor Male Toilet Entrance Black Vinyl 2325	Sample B18780-S17 No Asbestos Detected	A5	N/A
24 th June 2018

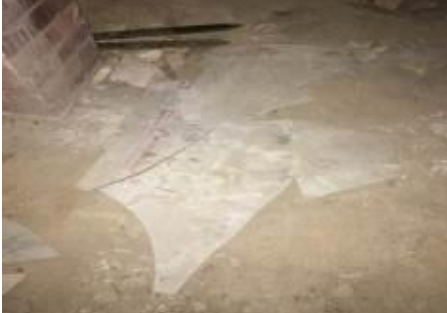
Lower Ground Floor Sub Floor Storage Debris 2326	Sample B18780-S20 No Asbestos Detected	A5	N/A

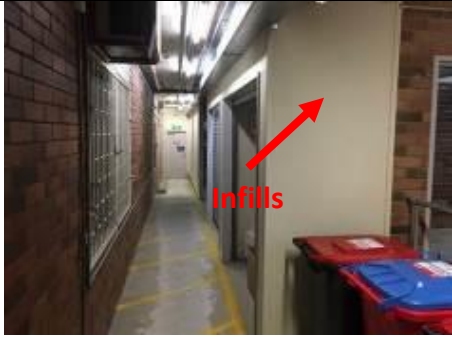
Lower Ground Floor Exit Hall Concrete Ceiling / Floor, Brick wall, Metal Roller Doors Fibre Cement Cupboard Infills	Sample B18780-S22 No Asbestos Detected 2327	A5	N/A
24 th June 2018

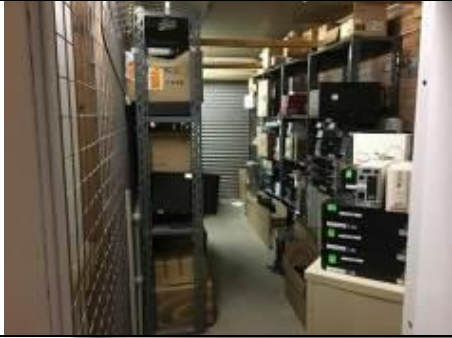
Lower Ground Floor-IT Store Fibre Cement West Wall, Concrete Render and Brick Walls, Concrete Ceiling	Similar to Sample B18780-S22 No Asbestos Detected 2328	A5	N/A
24 th June 2018

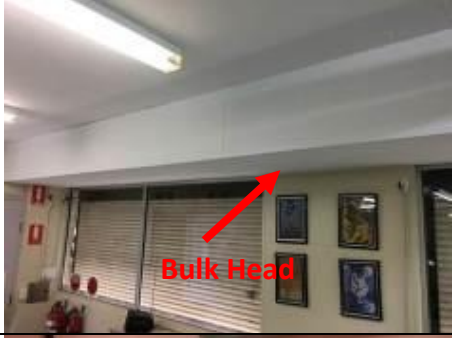
Lower Ground Floor Print Room Bulk Head	Sample B18780-S23 No Asbestos Detected 2329	A5	N/A
24 th June 2018

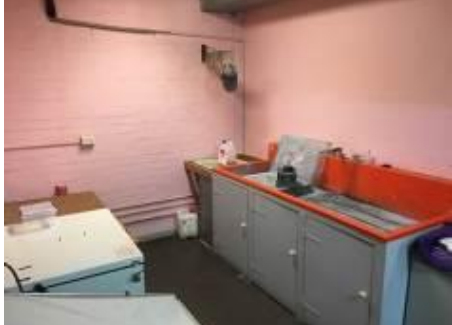
Lower Ground Floor Print Room Storage Concrete Render Ceiling, Brick Walls, Fibre Cement North Wall	Similar to Sample B18780-S23 No Asbestos Detected 2330	A5	N/A

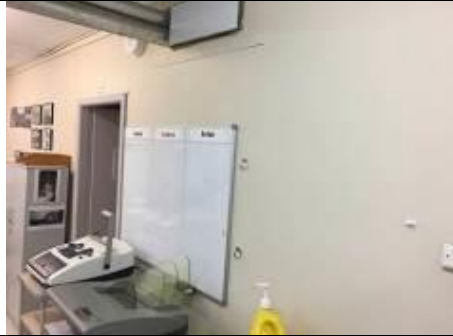
Lower Ground Floor Print Room South Wall 2331	Sample B18780-S24 No Asbestos Detected	A5	N/A
24 th June 2018

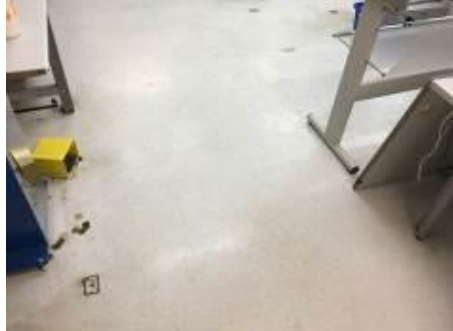
Lower Ground Floor Print Room Vinyl 2332	Sample B18780-S25 No Asbestos Detected	A5	N/A
24 th June 2018

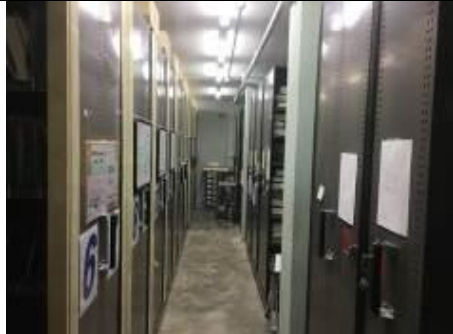
Lower Ground Floor Archives/Vault Concrete Ceiling, Walls and Floor, Aluminium Sliding Shelves 2333	No Sample Taken No Asbestos Containing Materials Sighted	A5	A5
24 th June 2018

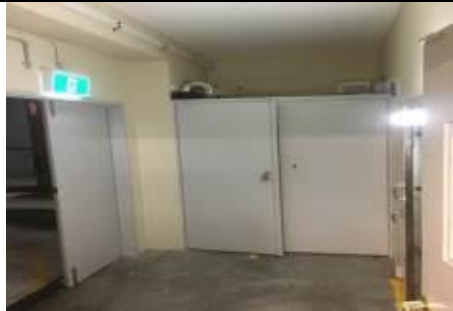
Lower Ground Floor Vault Void Concrete Ceiling, Walls and Floor 2334	No Sample Taken No Asbestos Containing Materials Sighted	A5	A5

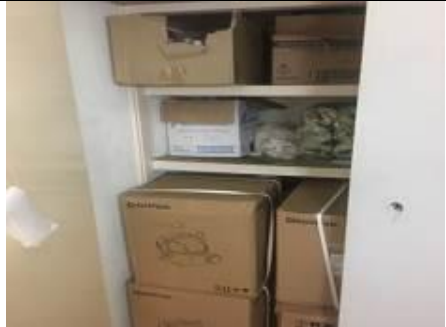
Lower Ground Floor Vault Void Storage Timber Door and Shelves, Concrete Walls 2335	No Sample Taken No Asbestos Containing Materials Sighted	A5	A5
24 th June 2018

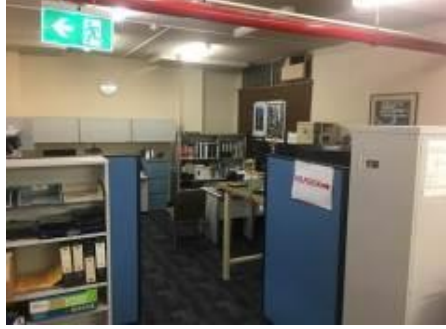
Lower Ground Floor IT Help Desk Concrete Render Walls, Carpet on Concrete Floor, Aluminium Window Frames 2336	No Sample Taken No Asbestos Containing Materials Sighted	A5	A5
24 th June 2018

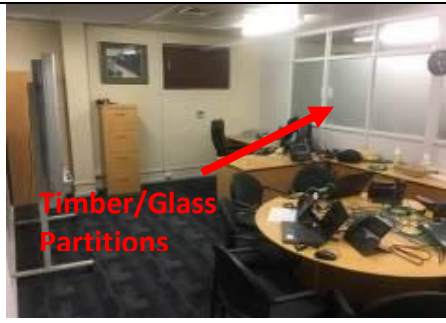
Lower Ground Floor Manager Information and Customer Service Timber and Glass Partitions, Carpet Tiles on Floor 2337	No Sample Taken No Asbestos Containing Materials Sighted	A5	A5
24 th June 2018

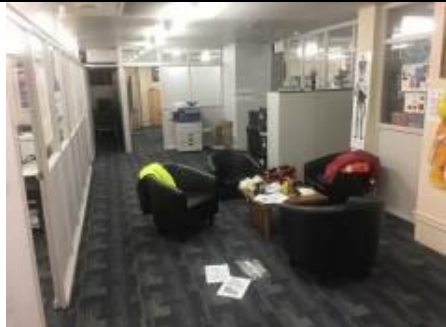
Lower Ground Floor First Aid Room Suspended Ceiling, Concrete Walls, Timber and Glass Partitions 2338	No Sample Taken No Asbestos Containing Materials Sighted	A5	A5

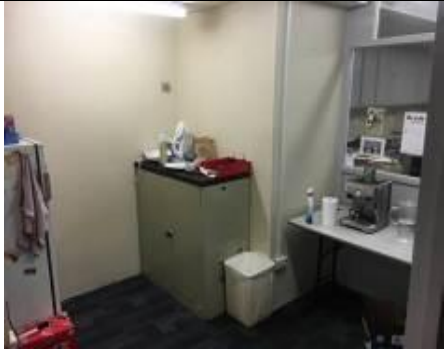
Lower Ground Floor Kitchen Concrete Render Walls, Timber Infill and Glass Partition Walls, Suspended SMF Ceiling, Carpet on Concrete Floor	No Sample Taken No Asbestos Containing Materials Sighted 2339	A5	A5
24 th June 2018

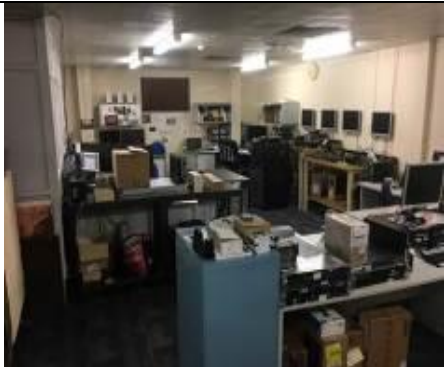
Lower Ground Floor Help Desk Aluminium and SMF Ceiling Panels, Concrete Render and Timber and Glass Walls	No Sample Taken No Asbestos Containing Materials Sighted 2340	A5	A5
24 th June 2018

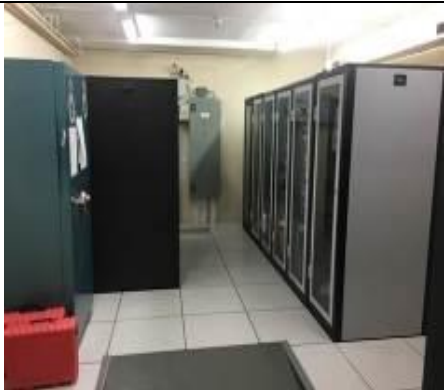
Lower Ground Floor Main Computer Room Concrete Render Ceiling and Walls, Plasterboard Infills, New Vinyl Floor Covering Entry Ramp, Ceramic Tile Floor	No Sample Taken No Asbestos Containing Material Sighted 2341	N/A	N/A

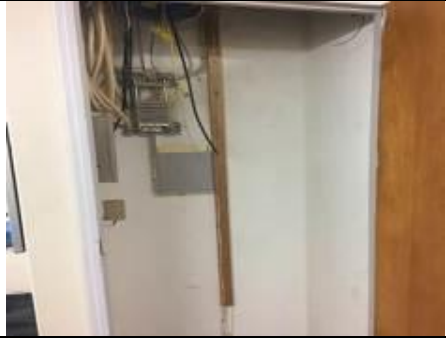
Lower Ground Floor Storage Cupboard Concrete Render and Timber Door/Door Frame 2342	No Sample Taken No Asbestos Containing Materials Sighted	A5	A5
24 th June 2018

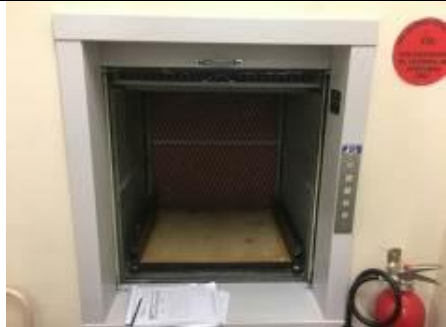
Lower Ground Floor Service Lift 2343	No Sample Taken No Asbestos Containing Materials Sighted	A5	A5
24 th June 2018

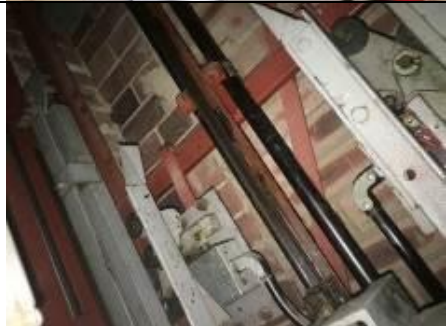
Lower Ground Floor Service Lift Mechanics 2344	No Sample Taken No Asbestos Containing Materials Sighted	A5	A5
24 th June 2018

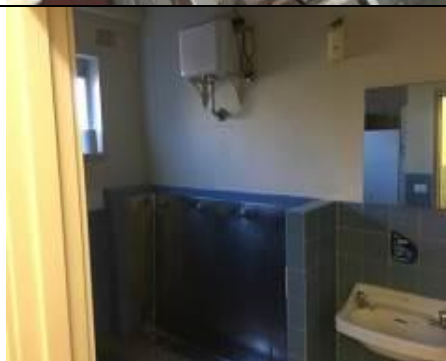
Lower Ground Floor Male Toilet and Shower Concrete Render Walls, Ceramic Tile Floors, Ceramic Tiles on Walls to 2 meters, Terrazzo Partitions 2345	No Sample Taken No Asbestos Containing Materials Sighted	A5	A5

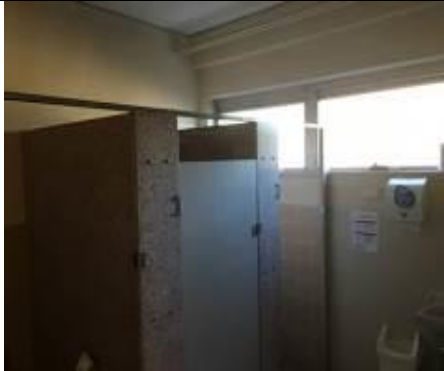
Lower Ground Floor Female Toilet and Showers Rendered Concrete Walls, Ceramic Tile Floors, Ceramic Tile Walls To 2 Metres, Terrazzo Partitions	No Sample Taken No Asbestos Containing Materials Sighted 2346	A5	A5
24 th June 2018

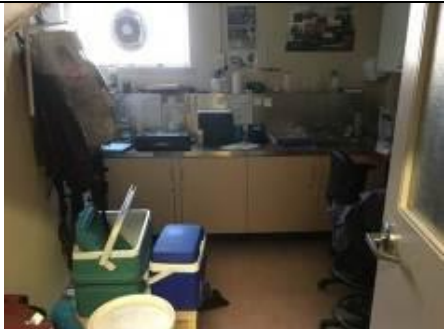
Lower Ground Floor Environment Branch Concrete Render Walls and Ceiling	No Sample Taken No Asbestos Containing Materials Sighted 2347	A5	A5
24 th June 2018

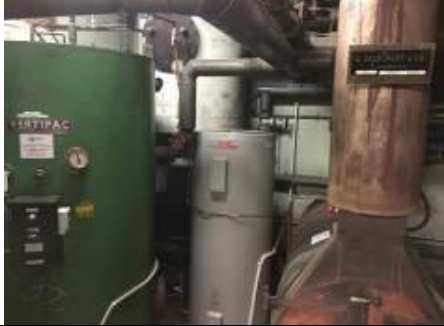
Lower Ground Floor Boiler Room Concrete Render Ceiling and Walls	No Sample Taken No Asbestos Containing Materials Sighted 2348	A5	A5
24 th June 2018

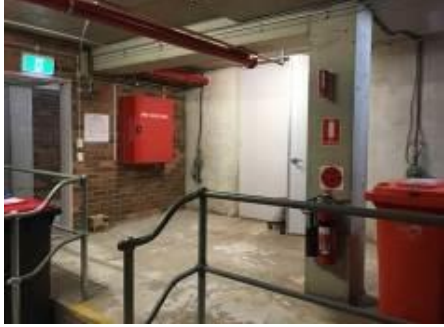
Lower Ground Floor Void Outside Boiler Room Concrete / Brick Walls, Concrete Floor, Metal Rails, Metal / PVC Piping	No Sample Taken No Asbestos Containing Materials Sighted 2349	A5	A5

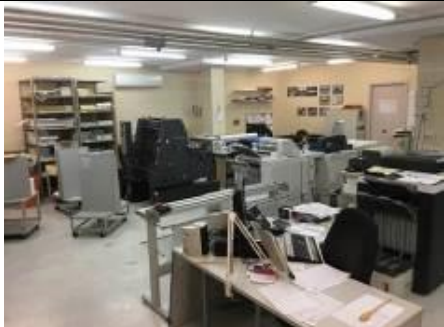
Lower Ground Floor Print Room Concrete Render Ceiling, Brick Walls 2350	No Sample Taken No Asbestos Containing Materials Sighted	A5	A5
24 th June 2018

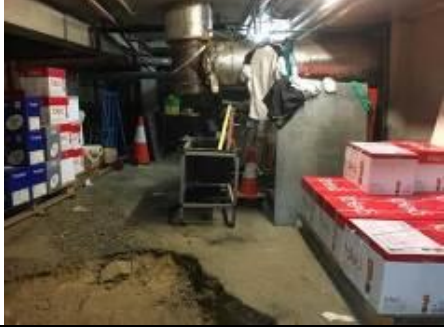
Lower Ground Floor Subfloor Storage Area 2351	No Sample Taken No Asbestos Containing Materials Sighted	A5	A5
24 th June 2018

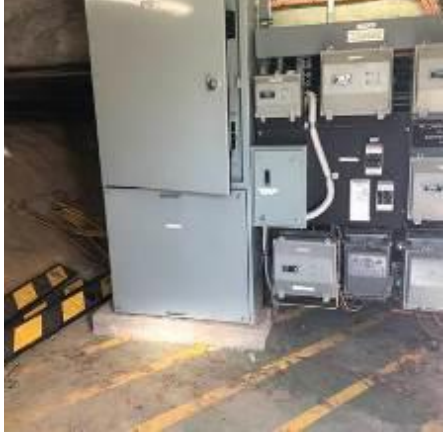
Lower Ground Floor Main Switchboard Room Entrance Concrete Floor & Ceiling, Northern & Western Brick Walls, Southern & Eastern Walls Concrete, Timber Door & Frame. 2352	No Sample Taken No Asbestos Containing Materials Sighted	A5	A5

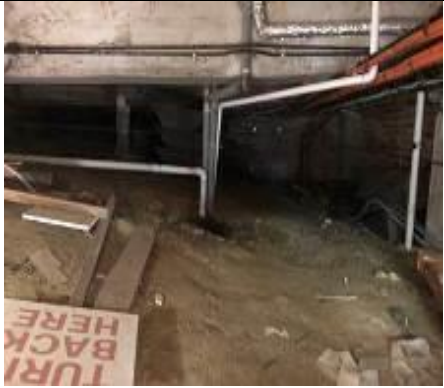
Lower Ground Floor Main Switchboard Room Subfloor Area Dirt Floor & Ceiling, Northern & Western Brick Walls, Southern & Eastern Walls Concrete, Stored Building Materials.	No Sample Taken No Asbestos Containing Materials Sighted 2353	A5	A5
24th June 2018

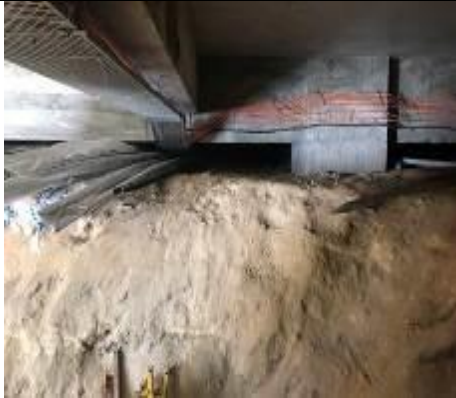
Lower Ground Floor Main Switchboard Room Subfloor Area Dirt Floor & Ceiling, Northern & Western Brick Walls, Southern & Eastern Walls Concrete, Stored Building Materials.	No Sample Taken. No Asbestos Containing Materials Sighted. 2354	A5	N/A

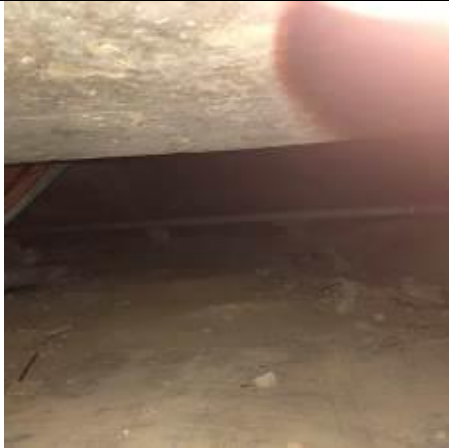
Lower Ground Floor Main Switchboard Room Subfloor Area Dirt Floor & Ceiling, Northern & Western Brick Walls, Southern & Eastern Walls Concrete, Stored Building Materials.	No Sample Taken. No Asbestos Containing Materials Sighted. 2355	A5	N/A
24th June 2018

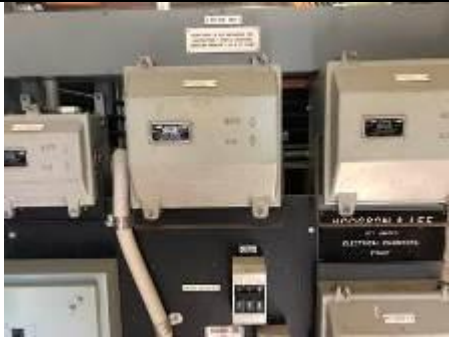
Lower Ground Floor Main Switchboard Room Section 2 Fuses 2356	No Sample Taken. No Asbestos Containing Materials Sighted. May Contain Phenols.	A5	N/A
24th June 2018

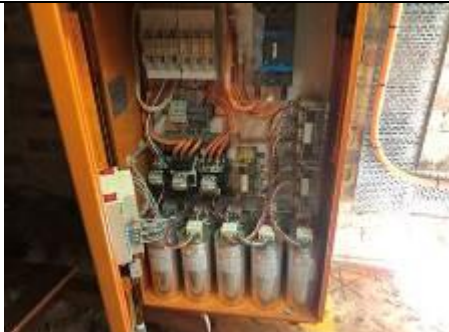
Lower Ground Floor Main Switchboard Room Power Factor Correction Capacitor Bank. 2357	No Sample Taken. No Asbestos Containing Materials Sighted. 2357	A5	N/A

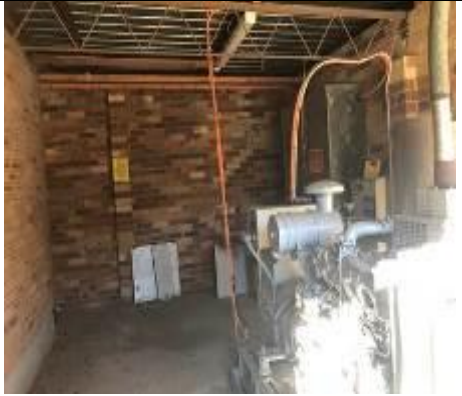
Lower Ground Floor Generator Garage Steel Corrugated Roof, Timber & Steel Supports, Brick Walls, Concrete Floor, Steel Roller Door, Steel Generator, Concrete Infill Above Door.	No Sample Taken. No Asbestos Containing Materials Sighted. 2358	A5	N/A
24th June 2018

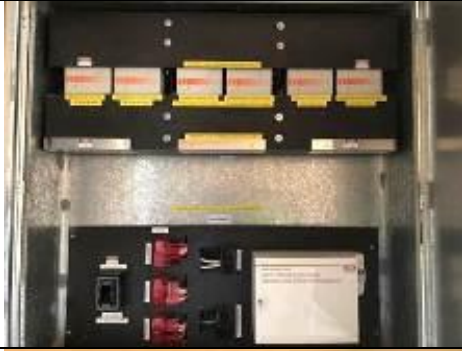
Lower Ground Floor Generator Garage Generator Power Boards New Type	No Sample Taken. No Asbestos Containing Materials Sighted. 2359	A5	N/A
24th June 2018

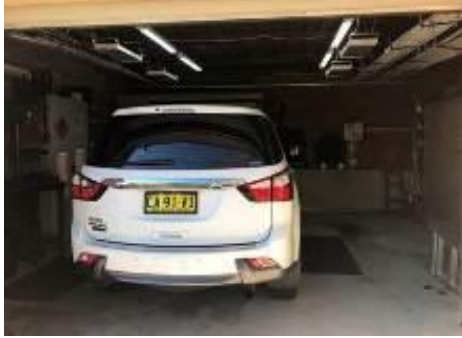
Lower Ground Floor Garage Adjacent Generator Garage Steel Roof, Timber & Metal Supports, Metal Roller Door to West, North, West & East Brick Walls, South Filing Cabinet Division Wall, Concrete Floor & Bench to East.	No Sample Taken. No Asbestos Containing Materials Sighted. 2360	A5	N/A

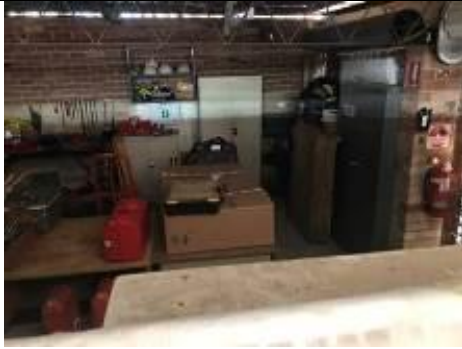
Lower Ground Surveyors Garage Steel Roof, Timber & Metal Supports, 2x Roller Doors, South, East & West Brick Walls, North Filing Cabinet Division Wall, Concrete Floor & Bench to East.	No Sample Taken. No Asbestos Containing Materials Sighted. 2361	A5	N/A

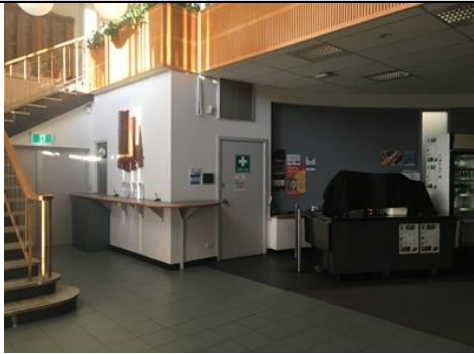
Ground Floor Reception/Waiting Area Ceramic Tiled & Carpet Floor, Timber Panelling, Terrazzo Staircase, Plasterboard & Rendered Brick Walls.	No Sample Taken. No Asbestos Materials Observed. 2362	A5	N/A
23 rd June 2018

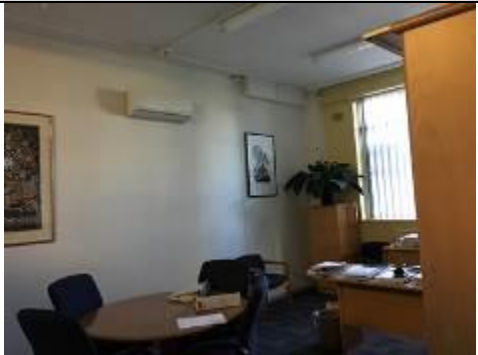
Ground Floor Group Manager Office Carpet Tiles, Plasterboard Walls, Concrete Ceiling, Timber Window Frame, Vinyl tiles under carpet Approx. 10m ²	Similar to Sample B18780-S35 Chrysotile Asbestos Detected Non-Friable 2366	A4	Good Condition, Encapsulated by Carpet tiles Accessible to Tradespeople Refer to Management Plan
23 rd June 2018

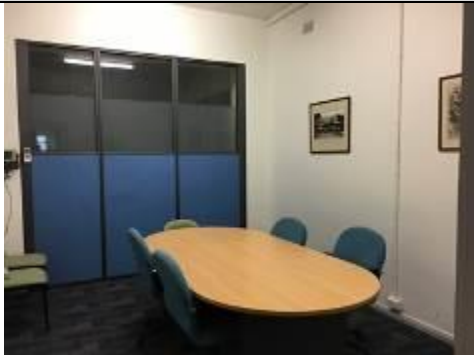
Ground Floor Kedumba Meeting Room Concrete and Plasterboard Walls, Concrete Ceiling, Timber Skirting and Architraves, Acoustic Panel/Glass Partitions, Carpet Tiles, Vinyl tiles under carpet Approx. 12m ²	Similar to Sample B18780-S35 Chrysotile Asbestos Detected Non-Friable 2370	A4	Good Condition, Encapsulated by Carpet tiles Accessible to Tradespeople Refer to Management Plan
23 rd June 2018

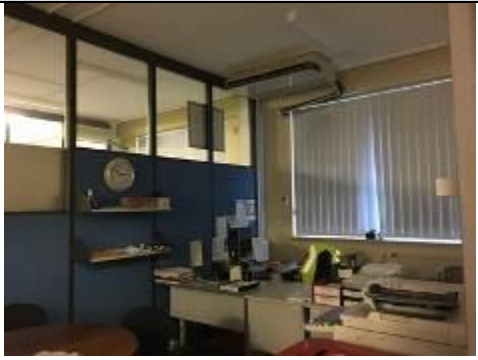
Ground Floor Payroll Services Concrete Ceiling, Concrete and Plasterboard Walls with Timber Infills, Carpet Tiles, Vinyl tiles under carpet Approx. 12m ²	Similar to Sample B18780- S35 Chrysotile Asbestos Detected Non- Friable	A4	Good Condition, Encapsulated by Carpet tiles Accessible to Tradespeople Refer to Management Plan 2372
23 rd June 2018

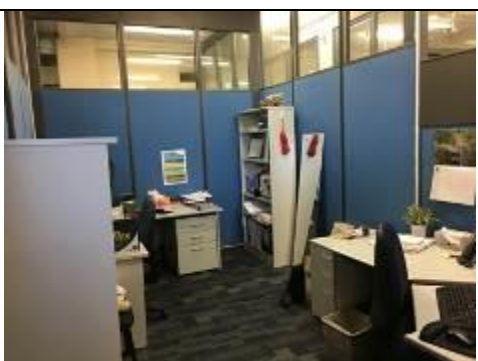
Ground Floor K Baker's Office Plasterboard Ceiling, Acoustic Panel/Glass Partitions, Carpet Tiles on Vinyl Tiles Approx. 10m ²	Similar to Sample B18780- S35 Chrysotile Asbestos Detected Non- Friable	A4	Good Condition, Encapsulated by Carpet tiles Accessible to Tradespeople Refer to Management Plan 2374

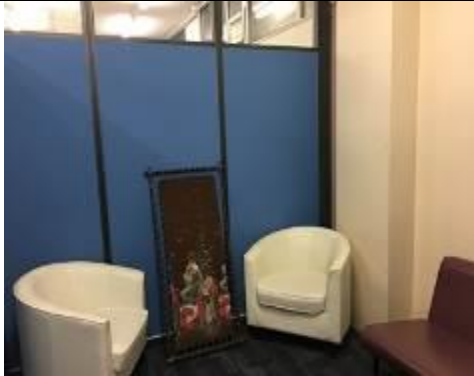
Ground Floor Baby Feeding Room Acoustic/Glass Partitions, Concrete Wall, Timber Electrical Riser, Carpet Tiles on Vinyl tiles 4m ²	Similar to Sample B18780-S35 Chrysotile Asbestos Detected Non-Friable 2375	A4	Good Condition, Encapsulated by Carpet tiles Accessible to Tradespeople Refer to Management Plan
23 rd June 2018

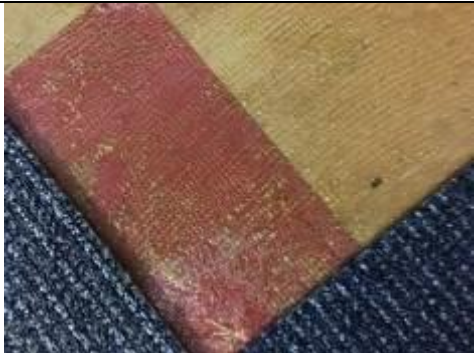
Ground Floor East to West Hallway Red Vinyl Tiles 2376	Sample B18780-S36 Chrysotile Asbestos Detected Non-Friable	A4	Good Condition, Encapsulated by Carpet tiles Accessible to Tradespeople Refer to Management Plan
23 rd June 2018

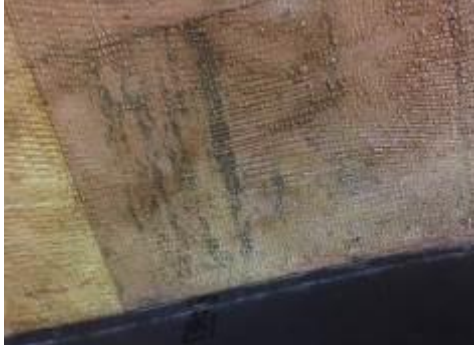
Ground Floor East to West Hallway Pink Vinyl Tiles 2377	Sample B18780-S37 Chrysotile Asbestos Detected Non-Friable	A4	Good Condition, Encapsulated by Carpet tiles Accessible to Tradespeople Refer to Management Plan

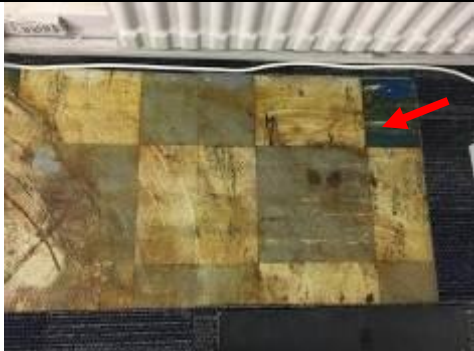
Ground Floor HR Services Blue Vinyl Tile 2387	Sample B18780-S40 Chrysotile Asbestos Detected Non-Friable	A4	Good Condition, Encapsulated by Carpet tiles Accessible to Tradespeople Refer to Management Plan

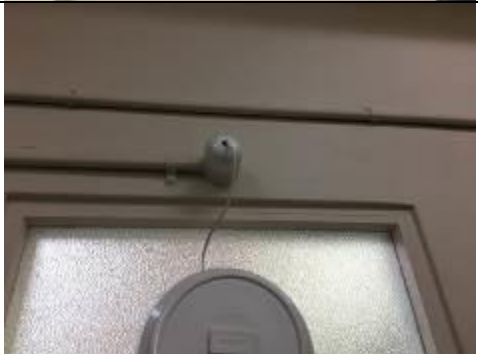
Ground Floor First Aid Room, Bakelite Fitting 2390	No Sample Taken, Assume Contains Asbestos Non- Friable	A4	Good Condition, No Damage, Accessible to Tradespeople Refer to Management Plan
23 rd June 2018

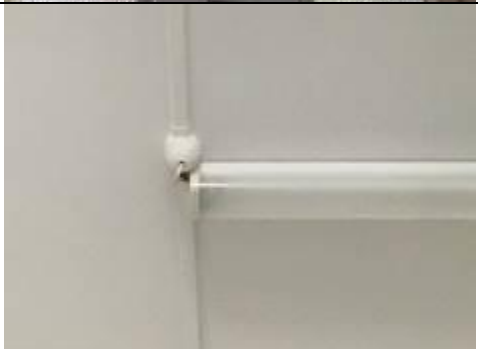
Ground Floor Locker Room Bakelite Light Fitting 2391	No Sample Taken, Assume Contains Asbestos Non- Friable	A4	Good Condition, Accessible to Tradespeople Refer to Management Plan

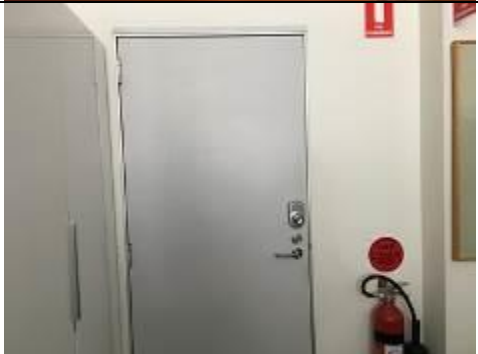
Ground Floor Safe Room Nil Access 2393	No Access During Survey	A4	Potentially Contains Asbestos Materials Refer to Management Plan
23 rd June 2018

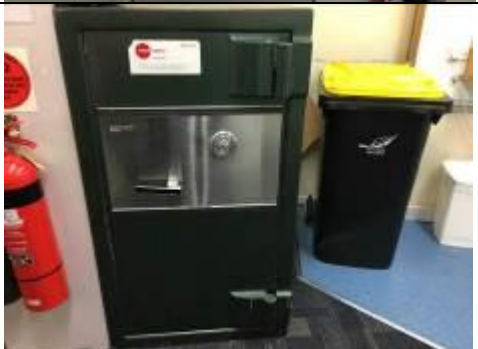
Ground Floor Safe Adjacent Kitchen Area Millboard Door Insulation 2394	No Sample Taken, No Access Assume Contains Asbestos Non-Friable	A4	Good Condition, Accessible to Tradespeople Refer to Management Plan

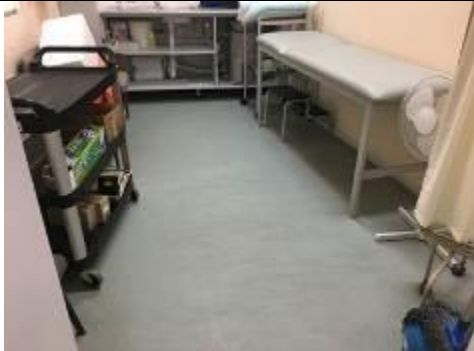
Ground Floor First Aid Room Vinyl Flooring 2395	Sample B18780-S29 No Asbestos Detected	A5	N/A
23 rd June 2018

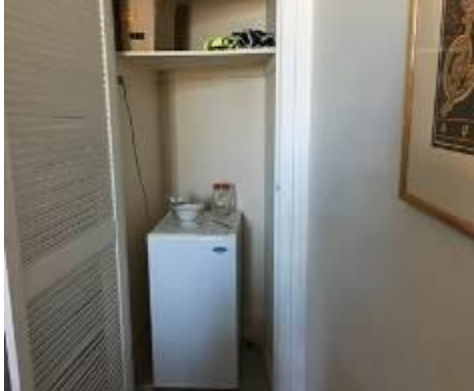
Ground Floor Cupboard in Group Manager's Office Timber Door, Plasterboard Walls and Ceiling Timber Shelving, Vinyl Sheeting on Floor 2396	Similar to Sample B18780-S29 No Asbestos Detected	A5	N/A
23 rd June 2018

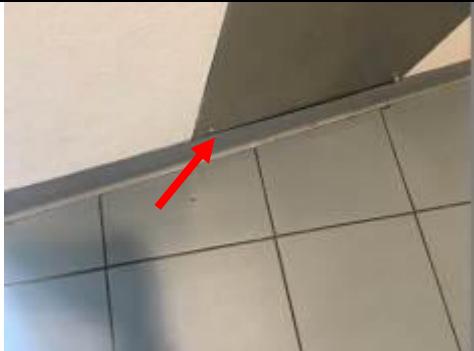
Ground Floor Lift Void Grey Vinyl Skirting 2397	Sample B18780-S30 No Asbestos Detected	A5	N/A

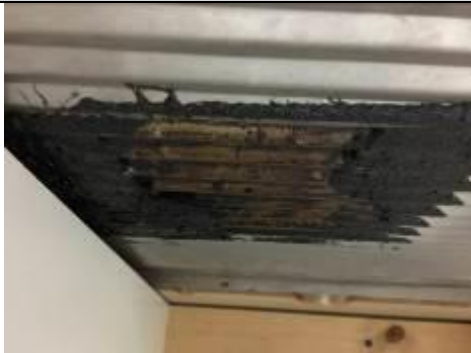
Ground Floor Under Kitchen Sink Bituminous Material 2398	Sample B18780-S31 No Asbestos Detected	A5	N/A
23 rd June 2018

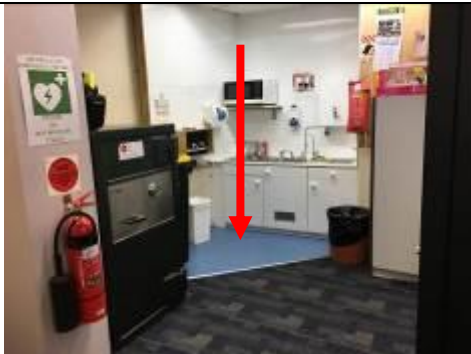
Ground Floor Blue Vinyl in Kitchen Area Approx. 2m ² 2399	Sample B18780-S32 No Asbestos Detected	A5	N/A
23 rd June 2018

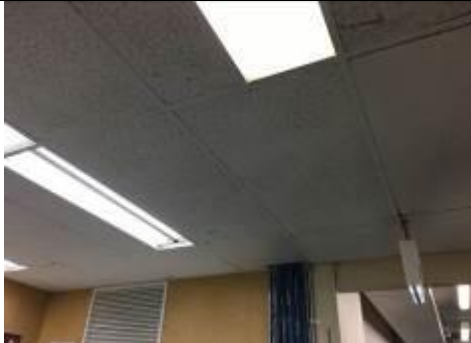
Ground Floor Kitchen Area Suspended Tiles 2400	Sample B18780-S33 No Asbestos Detected	A5	N/A

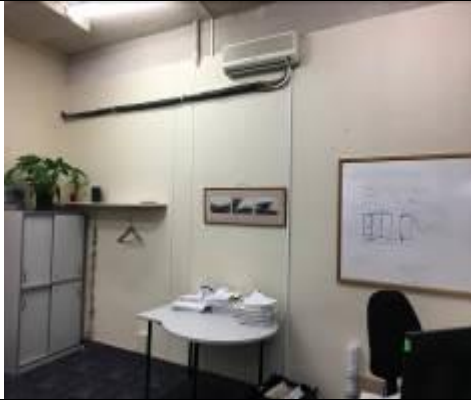
Ground Floor Office Adjacent Kitchen Carpet on Concrete Floor, Composite Timber and Plasterboard Walls, Vermiculite Ceiling	Sample B18780-S34 No Asbestos Detected 2401	A5	N/A
23 rd June 2018

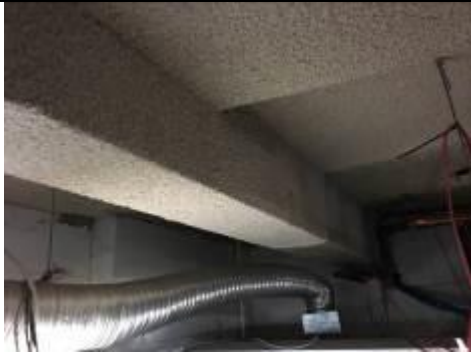
Ground Floor Ceiling Cavity Above Suspended Tiles in Kitchen Area Vermiculite Ceiling, Aluminium A/C Ducting	Similar to Sample B18780-S34 No Asbestos Detected 2402	A5	N/A
23 rd June 2018

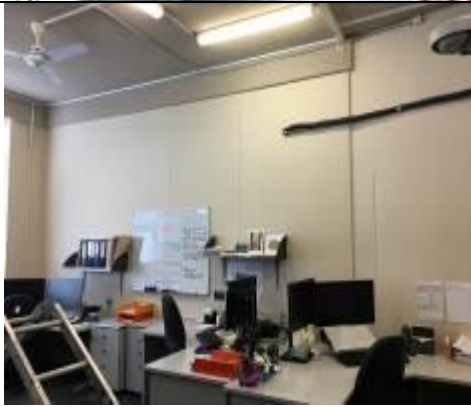
Ground Floor Registration Unit Area Plasterboard and Concrete Walls, Glass/Modern Acoustic Partition Panels, Carpet on Floor, Vermiculite Ceiling	Similar to Sample B18780-S34 No Asbestos Detected 2403	A5	N/A

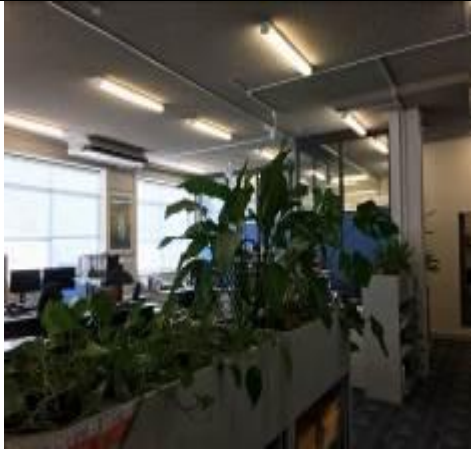
Ground Floor Building and Construction Area/ Development and Planning Carpet on Concrete Floor, Glass/ Modern Acoustic Partition, Concrete Walls, Vermiculite Ceiling	Similar to Sample B18780-S34 No Asbestos Detected 2404	A5	N/A
23 rd June 2018

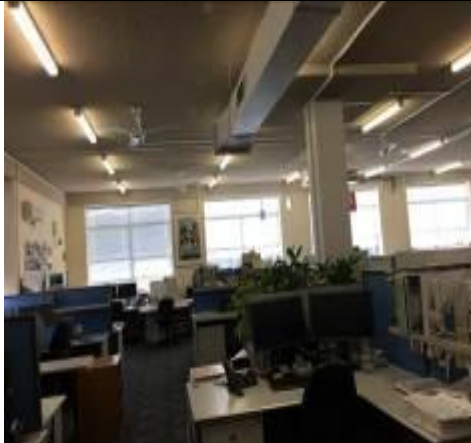
Ground Floor Land Use, Environmental and Engineering Area Concrete and Plasterboard Walls, Carpet on Concrete Floor, Modern Acoustic Partitions, Vermiculite Ceiling	Similar to Sample B18780-S34 No Asbestos Detected 2405	A5	N/A
23 rd June 2018

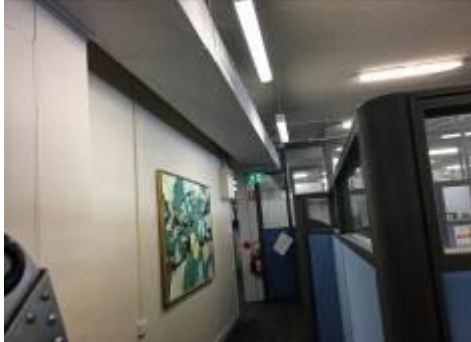
Ground Floor Hall from Kitchen to Stairwell Plasterboard and Concrete Walls, Carpet on Floor, Vermiculite Ceiling	Similar to Sample B18780-S34 No Asbestos Detected 2406	A5	N/A
