Asbestos Register

HAZARDOUS MATERIALS REGISTER

Regional EnviroScience Pty Ltd was requested by Mr. Jason Adams of Blue Mountains City Council to undertake a Hazardous Building Materials Register and to prepare a Hazardous Materials Management Plan of the property known as the Blue Mountains City Council Headquarters, 2-6 Civic Place, Katoomba, NSW, 2780. The purpose of the audit was to locate and identify asbestos based building materials and product within the building in accordance with the *NSW Work Health and Safety Act 2011* and *NSW Work Health and Safety Regulation 2017* and the *Code of Practice: How to Manage and Control Asbestos in the Workplace [Safe Work Australia: 2016]* and the *Code of Practice: How to Safely Remove Asbestos [Safe Work Australia: 2016]*.

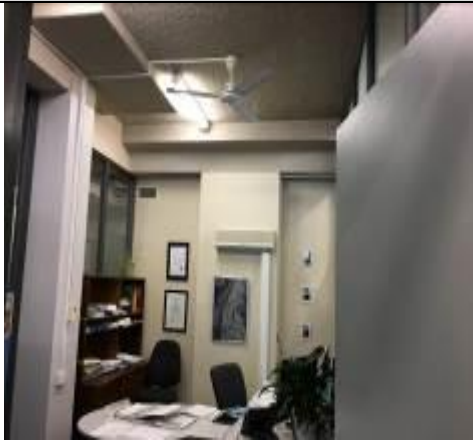
Ground Floor Meeting Room Plasterboard and concrete walls with Glass/Modern Acoustic Panel Partitions, Carpet on Floor, Plasterboard Infill Above Windows, Vermiculite Ceiling	Similar to Sample B18780-S34 No Asbestos Detected 2407	A5	N/A
23 rd June 2018

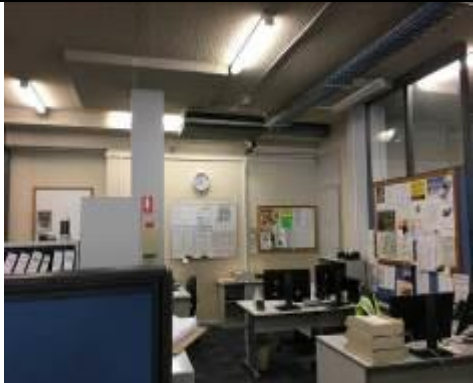
Ground Floor Ranger's Area Concrete and Plasterboard Walls, Carpet on Floor, Modern Acoustic Partitions, Vermiculite Ceiling	Similar to Sample B18780-S34 No Asbestos Detected 2408	A5	N/A
23 rd June 2018	No Image Available	Ground Floor Printing and Copying Area Carpet on Floor, Concrete Walls with Plasterboard, Timber Architraves, Composite Timber Infill, Vermiculite Ceiling	Similar to Sample B18780-S34 No Asbestos Detected 2409	A5	N/A

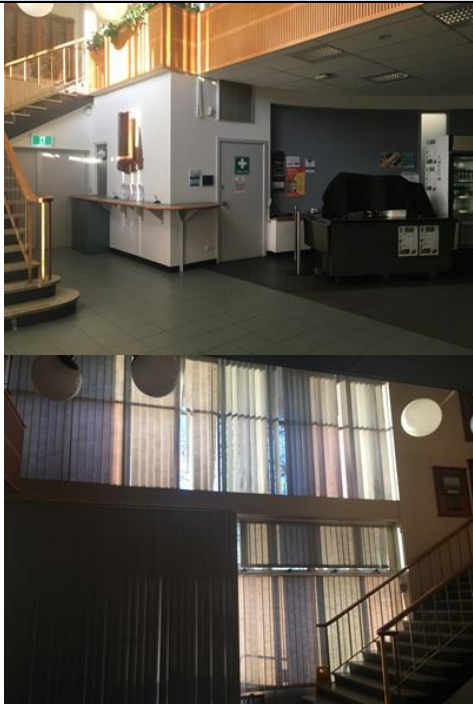
Ground Floor Reception/ Waiting Area-Entrance Foyer Ceramic Tile Floor, Aluminium Windows, Timber Panelling Around Mezzanine Area, Terrazzo Staircase, Composite Timber Desk and Underlining of Bulk Head	No Sample Taken No Asbestos Materials Sighted 2410	A5	N/A
23 rd June 2018

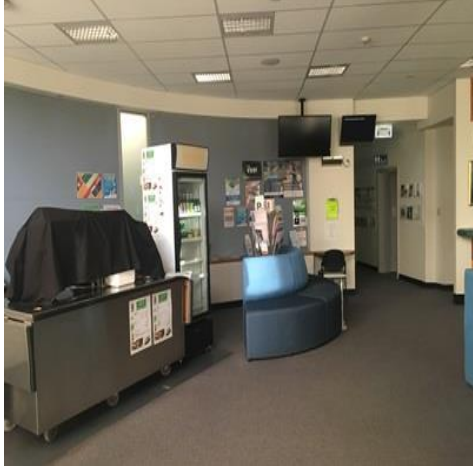
Ground Floor Reception Waiting Area-Coffee Shop Area Carpet on Floor, Curved Plasterboard Wall, Pin Board Material on Wall, Aluminium Plate Under Coffee Service Area, Composite Timber and Plasterboard Information Desk, Suspended Ceiling Cainite Tiles Below Concrete Ceiling	No Sample Taken No Asbestos Materials Sighted 2411	A5	N/A

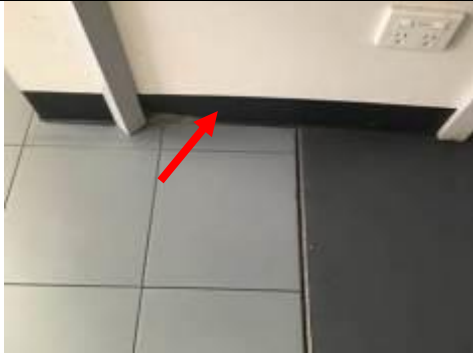
Ground Floor, Reception/ Waiting Area Black Vinyl Skirting 2412	Sample B18780-S27 No Asbestos Detected	A5	N/A
23 rd June 2018

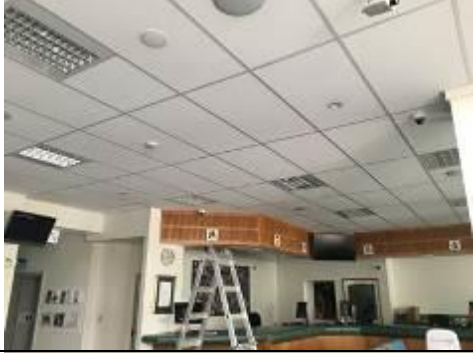
Ground Floor Suspended Ceiling Tile Throughout Reception/ Waiting Area Cainite 2413	No Sample Taken No Asbestos Materials Sighted	A5	N/A
23 rd June 2018

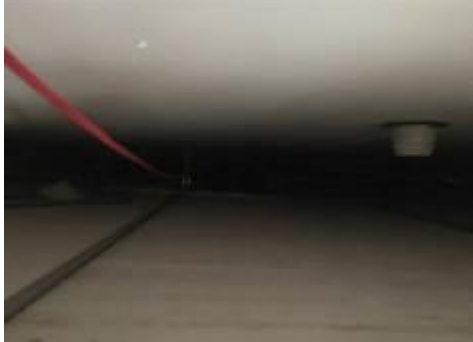
Ground Floor Ceiling Cavity Above Suspended Tile Ceiling Concrete Ceiling with Electrical Wiring 2414	No Sample Taken No Asbestos Materials Sighted	A5	N/A

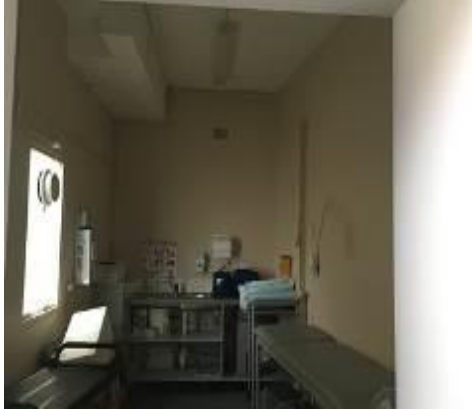
Ground Floor First Aid Room Timber Architraves and Skirting, Composite Timber and Laminate Bench, Concrete Ceiling and Bulkhead, West Wall Gyprock	No Sample Taken No Asbestos Materials Sighted 2415	A5	N/A
23 rd June 2018

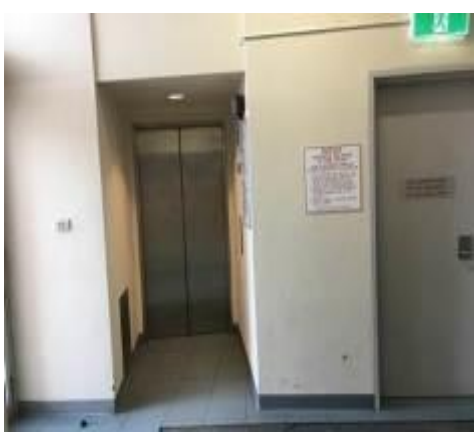
Ground Floor Lift Void Aluminium Door into Storage Cupboard, Concrete Ceiling, Plasterboard and Concrete Walls, Aluminium Windows, Ceramic Tile Floor	No Sample Taken No Asbestos Materials Sighted 2416	A5	N/A

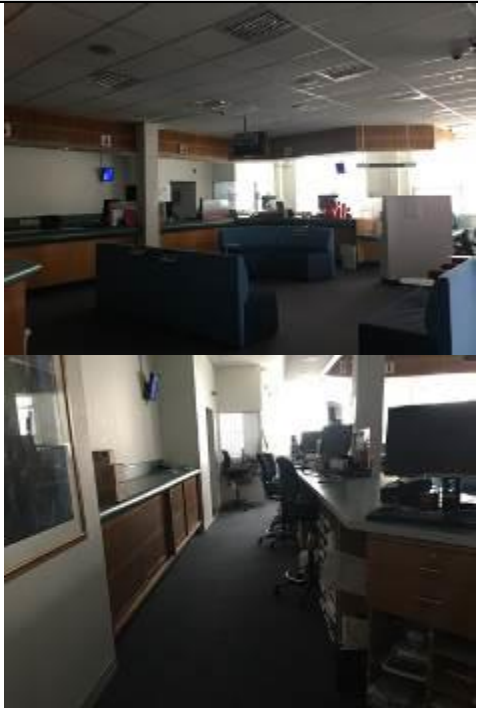
Ground Floor Customer Service/ Waiting Area Desk Area Timber and Laminate Benches, Carpet on Floor on Concrete, Black Plastic and Aluminium Skirting, Plasterboard and Timber Bulkhead Above Desks, Aluminium Windows, Glass Partitions, Timber Doors, Concrete and Plasterboard Walls, Suspended Tile Ceiling Below Concrete	No Sample Taken No Asbestos Materials Sighted 2417	A5	N/A
23 rd June 2018

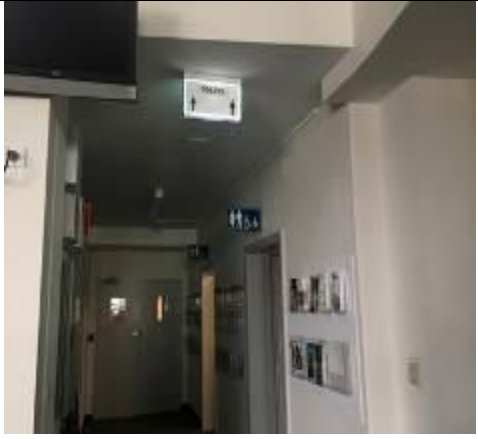
Ground Floor Reception/ Waiting Area Hallway to Toilets Gyprock, Glass and Concrete Walls, Carpet on Floor, Plasterboard Ceiling and Bulkhead, Compressed Timber Patching on Ceiling	No Sample Taken No Asbestos Materials Sighted 2418	A5	N/A

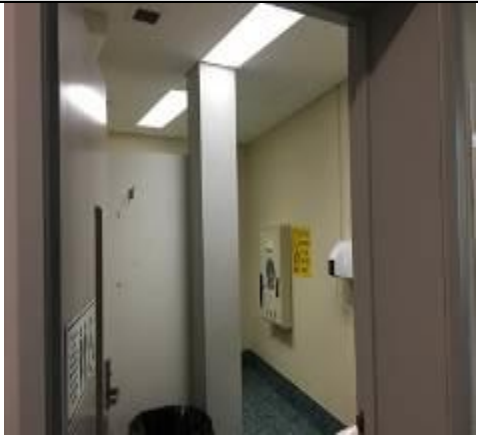
Ground Floor Eastern Toilet Concrete Walls, Ceramic Tiles on Floor and Skirting, Composite Timber and Laminate Partition, Timber Architraves and Infill, Plasterboard Ceiling	No Sample Taken No Asbestos Materials Sighted 2419	A5	N/A
24 th June 2018

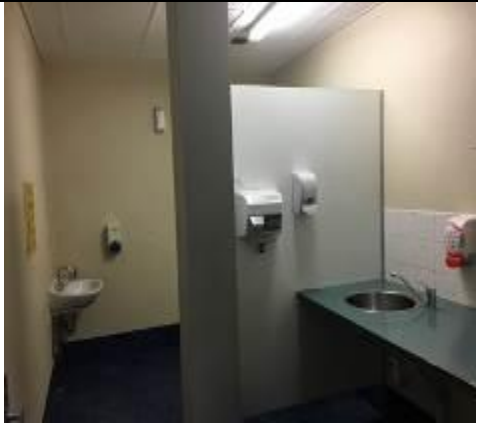
Ground Floor Western Toilet Concrete Walls, Ceramic Tiles on Floor and Skirting, Composite Timber and Laminate Partition, Timber Architraves and Infill, Plasterboard Ceiling	No Sample Taken No Asbestos Materials Sighted 2420	A5	N/A
23 rd June 2018

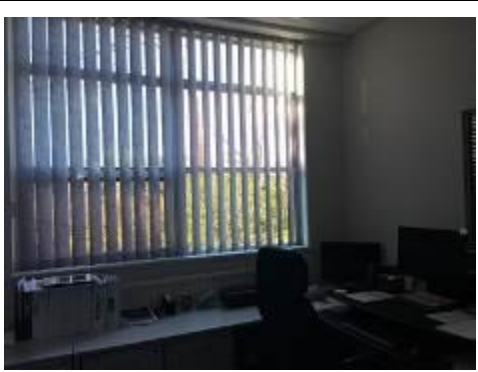
Ground Floor Customer Service Co-ordinator Office Suspended Tile Ceiling, Plasterboard Walls, Carpet on Floor, Aluminium Skirting, Timber Infill Panel	No Sample Taken No Asbestos Materials Sighted 2421	A5	N/A

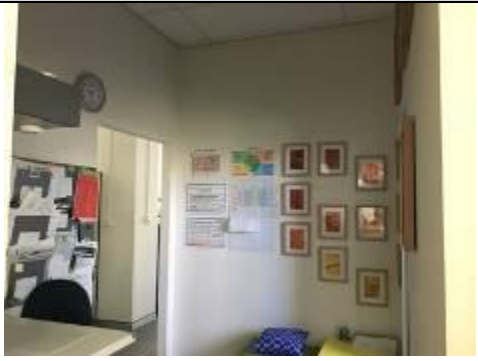
Ground Floor Office in alcove off Customer Service Area Suspended Tile Ceiling, Carpet on Floor, Plasterboard Walls, Aluminium Skirting	No Sample Taken No Asbestos Materials Sighted 2422	A5	N/A
23 rd June 2018

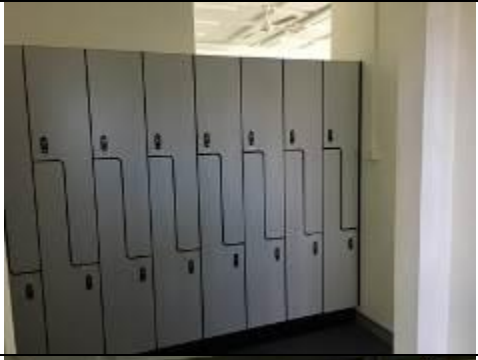
Ground Floor Locker Room Carpet on Floor, Plasterboard Walls, Aluminium Skirting, Plasterboard Ceiling	No Sample Taken No Asbestos Materials Sighted 2423	A5	N/A
23 rd June 2018

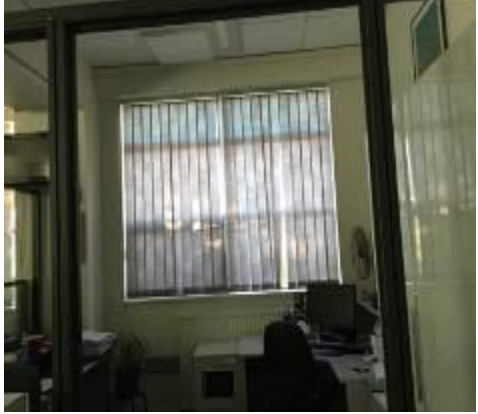
Ground Floor Senior Customer Service Office Carpet on Floor, Plasterboard, Concrete and Acoustic Panelling/Glass Walls, Timber Window Sills, Plasterboard Ceiling with Foam Acoustic Panels	No Sample Taken No Asbestos Materials Sighted 2424	A5	N/A

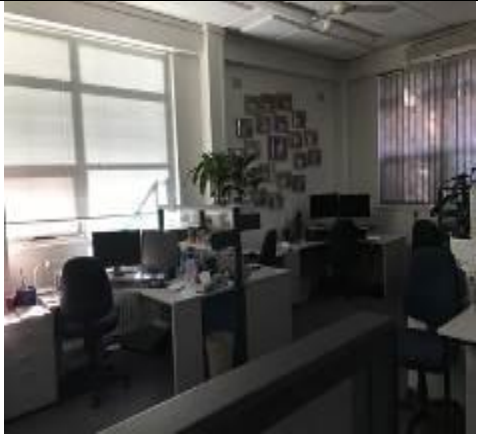
Ground Floor Call Centre Area Carpet on Floor, Concrete and Plasterboard Walls, Timber Window Sill, Aluminium Windows, Plasterboard Ceiling with Foam Acoustic Panels	No Sample Taken No Asbestos Materials Sighted 2425	A5	N/A
23 rd June 2018

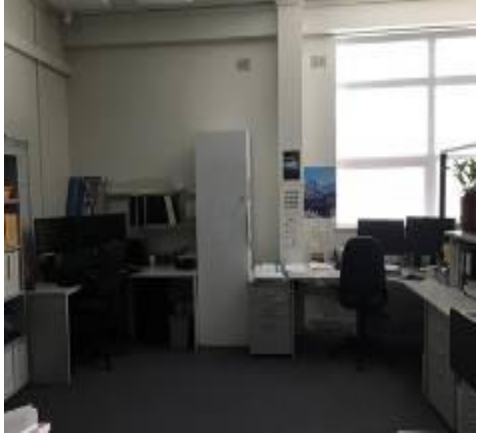
Ground Floor Customer Bookings Area Carpet on Floor, Plasterboard and Concrete Walls, Glass and Acoustic Panel Partitions, Plasterboard Ceiling with Foam Acoustic Panels	No Sample Taken No Asbestos Materials Sighted 2426	A5	N/A
23 rd June 2018

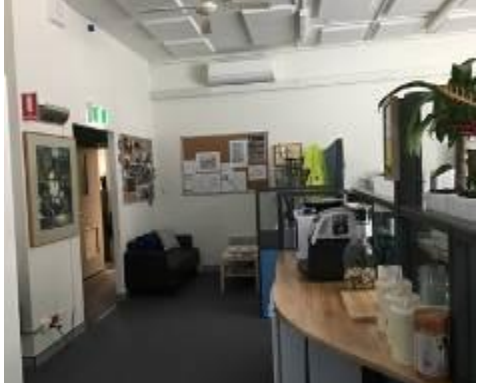
Ground Floor Customer Service Kitchenette and Break Area Carpet on Floor, Plasterboard Walls, Plasterboard Ceiling with Foam Acoustic Panels	No Sample Taken No Asbestos Materials Sighted 2427	A5	N/A

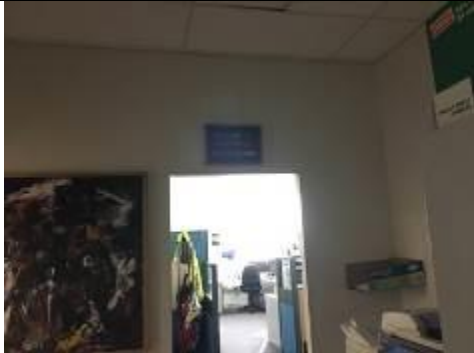
Ground Floor Photocopier Room Carpet on Floor, Suspended Tile Ceiling, Timber Architraves, Plasterboard Walls	No Sample Taken No Asbestos Materials Sighted 2428	A5	N/A
23 rd June 2018

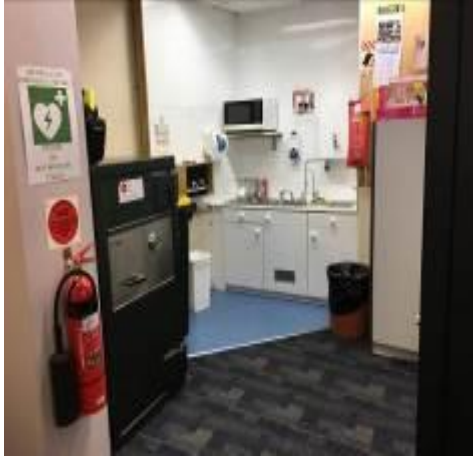
Ground Floor Kitchen Area Plastic Splashback with Timber Backing, Composite Timber Cupboards, Carpet on Concrete Floor, Timber Risers Plasterboard Bulkhead, Composite Timber North Wall	No Sample Taken No Asbestos Materials Sighted 2429	A5	N/A
23 rd June 2018

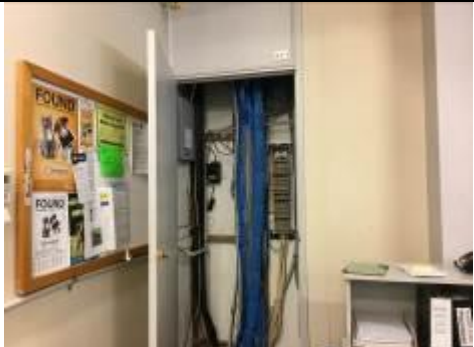
Ground Floor Electrical Cupboard Concrete Walls and Ceiling, Timber Veneer Infill and Timber Door	No Sample Taken No Asbestos Materials Sighted 2430	A5	N/A

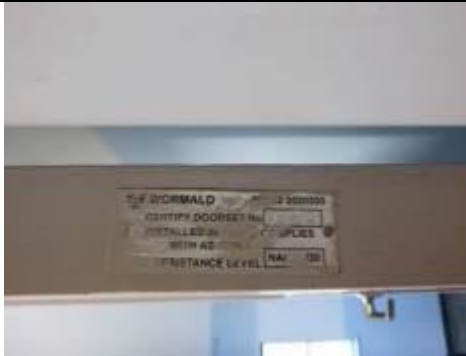
Internal - First Floor South Stairwell Emergency Exit Door No Access to Door Internals (Installed in 1999 & Complies to AS1905.1 for Door Sets)	No Sample Taken Assume Asbestos Containing Material 2435	A4	Unknown Condition Accessible to Tradespeople Refer to Asbestos Management Plan
23 rd June 2018

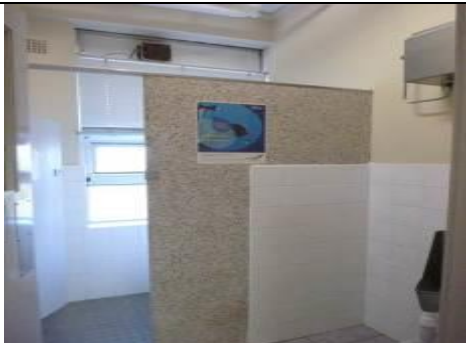
Internal - First Floor Male Toilet External Spandrel Panel Above the Window	No Sample Taken Assume Asbestos Containing Material Non-Friable 2436	A4	Good Condition Accessible to Tradespeople Refer to Asbestos Management Plan

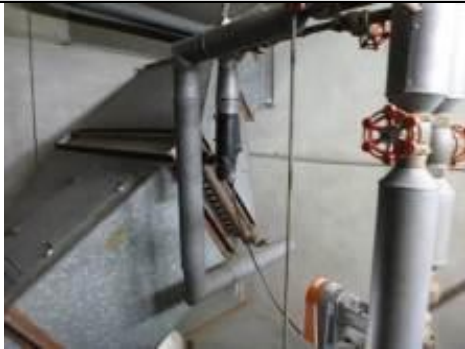
Internal - First Floor Plant Room Gas Powered Heaters Note: There was No Visual Evidence of Heater Banks from the External Inspection	No Sample Taken Assume Asbestos Containing Material During Maintenance / Removal 2437	A4	Accessible to Tradespeople Refer to Asbestos Management Plan
23 rd June 2018

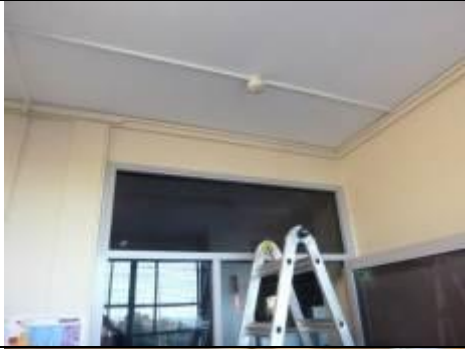
Internal - First Floor Property Bonded Board Infill Above Door	Sample B18780-S41 No Asbestos Detected 2438	A5	N/A
23 rd June 2018

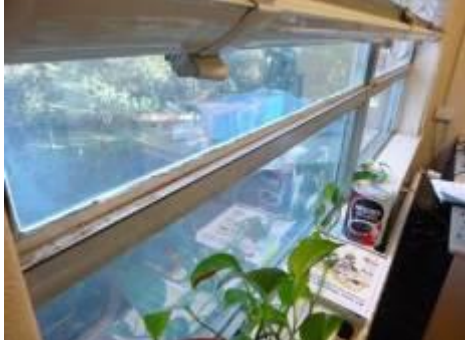
Internal - First Floor Property Window Putty	Sample B18780-S42 No Asbestos Detected 2439	A5	N/A

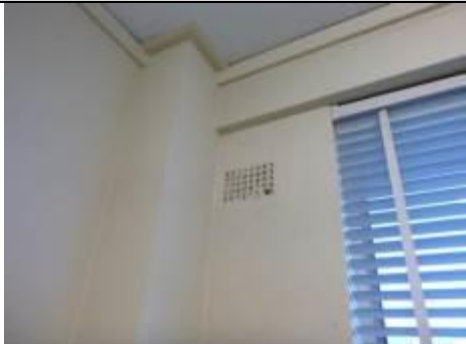
Internal - First Floor Building & Facilities Ventilation Brick	Sample B18780-S43 No Asbestos Detected 2440	A5	N/A
23 rd June 2018

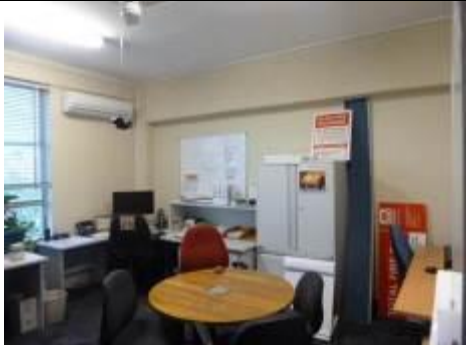
Internal - First Floor Bushfire & Emergency Management Vermiculite to Upper Western Wall	Sample B18780-S44 No Asbestos Detected 2441	A5	N/A
23 rd June 2018

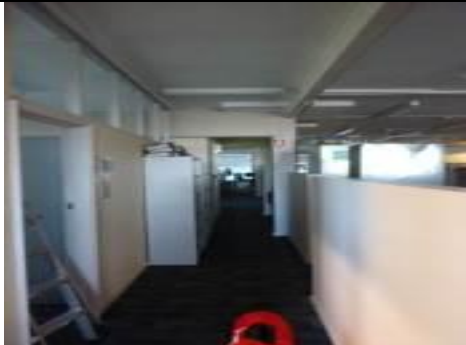
Internal - First Floor Southern Corridor Looking West Vermiculite Wall Extending from Bushfire & Emergency Management	Similar to Sample B18780-S44 No Asbestos Detected 2442	A5	N/A

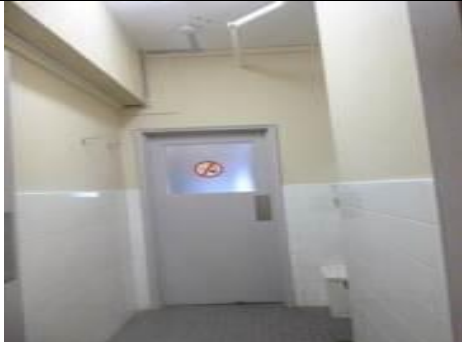
Internal - First Floor Male Toilet Entry & Urinal Vermiculite to Eastern Wall	Similar to Sample B18780-S44 No Asbestos Detected 2443	A5	N/A
23 rd June 2018

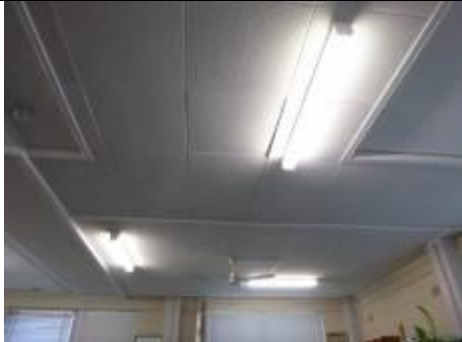
Internal - First Floor Natural Waterways Acoustic Ceiling Panel	Sample B18780-S45 No Asbestos Detected 2444	A5	N/A
23 rd June 2018

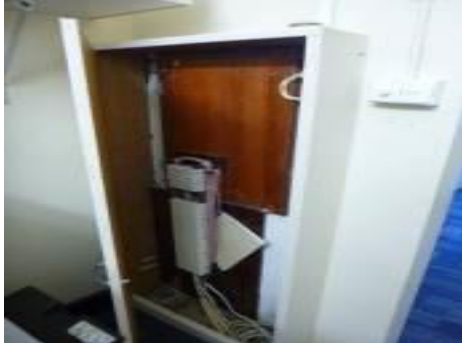
Internal - First Floor Photocopier Data Communications Box Wall Cement Render	Sample B18780-S46 No Asbestos Detected 2445	A5	N/A
23 rd June 2018

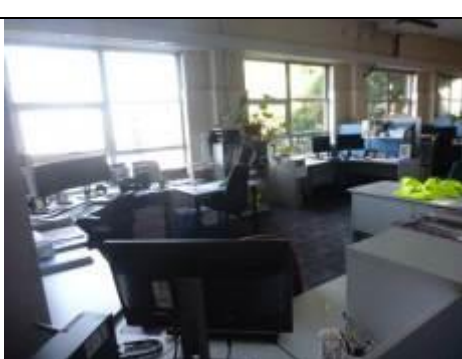
Internal - First Floor Land Use Outcomes Fibre Cement Ceiling	Sample B18780-S47 No Asbestos Detected 2446	A5	N/A

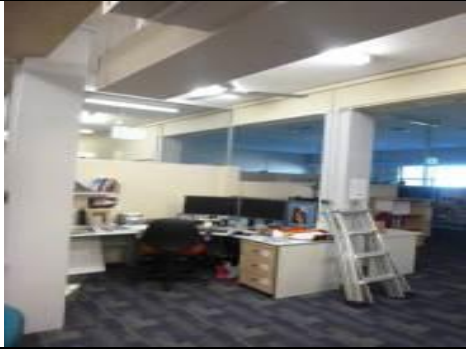
Internal - First Floor R. Vlakov & A. Kazis Area Textured Ceiling Coating	Sample B18780-S48 No Asbestos Detected 2447	A5	N/A
23 rd June 2018

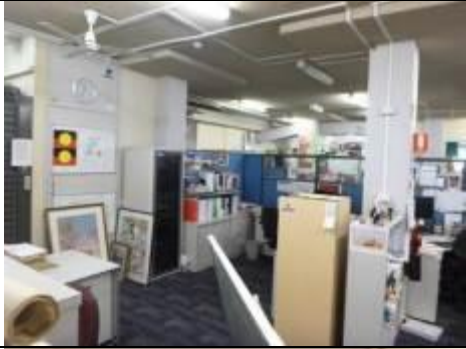
Internal - First Floor Entire First Floor Vermiculite Ceiling	Sample B18780-S49 No Asbestos Detected 2448	A5	N/A
23 rd June 2018

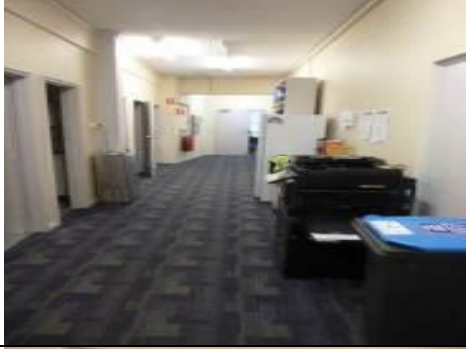
Internal - First Floor Central Corridor Adjacent Cleaners Room Textured Ceiling Coating	Similar to Sample B18780-S48 No Asbestos Detected 2449	A5	N/A
23 rd June 2018

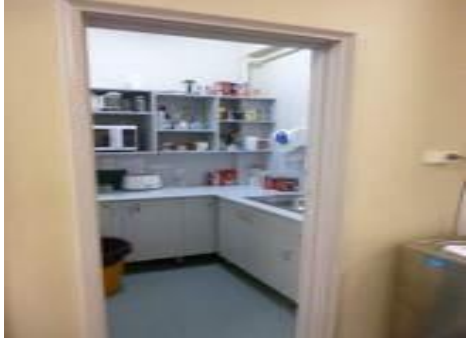
Internal - First Floor Kitchen & Cleaners Room Light Green Linoleum Floor Covering	Sample B18780-S50 No Asbestos Detected 2450	A5	N/A

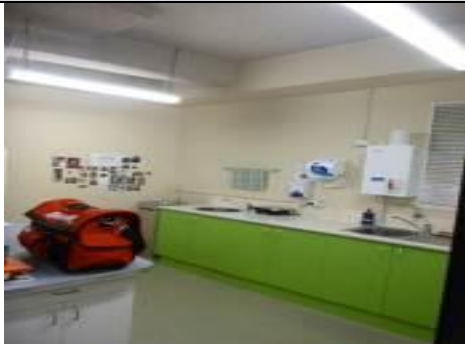
Internal - First Floor Western Kitchen Light Green Linoleum Floor Covering	Similar to Sample B18780-S50 No Asbestos Detected 2451	A5	N/A
23 rd June 2018	No Image Available	Internal - First Floor Southern Corridor Blue Vinyl Tile Beneath Carpet	Sample B18780-S51 No Asbestos Detected 2452	A5	N/A
23 rd June 2018	No Image Available	Internal - First Floor Southern Corridor Cream Vinyl Tile Beneath Carpet	Sample B18780-S52 No Asbestos Detected 2453	A5	N/A
23 rd June 2018

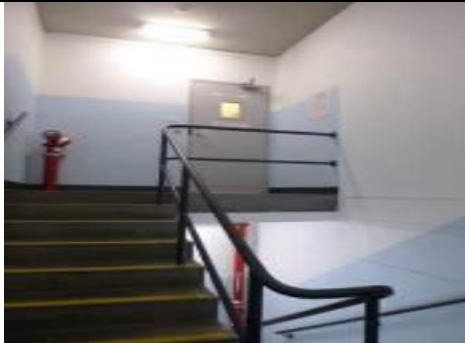
Internal - First Floor Emergency Exit Stairs Level 2 Vermiculite Ceiling	Similar to Sample B18780-S49 No Asbestos Detected 2454	A5	N/A

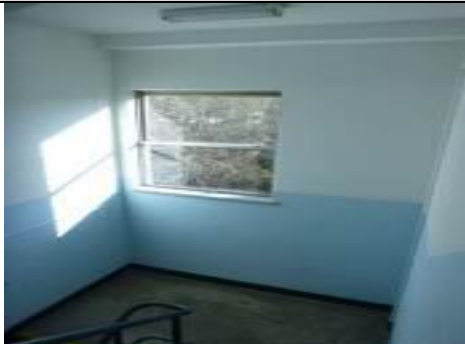
Internal - First Floor Southern Emergency Exit Stairs Window Putty	Similar to Sample B18780-S42 No Asbestos Detected 2455	A5	N/A
23 rd June 2018

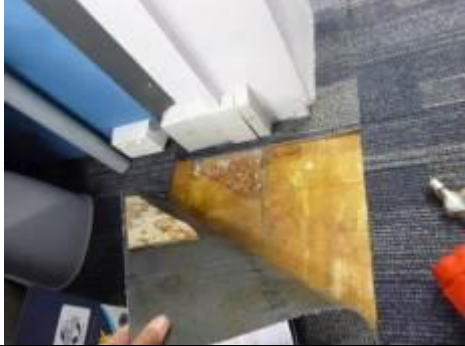
Internal - First Floor T. Snape Area Cream Vinyl Floor Tiles Beneath Carpet	Similar to Sample B18780-S52 No Asbestos Detected 2456	A5	N/A
23 rd June 2018	No Image Available	Internal - First Floor Central Area Grey Vinyl Floor Tile Beneath Carpet	Sample B18780-S55 No Asbestos Detected 2457	A5	N/A
23 rd June 2018

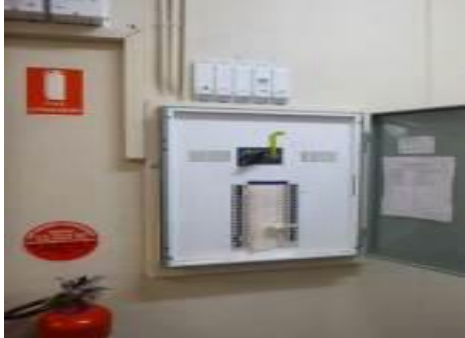
Internal - First Floor Distribution Board "D"	No Sample Taken No Asbestos Containing Materials Sighted 2458	A5	N/A

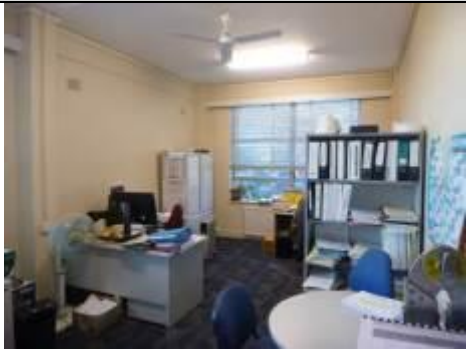
Internal - First Floor Property Concrete Ceiling, Brick & Render Wall, Fibre Cement Infill, Aluminium & Timber Window / Door Frames Skirting / Sill / Bead to Top of Wall, Carpet, Steel Data Cable Cover, Steel Radiator	No Sample Taken No Asbestos Containing Materials Sighted 2459	A5	N/A
23 rd June 2018

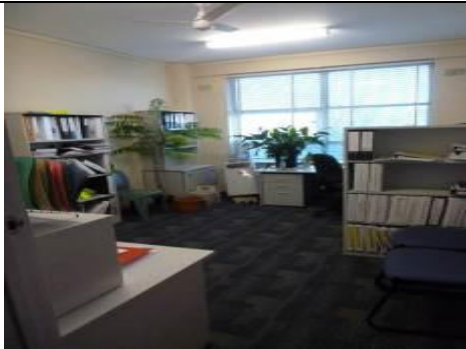
Internal - First Floor Building & Facilities Concrete Ceiling, Brick & Render Wall, Fibre Cement Infill, Aluminium & Timber Window / Door Frames Skirting / Sill / Bead to Top of Wall, Carpet, Steel Data Cable Cover, Steel Radiator	No Sample Taken No Asbestos Containing Materials Sighted 2460	A5	N/A

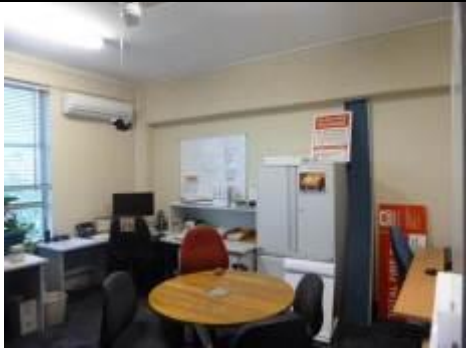
Internal - First Floor Bushfire & Emergency Management Concrete Ceiling, Brick & Render Wall, Fibre Cement Infill, Aluminium & Timber Window / Door Frames Skirting / Sill / Bead to Top of Wall, Carpet, Steel Data Cable Cover, Steel Radiator	No Sample Taken No Asbestos Containing Materials Sighted 2461	A5	N/A

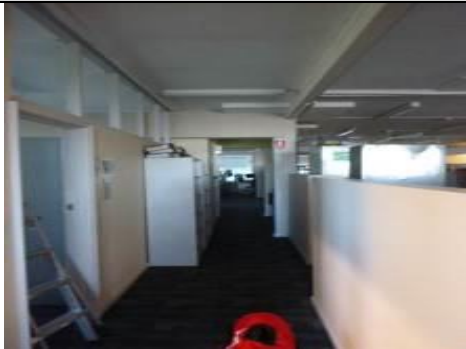
Internal - First Floor Southern Corridor Render to Concrete Ceiling & Columns, Plasterboard Partition Walls to North, Concrete Walls to Office to South, Timber Door Frames / Architraves / Skirting / Header Across Ceiling, Carpet	No Sample Taken No Asbestos Containing Materials Sighted 2462	A5	N/A
23 rd June 2018

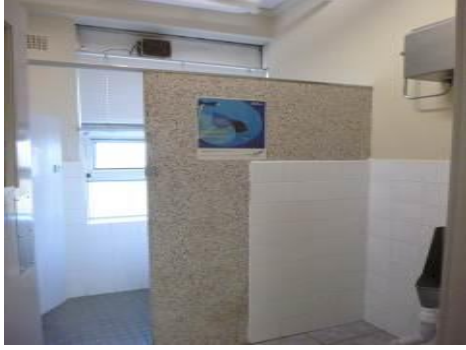
Internal - First Floor Male Toilet Concrete Ceiling, Brick & Cement Render Wall, Ceramic Tile to Half of Wall & Floor, Ceramic Wash Basin, Reconstituted Stone Partition to Toilet, Particle Board Covering Around Riser in Toilet & Steel Urinal & Cistern	No Sample Taken No Asbestos Containing Materials Sighted 2463	A5	N/A

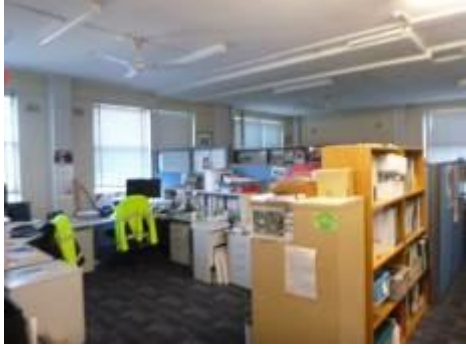
Internal - First Floor Environmental Culture & Education Concrete Ceiling, Brick & Cement Render Walls, Aluminium & Timber Window / Door Frames / Bead to Top of Wall & Ceiling / Sill / Skirting, Carpet, Steel Radiator, Steel & Fabric Partitions	No Sample Taken No Asbestos Containing Materials Sighted 2464	A5	N/A

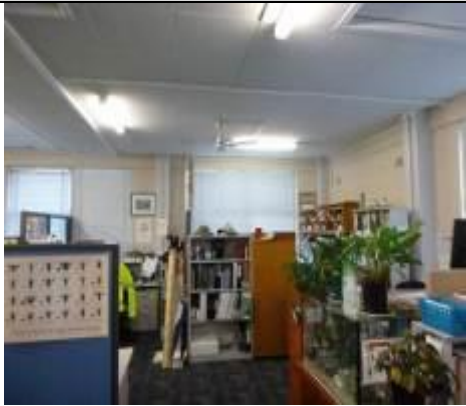
Internal - First Floor Environmental Culture & Education Concrete Ceiling, Brick & Cement Render Walls, Aluminium & Timber Window / Door Frames / Bead to Top of Wall & Ceiling / Sill / Skirting, Carpet, Steel Radiator, Steel & Fabric Partitions	No Sample Taken No Asbestos Containing Materials Sighted 2465	A5	N/A
23 rd June 2018

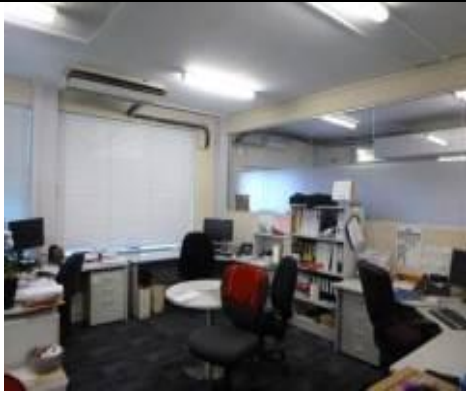
Internal - First Floor Natural Areas Cultural & Heritage Concrete Ceiling, Brick & Cement Render Walls, Aluminium & Timber Window / Door Frames / Bead to Top of Wall & Ceiling / Sill / Skirting, Carpet, Steel Radiator, Steel & Fabric Partitions, Plasterboard Partition to the North	No Sample Taken No Asbestos Containing Materials Sighted 2466	A5	N/A

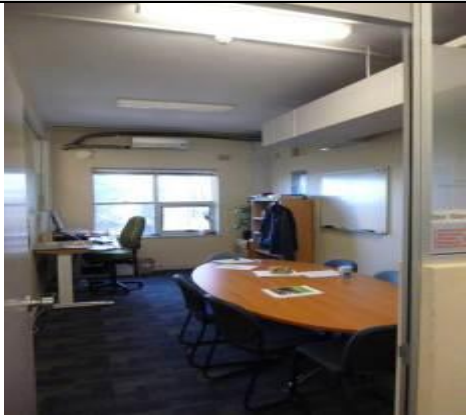
Internal - First Floor N. Rigby Office Concrete Ceiling, Brick & Cement Render Walls, Aluminium & Timber Window / Door Frames / Bead to Top of Wall & Ceiling / Sill / Skirting, Carpet, Steel Radiator, Steel & Fabric Partitions, Plasterboard Partition to the North & South, Timber Infill Above Door	No Sample Taken No Asbestos Containing Materials Sighted 2467	A5	N/A
23 rd June 2018

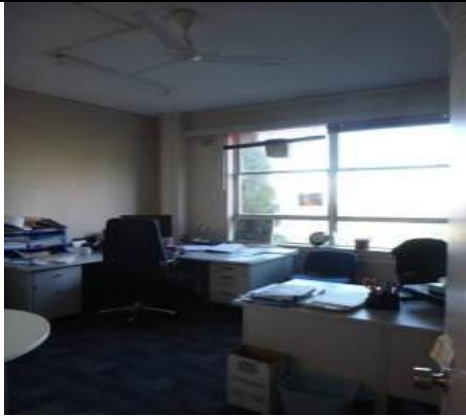
Internal - First Floor Program Leader Transport & Recreation Program Leader Recreation & Facilities Management Concrete Ceiling, Brick & Cement Render Walls, Aluminium & Timber Window / Door Frames / Bead to Top of Wall & Ceiling / Sill / Skirting, Carpet, Steel Radiator, Steel & Fabric Partitions & Particle Board Partition Wall to West	No Sample Taken No Asbestos Containing Materials Sighted 2468	A5	N/A

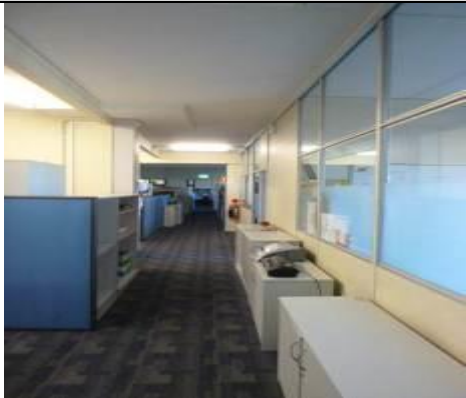
Internal - First Floor Eastern Corridor Concrete Ceiling, Brick & Cement Render Walls, Aluminium & Timber Window / Door Frames / Sill / Skirting, Carpet, Particleboard Partition Wall to East & Plasterboard Wall to East Opposite Print Room	No Sample Taken No Asbestos Containing Materials Sighted 2469	A5	N/A
23 rd June 2018

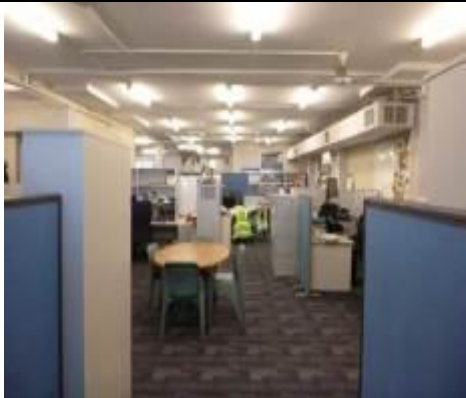
Internal - First Floor Bushfire & Emergency Management & Civil Assets Concrete Ceiling, Brick & Render Wall, Steel & Fabric Partitions, Plasterboard Partitions, Steel Data Casings Around Base of Walls, Timber Skirtings, Carpet & A/C Ducting on Ceiling	No Sample Taken No Asbestos Containing Materials Sighted 2470	A5	N/A

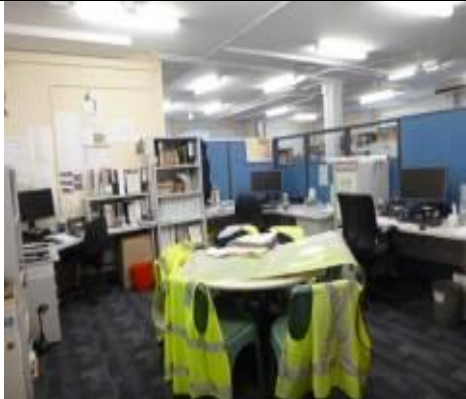
Internal - First Floor Bushfire & Emergency Management & Civil Assets Concrete Ceiling, Brick & Render Wall, Steel & Fabric Partitions, Plasterboard Partitions, Steel Data Casings Around Base of Walls, Timber Skirtings, Carpet & A/C Ducting on Ceiling	No Sample Taken No Asbestos Containing Materials Sighted 2471	A5	N/A

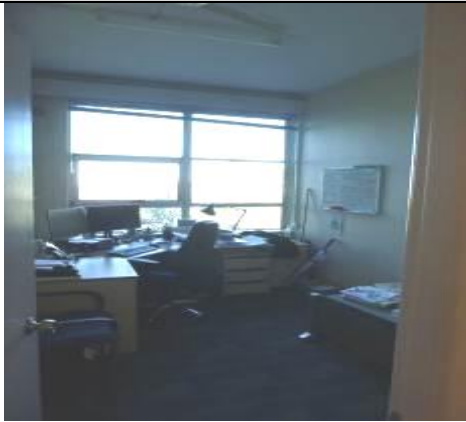
Internal - First Floor Program Leader Community Services Concrete Ceiling, Brick & Render Wall, Fibre Cement Infill, Aluminium & Timber Window / Door Frame / Bead to Top of Wall & Ceiling / Pelmet, Carpet, Plasterboard Wall to North & West	No Sample Taken No Asbestos Containing Materials Sighted 2472	A5	N/A
23 rd June 2018

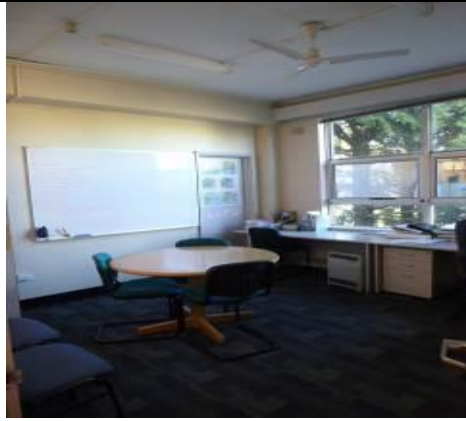
Internal - First Floor Manager Community & Economic Branch Concrete Ceiling, Brick & Render Wall, Fibre Cement Infill, Aluminium & Timber Window / Door Frame / Bead to Top of Wall & Ceiling, Carpet, Plasterboard Wall to South & Particleboard Partition to West	No Sample Taken No Asbestos Containing Materials Sighted 2473	A5	N/A

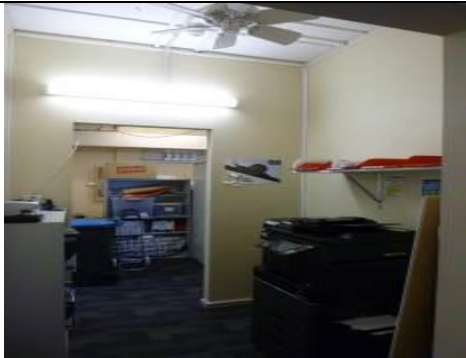
Internal - First Floor Photocopier Room Concrete Ceiling, Brick & Cement Render Wall, Plasterboard Wall, Timber Bead Around Ceiling & Skirting, Steel Data Casing Around Base of South Wall, Carpet	No Sample Taken No Asbestos Containing Materials Sighted 2474	A5	N/A

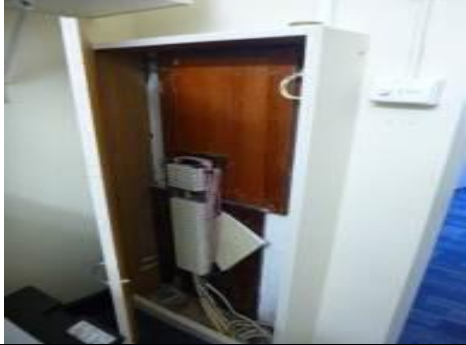
Internal - First Floor Photocopier Communications Box Timber Backing Boards 2475	No Sample Taken No Asbestos Containing Materials Sighted	A5	N/A
23 rd June 2018

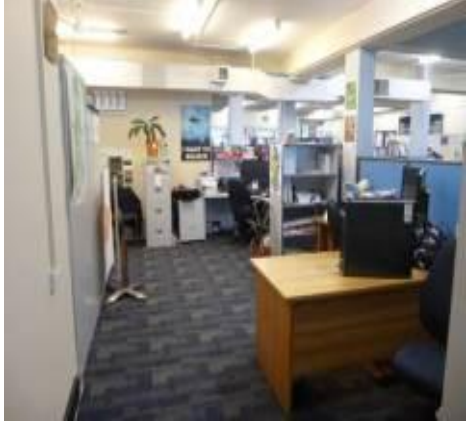
Internal - First Floor Hot Desk & Open Plan Area Concrete Ceiling, Brick & Cement Render Wall, Plasterboard Partitions to South, Steel & Fabric Partitions, Steel Data Casings Around Base of Walls, Timber Skirtings, Carpet, A/C Ducting on Ceiling	No Sample Taken No Asbestos Containing Materials Sighted 2476	A5	N/A
23 rd June 2018

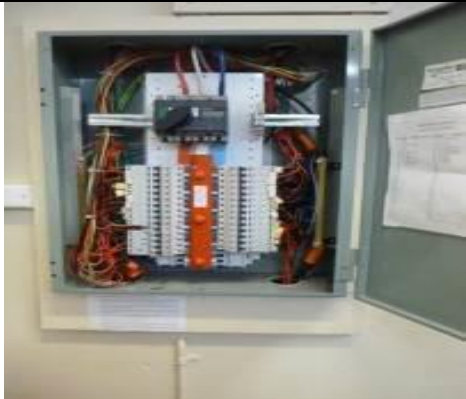
Internal - First Floor Hot Desk & Open Plan Area Distribution Board B No Backing Board Installed	No Sample Taken No Asbestos Containing Materials Sighted 2477	A5	N/A

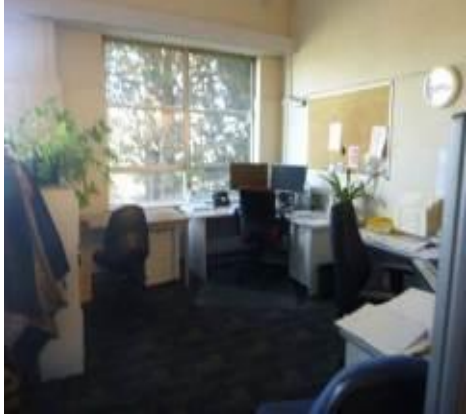
Internal - First Floor Recreation Asset Plasterboard Ceiling, Aluminium & Timber Window & Door Frames / Skirting / Sill / Bead to Top of Wall / Pelmet, Carpet, Steel & Fabric Partitions, Particleboard Wall to East, South & North	No Sample Taken No Asbestos Containing Materials Sighted 2478	A5	N/A
23 rd June 2018

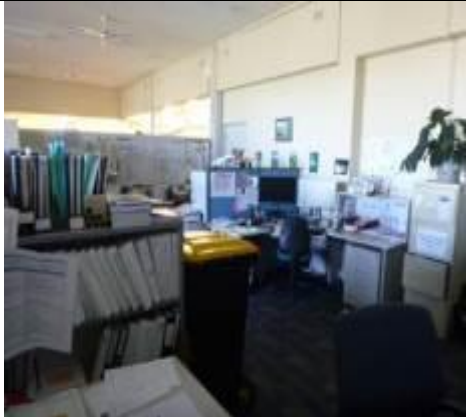
Internal - First Floor R. Reid & R. Deveridge Open Plan Area Plasterboard Ceiling, Aluminium & Timber Window & Door Frames / Skirting / Sill / Bead to Top of Wall / Pelmet, Carpet, Steel & Fabric Partitions to East, Plasterboard Wall to West	No Sample Taken No Asbestos Containing Materials Sighted 2479	A5	N/A

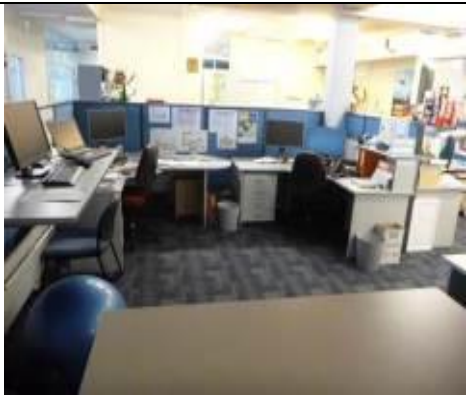
Internal - First Floor C. Aitken & N. Aitken Open Plan Area Plasterboard Ceiling, Aluminium & Timber Window & Door Frames / Skirting / Sill / Bead to Top of Wall / Pelmet, Carpet, Steel & Fabric Partitions East, South & North	No Sample Taken No Asbestos Containing Materials Sighted 2480	A5	N/A

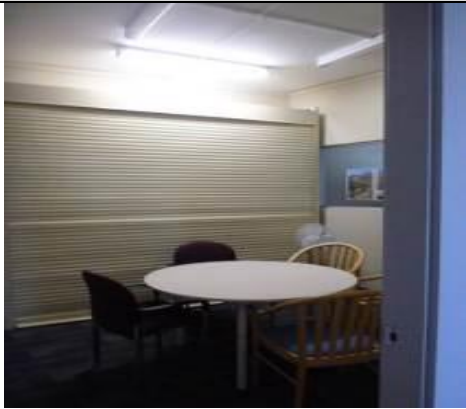
Internal - First Floor Meeting & Storage Concrete Ceiling, Brick & Cement Render Wall, Plasterboard Walls, Aluminium & Fabric Partition to South, Steel Data Cable Casing, Timber Door / Frames / Architraves	No Sample Taken No Asbestos Containing Materials Sighted 2481	A5	N/A
23 rd June 2018

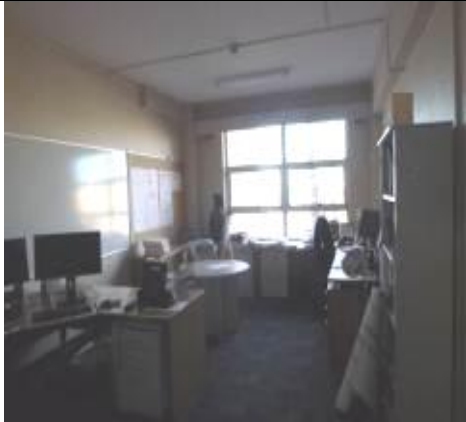
Internal - First Floor Program Leader Place Outcomes Program Leader Strategic Planning Concrete Ceiling, Brick & Cement Render Wall, Aluminium & Timber Window / Door Frames / Skirting / Sill / Bead to Top of Wall / Pelmet, Carpet, Steel Data Cable Cover, Steel Radiator, Plasterboard Wall to West & Entry Opening	No Sample Taken No Asbestos Containing Materials Sighted 2482	A5	N/A

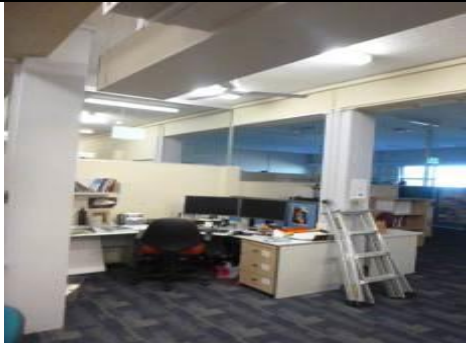
Internal - First Floor R. Vlakov & A. Kazis Open Plan Area Concrete Ceiling & Columns, Aluminium / Fabric / Plasterboard Partitions, Carpet	No Sample Taken No Asbestos Containing Materials Sighted 2483	A5	N/A

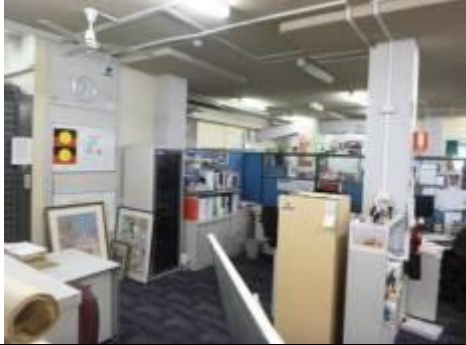
Internal - First Floor Cultural & Heritage Concrete Ceiling & Columns, Aluminium / Fabric / Plasterboard Partitions, Carpet 2484	No Sample Taken No Asbestos Containing Materials Sighted	A5	N/A
23 rd June 2018

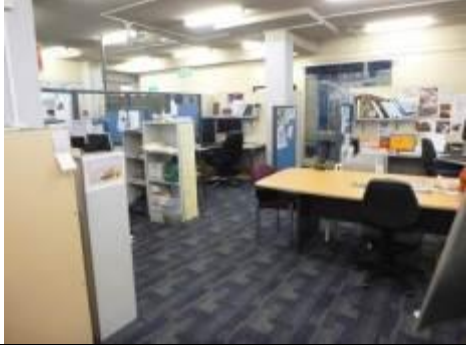
Internal - First Floor Community Outcomes Concrete Ceiling & Columns, Aluminium / Fabric / Plasterboard Partitions, Carpet 2485	No Sample Taken No Asbestos Containing Materials Sighted	A5	N/A
23 rd June 2018

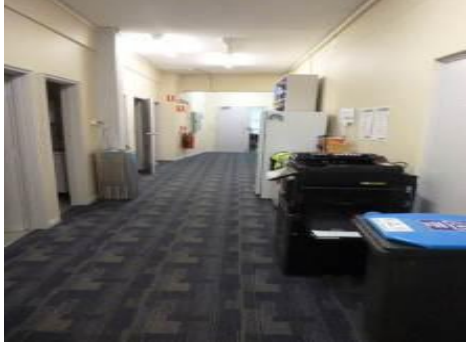
Internal - First Floor Central Corridor Adjacent Cleaners Room Concrete Ceiling, Cement Render Wall, Plasterboard Wall, Timber Door / Frame / Architraves / Skirting / Bead Around Ceiling 2486	No Sample Taken No Asbestos Containing Materials Sighted	A5	N/A

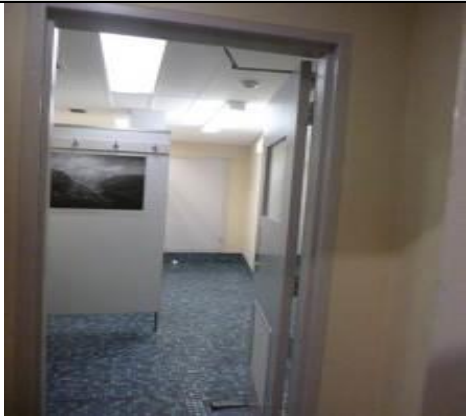
Internal - First Floor Female Toilet Suspended Plasterboard Panel Ceiling, Brick & Cement Render Wall, Laminated Particleboard Toilet Cubicle Dividers, Ceramic Tile Floor, PVC Cistern & Seat, Timber Door / Frames / Architraves, Ceramic Wash Basins	No Sample Taken No Asbestos Containing Materials Sighted 2487	A5	N/A
23 rd June 2018	Not Available Due to Poor Quality of Image	Internal - First Floor Female Toilet Ceiling Cavity Risers Have Expander Foam Through Services Penetrations 2488	No Sample Taken No Asbestos Containing Materials Sighted	A5	N/A
23 rd June 2018

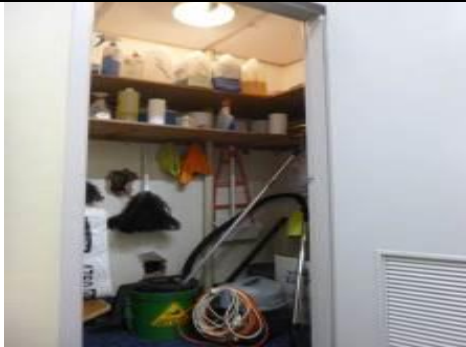
Internal - First Floor Cleaners Cupboard Suspended Plasterboard Panel Ceiling, Brick & Cement Render Wall, Ceramic Tile Floor, Timber Door, Frames & Architraves.	No Sample Taken No Asbestos Containing Materials Sighted 2489	A5	N/A

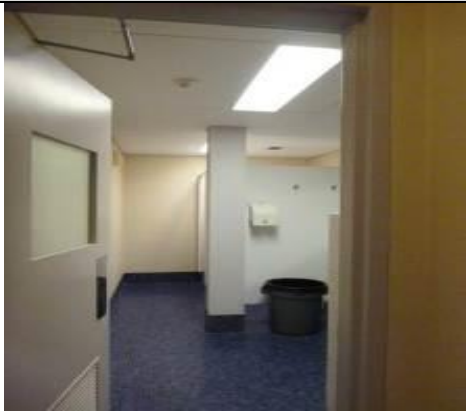
Internal - First Floor Female Toilet Suspended Plasterboard Panel Ceiling, Brick & Cement Render Wall, Laminated Particleboard Toilet Cubicle Dividers, Ceramic Tile Floor, PVC Cistern & Seat, Timber Door / Frame / Architraves, Ceramic Wash Basins, Steel Urinal	No Sample Taken No Asbestos Containing Materials Sighted 2490	A5	N/A
23 rd June 2018

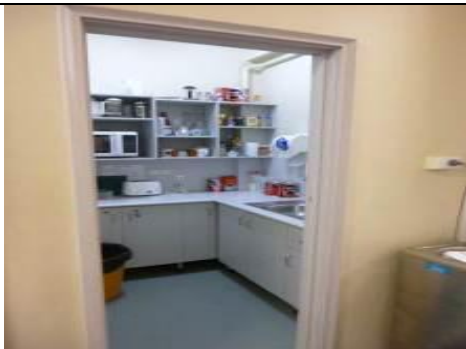
Internal - First Floor Kitchen Concrete Ceiling, Brick & Cement Render Wall, MDF Modular Kitchen Cabinets, Linoleum Floor 2491	No Sample Taken No Asbestos Containing Materials Sighted	A5	N/A
23 rd June 2018

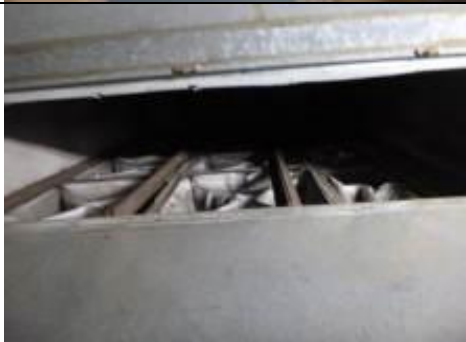
Internal - First Floor Plant Room Fabric Filters in Ducting 2492	No Sample Taken No Asbestos Containing Materials Sighted	A5	N/A

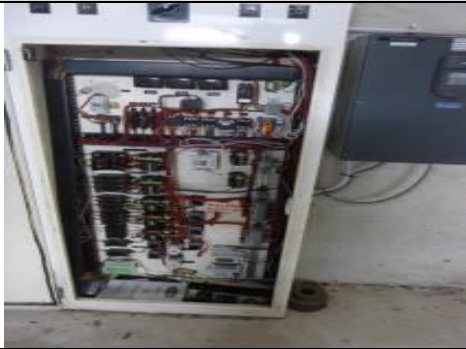
Internal - First Floor Plant Room Electrical Cabinet 2493	No Sample Taken No Asbestos Containing Materials Sighted	A5	N/A
23 rd June 2018

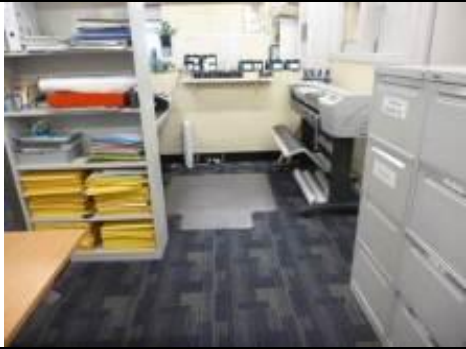
Internal - First Floor Hot Desk Standing Desk Concrete Ceiling & Columns, Aluminium, Fabric & Plasterboard Partitions, Carpet 2494	No Sample Taken No Asbestos Containing Materials Sighted	A5	N/A
23 rd June 2018

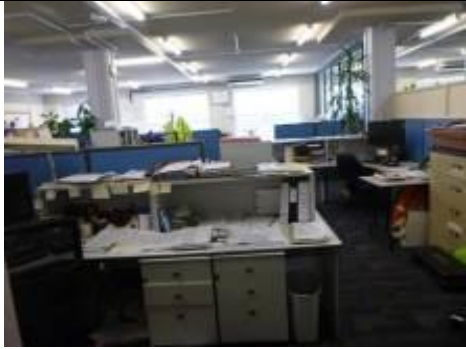
Internal - First Floor Natural Areas Cultural & Heritage Concrete Ceiling & Columns, Aluminium, Fabric & Plasterboard Partitions, Plasterboard Wall to South, Carpet 2495	No Sample Taken No Asbestos Containing Materials Sighted	A5	N/A
23 rd June 2018

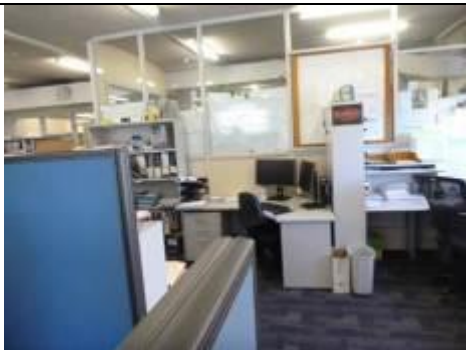
Internal - First Floor VAC Area Program Leader & Survey Design Concrete Ceiling & Columns, Aluminium, Fabric / Timber / Plasterboard / Glass Partitions, Carpet 2496	No Sample Taken No Asbestos Containing Materials Sighted	A5	N/A

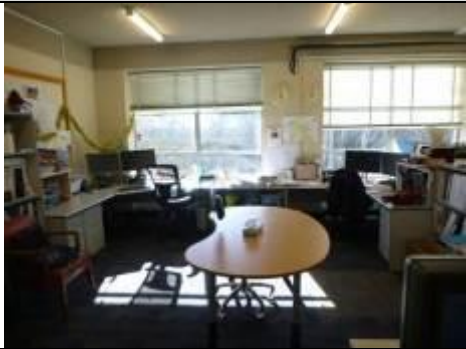
Internal - First Floor T. Gibbs & G. Sherlock Area Concrete Ceiling & Columns, Aluminium, Fabric / Timber / Plasterboard / Glass Partitions, Carpet 2497	No Sample Taken No Asbestos Containing Materials Sighted	A5	N/A
23 rd June 2018

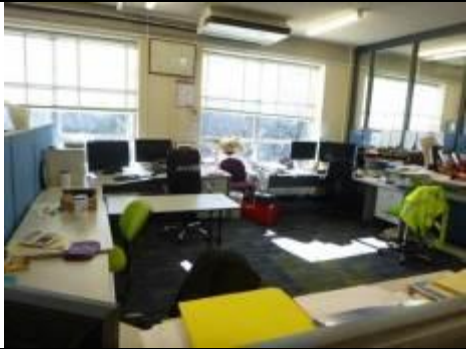
Internal - First Floor Survey & Design Concrete Ceiling & Columns, Aluminium / Fabric / Plasterboard Partitions, Carpet 2498	No Sample Taken No Asbestos Containing Materials Sighted	A5	N/A
23 rd June 2018

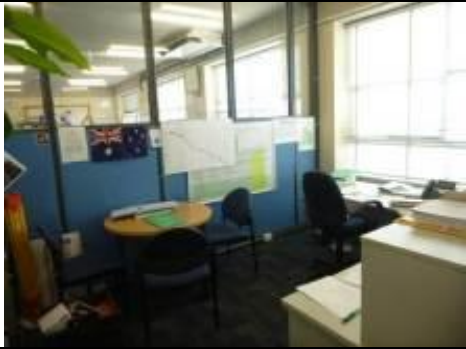
Internal - First Floor Program Leader Project Management Concrete Ceiling & Columns, Aluminium / Fabric / Plasterboard Partitions, Carpet 2499	No Sample Taken No Asbestos Containing Materials Sighted	A5	N/A

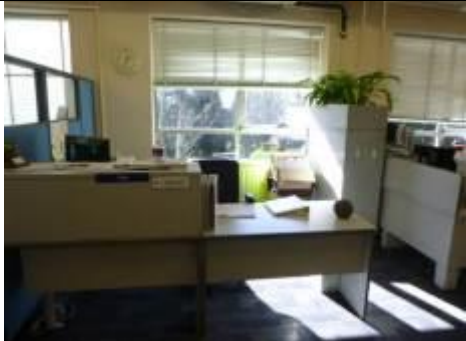
Internal - First Floor I. Tolhurst Area Concrete Ceiling & Columns, Aluminium / Fabric / Plasterboard Partitions, Carpet 2500	No Sample Taken No Asbestos Containing Materials Sighted	A5	N/A

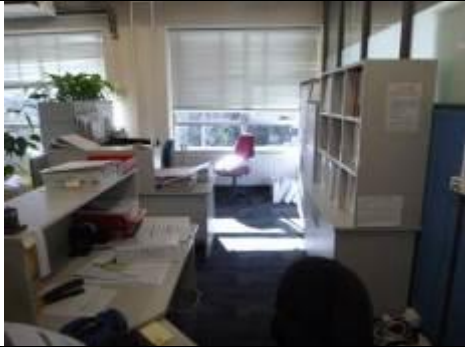
Internal - First Floor A. Nadarajah Area Concrete Ceiling & Columns, Aluminium / Fabric / Plasterboard Partitions, Carpet 2501	No Sample Taken No Asbestos Containing Materials Sighted	A5	N/A
23 rd June 2018

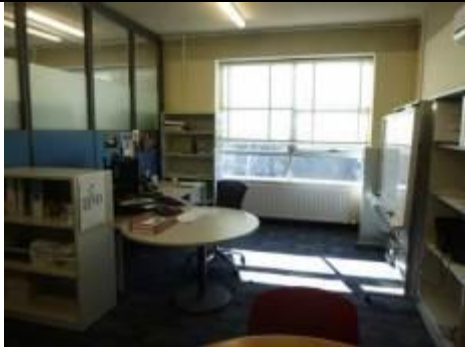
Internal - First Floor Manager Infrastructure & Strategic Assets Branch Concrete Ceiling & Columns, Aluminium / Fabric / Plasterboard Partitions, Carpet 2502	No Sample Taken No Asbestos Containing Materials Sighted	A5	N/A
23 rd June 2018

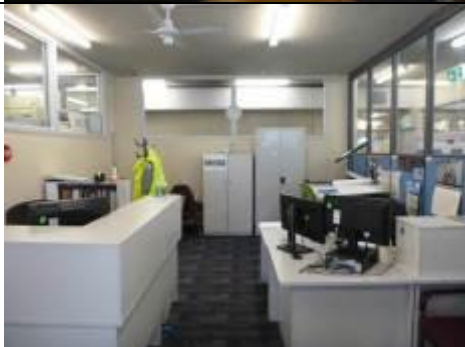
Internal - First Floor Project Area Concrete Ceiling & Columns, Aluminium / Fabric / Plasterboard Partitions, Carpet 2503	No Sample Taken No Asbestos Containing Materials Sighted	A5	N/A

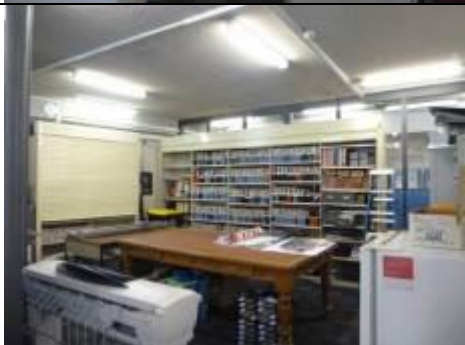
Internal - First Floor Plans Room Concrete Ceiling & Columns, Aluminium / Fabric / Plasterboard Partitions, Carpet 2504	No Sample Taken No Asbestos Containing Materials Sighted	A5	N/A

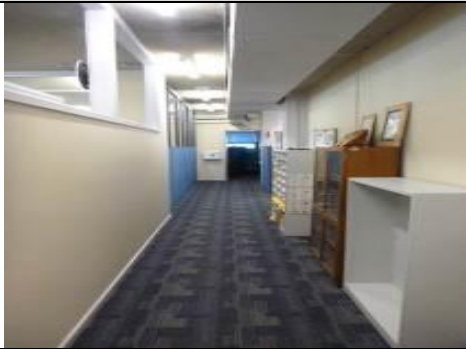
Internal - First Floor Western Corridor Particleboard / Aluminium / Fabric Partition Walls, Concrete Ceiling, Brick & Cement Render Wall, Carpet 2505	No Sample Taken No Asbestos Containing Materials Sighted	A5	N/A
23 rd June 2018

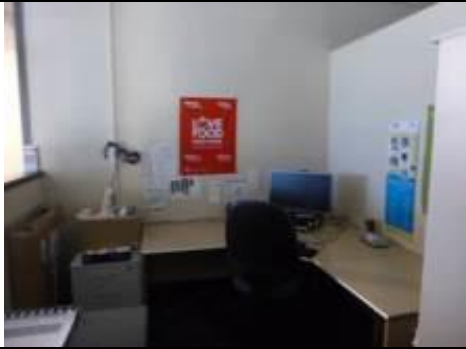
Internal - First Floor J. Allen Area Concrete Ceiling, Brick & Cement Render Wall, Plasterboard Wall & Partition, Timber Door / Frame / Skirting, Carpet 2506	No Sample Taken No Asbestos Containing Materials Sighted	A5	N/A
23 rd June 2018
