Asbestos Register

HAZARDOUS MATERIALS REGISTER

Regional EnviroScience Pty Ltd was requested by Mr. Jason Adams of Blue Mountains City Council to undertake a Hazardous Building Materials Register and to prepare a Hazardous Materials Management Plan of the property known as the Blue Mountains City Council Headquarters, 2-6 Civic Place, Katoomba, NSW, 2780. The purpose of the audit was to locate and identify asbestos based building materials and product within the building in accordance with the *NSW Work Health and Safety Act 2011* and *NSW Work Health and Safety Regulation 2017* and the *Code of Practice: How to Manage and Control Asbestos in the Workplace [Safe Work Australia: 2016]* and the *Code of Practice: How to Safely Remove Asbestos [Safe Work Australia: 2016]*.

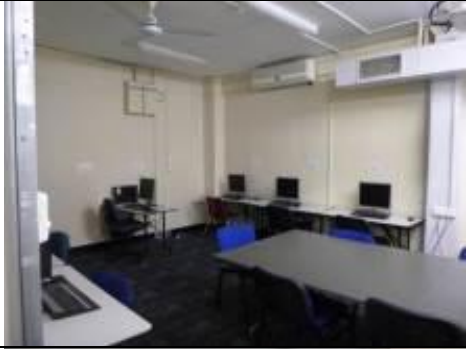
Internal - First Floor Training Room Concrete Ceiling, Brick & Cement Wall, Plasterboard Wall & Partition, Timber Door / Frame / Skirtings, Carpet 2507	No Sample Taken No Asbestos Containing Materials Sighted	A5	N/A

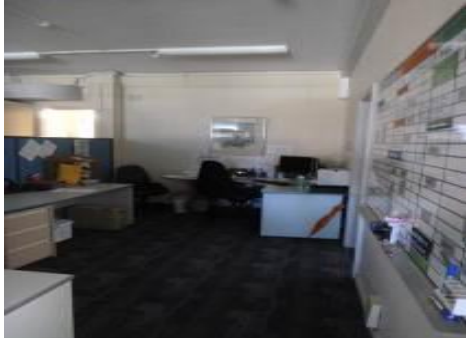
Internal - First Floor K. Moseley & Vacant Area Concrete Ceiling, Brick & Cement Wall, Plasterboard Wall & Partition, Timber Door / Frame / Skirtings, Carpet 2508	No Sample Taken No Asbestos Containing Materials Sighted	A5	N/A

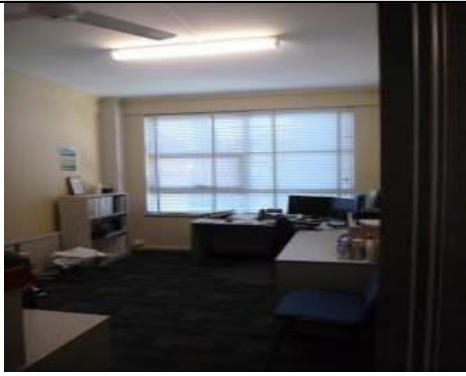
Internal - First Floor Program Leader Asset Planning Concrete Ceiling & Columns, Aluminium / Fabric / Plasterboard Partitions, Aluminium & Glass Windows to West, Carpet	No Sample Taken No Asbestos Containing Materials Sighted 2509	A5	N/A
23 rd June 2018

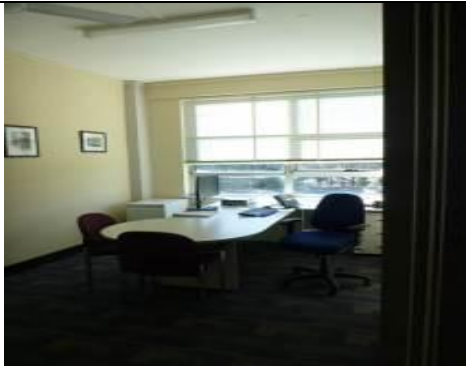
Internal - First Floor Manager Strategy Outcomes & Projects Concrete Ceiling & Columns, Aluminium / Fabric / Plasterboard Partitions, Aluminium & Glass Windows to West, Carpet	No Sample Taken No Asbestos Containing Materials Sighted 2510	A5	N/A
23 rd June 2018

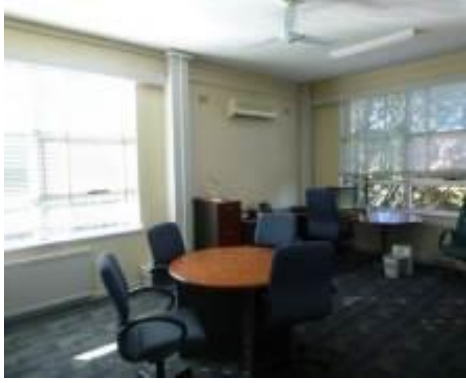
Internal - First Floor Director City & Community Outcomes Concrete Ceiling & Columns, Aluminium / Fabric / Plasterboard Partitions, Aluminium & Glass Windows to North & West, Carpet	No Sample Taken No Asbestos Containing Materials Sighted 2511	A5	N/A

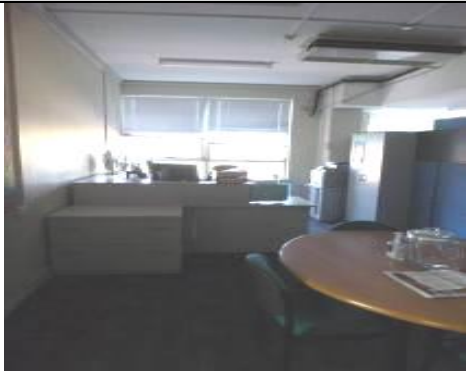
Internal - First Floor D. Hope Area Concrete Ceiling, Brick & Cement Render Wall, Plasterboard Wall & Partition, Timber Door, Frame / Skirting, Carpet, Aluminium & Glass Windows to North	No Sample Taken No Asbestos Containing Materials Sighted 2512	A5	N/A
23 rd June 2018

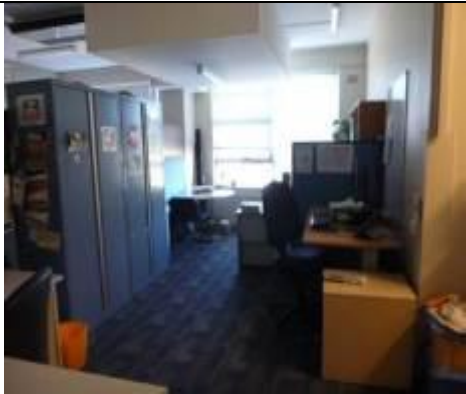
Internal - First Floor Waste & Resources Concrete & Plasterboard Ceiling, Brick & Cement Render Wall, Plasterboard Wall, Aluminium & Glass Window to North, Carpet, Timber Architrave, MDF Modular Work Stations, Aluminium & Fabric Partitions.	No Sample Taken No Asbestos Containing Materials Sighted 2513	A5	N/A
23 rd June 2018

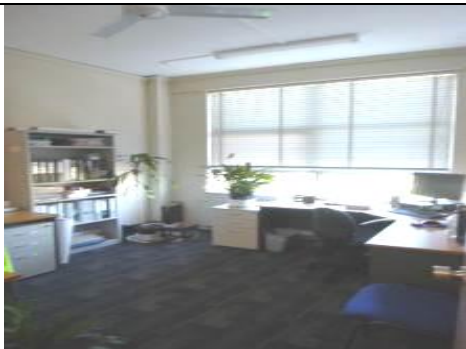
Internal - First Floor M. White & D. Hume Office Concrete Ceiling, Cement Render Wall, Plasterboard Partition Walls, Carpet, Timber Door / Frame / Architraves / Skirting, MDF Workstations	No Sample Taken No Asbestos Containing Materials Sighted 2514	A5	N/A

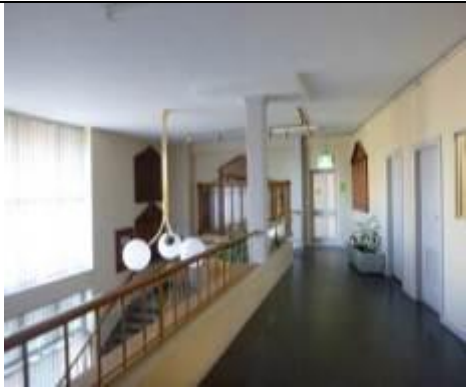
Internal - First Floor Entry & Landing Area Concrete Ceiling, Cement & Render Wall, Plasterboard Walls, Timber Doors / Frame / Architrave / Skirting, Terrazzo Tile Floor & Steps to Reception, Aluminium & Glass Window to North	No Sample Taken No Asbestos Containing Materials Sighted 2516	A5	N/A

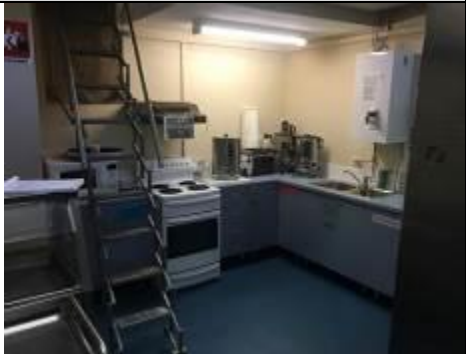
Second Floor Kitchen Floor Covering Blue Vinyl Approx. 20m ² 2517	Sample B18780-S56 No Asbestos Detected	A5	N/A
23 rd June 2018

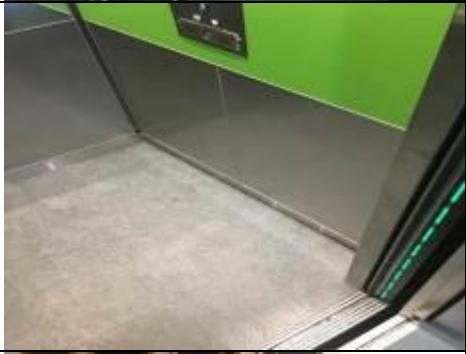
Second Floor Elevator Floor Covering Grey Vinyl Approx. 3m ² 2518	Sample B18780-S57 No Asbestos Detected	A5	N/A
23 rd June 2018

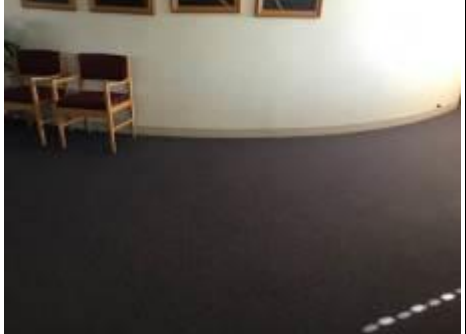
Second Floor Vinyl Skirting Cream Vinyl Approx. 4m ² 2519	Sample B18780-S58 No Asbestos Detected	A5	N/A

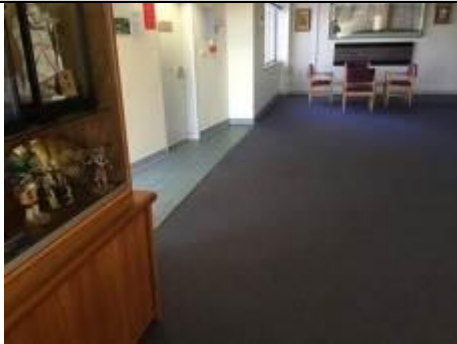
Second Floor Vinyl Skirting Grey Vinyl Approx. 1m ² 2520	Sample B18780-S59 No Asbestos Detected	A5	N/A
23 rd June 2018

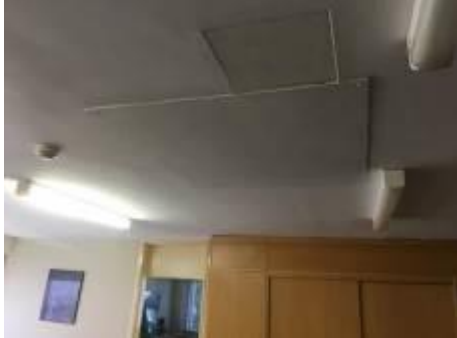
Second Floor Mayor's Office Bonded Board Infill Approx. 1m ² 2523	Sample B18780-S60 No Asbestos Detected.	A5	N/A
23 rd June 2018

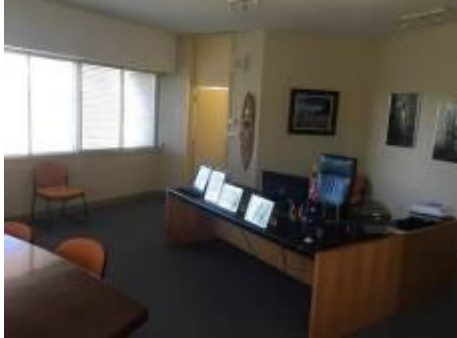
Second Floor Mayor's Office Brown Vinyl Skirting Approx. 2m ² 2524	Sample B18780-S61 No Asbestos Detected	A5	N/A
23 rd June 2018

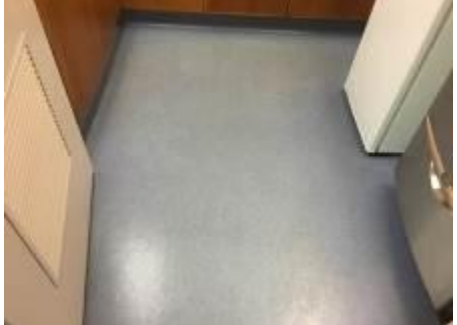
Second Floor Kitchen Floor Covering Blue Vinyl Approx. 3m ² 2525	Sample B18780-S62 No Asbestos Detected	A5	N/A

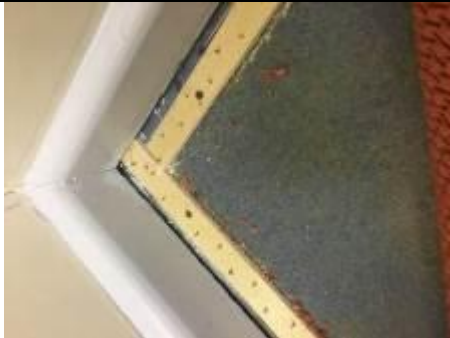
Second Floor Jamison Meeting Room Vinyl Floor Covering Below Carpet Approx. 16m ²	Sample B18780-S63 No Asbestos Detected 2526	A5	N/A
23 rd June 2018

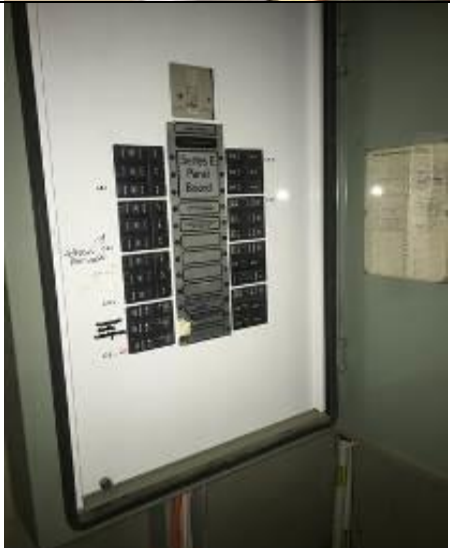
Second Floor Ceiling Cavity Above Kitchen Bakelite Fittings in Electrical Box.	No Sample Taken. Assume Contains Asbestos. 2527	A4	Good Condition Accessible to Tradespeople Refer to Asbestos Management Plan

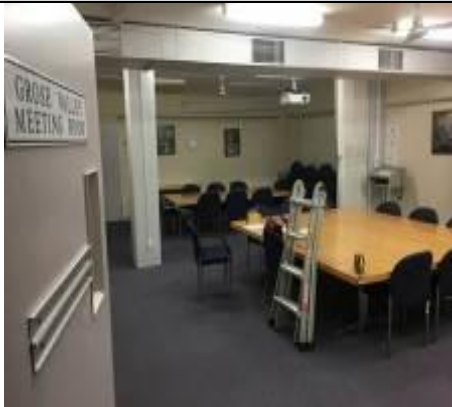
Second Floor Grose Valley Meeting Room Plasterboard Ceiling / Northern Wall, Eastern Wall Rendered Concrete, Western Wall Timber, Southern Curtain Partition Wall, Concrete Render Pylons, Timber Architraves, Carpet on Concrete & Aluminium Sliding Door to Kitchen.	No Sample Taken. No Asbestos Containing Material Sighted. 2528	A5	N/A
23 rd June 2018

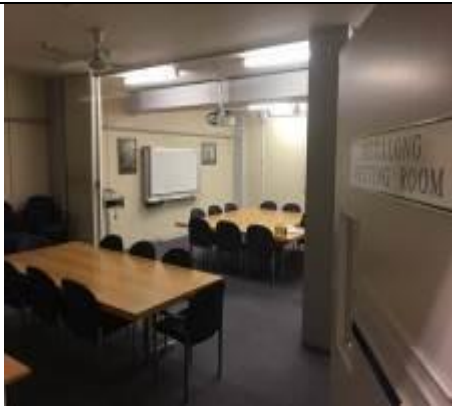
Second Floor Megalong Meeting Room Plasterboard Ceiling, Timber Southern & Western Walls & Architraves, Eastern Concrete Rendered Wall & Carpet on Concrete.	No Sample Taken. No Asbestos Containing Material Sighted. 2529	A5	N/A

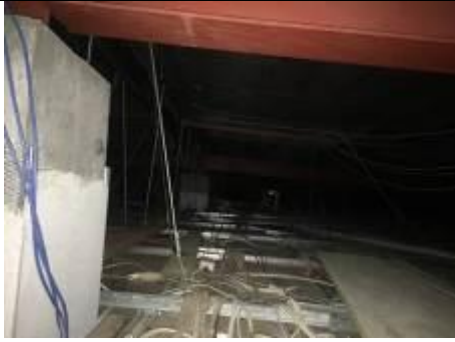
Second Floor Ceiling Space Suspended Ceiling, Metal Reinforced Steel Joists, Exposed Brick Wall, Foil Roof Insulation.	No Sample Taken. No Asbestos Containing Material Sighted. 2530	A5	N/A
23 rd June 2018

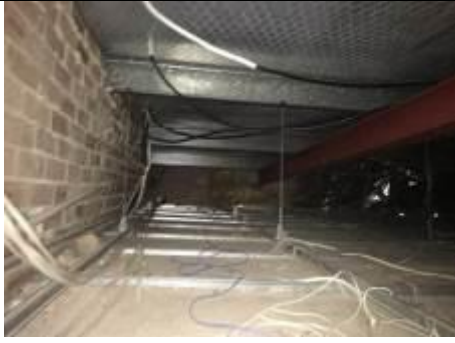
Second Floor Ceiling Space Suspended Ceiling, Metal Reinforced Steel Joists, Exposed Brick Wall, Foil Roof Insulation.	No Sample Taken. No Asbestos Containing Material Sighted. 2531	A5	N/A
23 rd June 2018

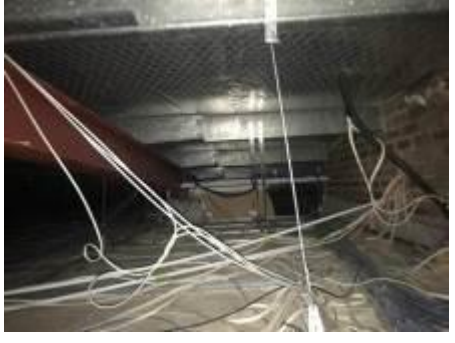
Second Floor Ceiling Space Suspended Ceiling, Metal Reinforced Steel Joists, Exposed Brick Wall, Foil Roof Insulation.	No Sample Taken. No Asbestos Containing Material Sighted. 2532	A5	N/A

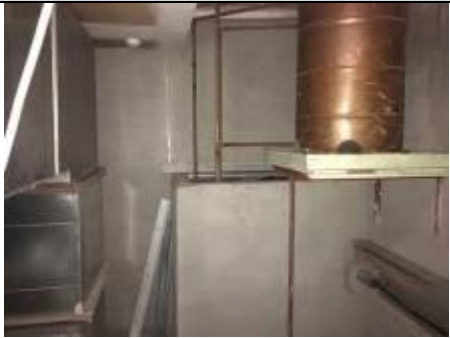
Second Floor Ceiling Cavity Above Kitchen Air Conditioning Unit, Hot Water Boiler, Rendered Brick Walls, Plasterboard Ceiling & Concrete Floor.	No Sample Taken. No Asbestos Containing Material Sighted. 2533	A5	N/A
23 rd June 2018

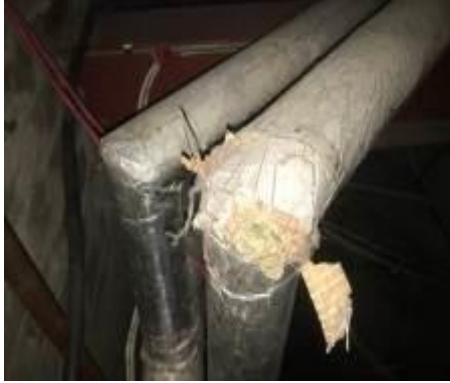
Second Floor Ceiling Cavity Above Kitchen Air Conditioning Unit, Hot Water Boiler, SMF Lagged Piping, Rendered Brick Walls, Plasterboard Ceiling & Concrete Floor.	No Sample Taken. No Asbestos Containing Material Sighted. 2534	A5	N/A
23 rd June 2018

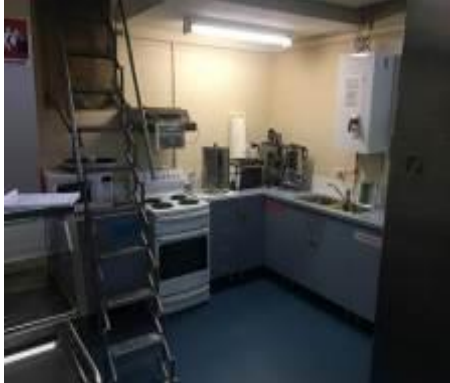
Second Floor Kitchen Plasterboard Ceiling, Concrete Rendered Walls & Vinyl Floor. Rendered Concrete Ceiling & Walls & Plasterboard Infill to Kitchen Void.	No Sample Taken. No Asbestos Containing Material Sighted. 2535	A5	N/A

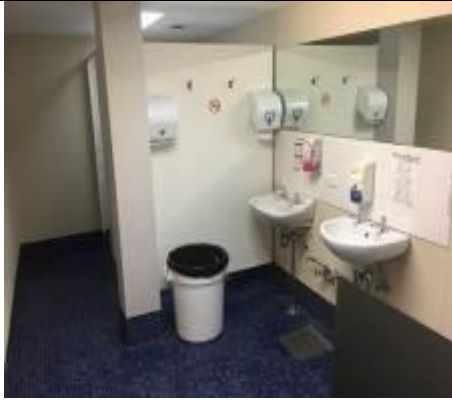
Second Floor Male Toilet Plasterboard Suspended Ceiling, Concrete Rendered Walls, Ceramic Tile Floor & Splashback, Laminated Timber Partitions. Entrance Void Same as Toilets.	No Sample Taken. No Asbestos Containing Material Sighted. 2536	A5	N/A
23 rd June 2018

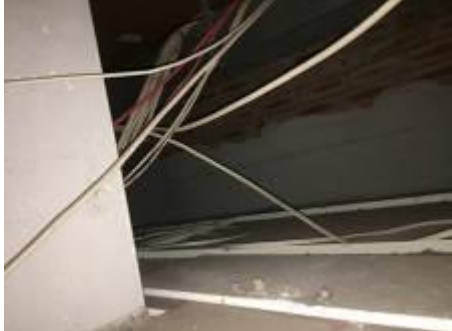
Second Floor Male Toilet Plasterboard Suspended Ceiling, Rendered Brick Walls & Concrete Ceiling.	No Sample Taken. No Asbestos Containing Material Sighted. 2537	A5	N/A
23 rd June 2018

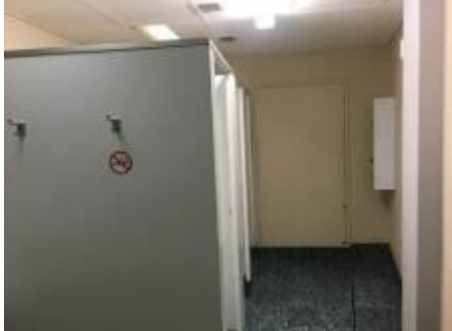
Second Floor Female Toilet Plasterboard Suspended Ceiling, Concrete Rendered Walls, Ceramic Tile Floor & Splashback, Laminated Timber Partitions & Compressed Board Infill to Northern Wall. Entrance Void Same as Toilets.	No Sample Taken. No Asbestos Containing Material Sighted. 2538	A5	N/A

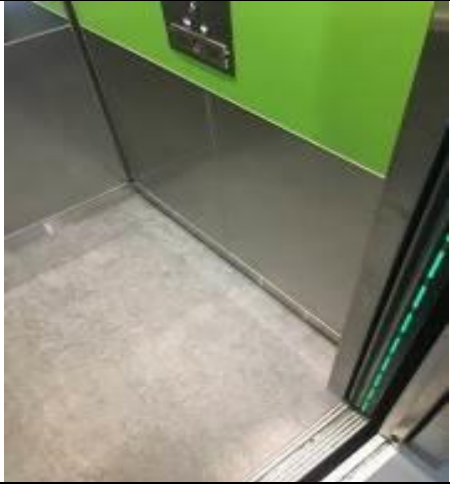
Second Floor Elevator Laminated Timber Walls & Ceiling, Aluminium Base-Board. 2539	No Sample Taken. No Asbestos Containing Material Sighted.	A5	N/A
23 rd June 2018

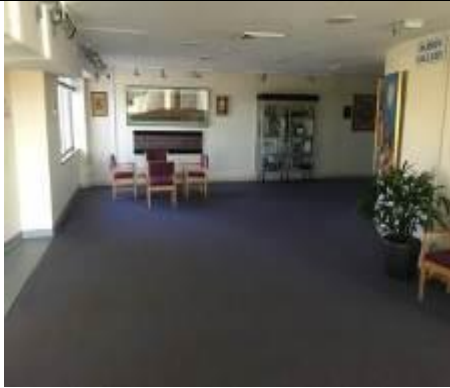
Second Floor Entrance/Hall Plasterboard Ceiling, Rendered Concrete Walls, Aluminium Windows, Timber Window Skirting & Carpet on Concrete. 2540	No Sample Taken. No Asbestos Containing Material Sighted.	A5	N/A
23 rd June 2018

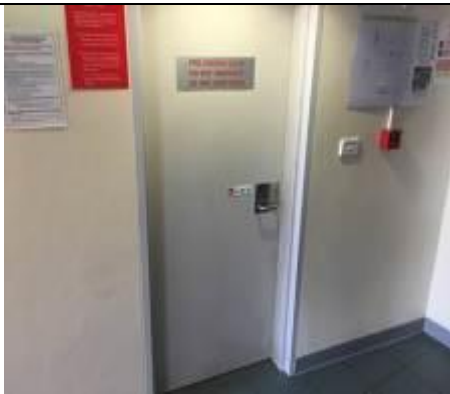
Second Floor Entrance/Hall Fire Door. Manufactured in 2005. 2541	No Sample Taken. No Asbestos Containing Material Sighted.	A5	N/A

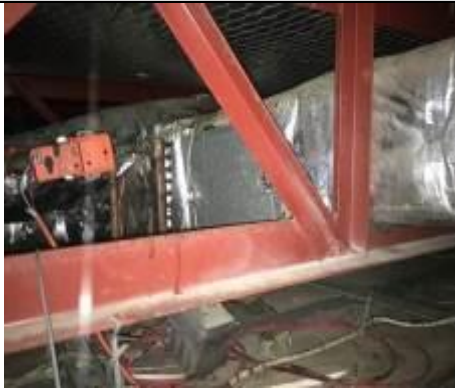
Second Floor Ceiling Space Above Entrance Plasterboard Floor, Steel Reinforced Joists, Air Conditioning Unit, Concrete Ceiling.	No Sample Taken. No Asbestos Containing Material Sighted. 2542	A5	N/A
23 rd June 2018

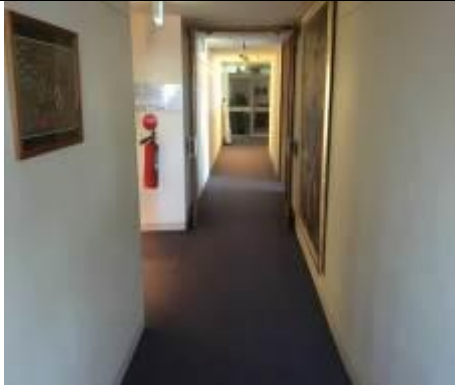
Second Floor Eastern Hallway Running North-South Concrete Rendered Walls, Plasterboard Ceiling, Timber Doors & Frames, Carpet on Concrete.	No Sample Taken. No Asbestos Containing Material Sighted. 2543	A5	N/A
23 rd June 2018

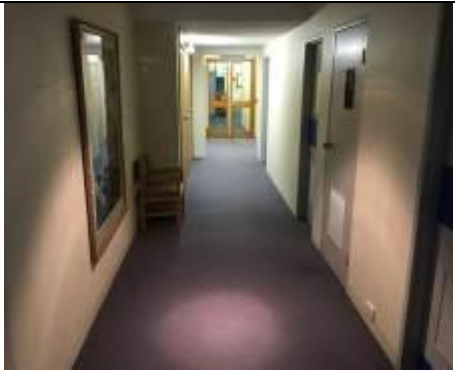
Second Floor Southern Hallway Running East-West Concrete Rendered Walls, Plasterboard Ceiling, Timber & Metal Doors & Frames, Carpet on Concrete.	No Sample Taken. No Asbestos Containing Material Sighted. 2544	A5	N/A

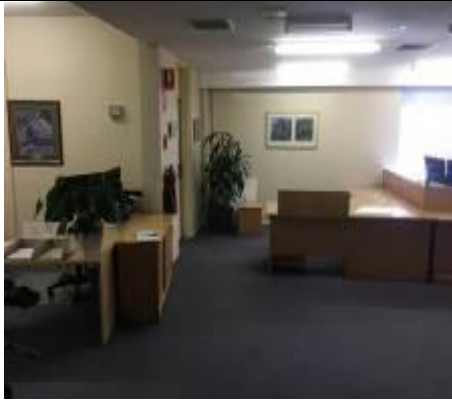
Second Floor Mayor's Office Reception Concrete Rendered Walls, Plasterboard Ceiling, Bonded Board Infill, Carpet on Concrete & Timber & Metal Doors, Frames & Window Frames.	No Sample Taken. No Asbestos Containing Material Sighted. 2545	A5	N/A
23 rd June 2018

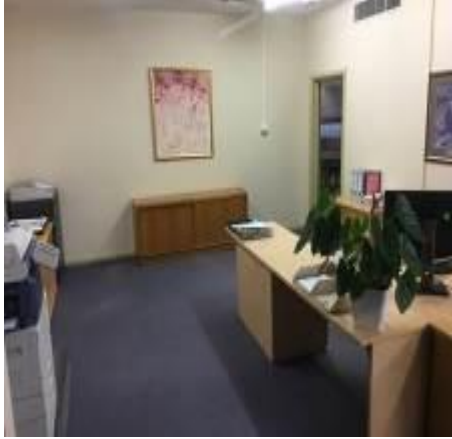
Second Floor Mayor's Office Reception Plasterboard Ceiling & Northern, Southern & Western Walls, Bonded Board Infill, Carpet on Concrete & Timber & Metal Doors, Frames & Window Frames & Timber Skirting.	No Sample Taken. No Asbestos Containing Material Sighted. 2546	A5	N/A

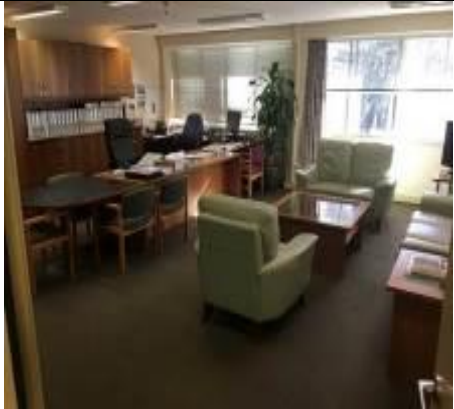
Second Floor General Manager's Office Plasterboard Ceiling & Walls Except Northern Rendered Concrete Wall, Timber Architraves & Carpet on Concrete.	No Sample Taken. No Asbestos Containing Material Sighted. 2547	A5	N/A
23 rd June 2018

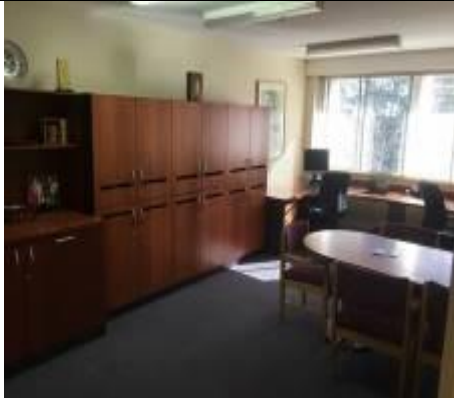
Second Floor Councillor's Room Plasterboard Ceiling, Southern & Western Walls, Rendered Concrete Northern & Eastern Walls, Carpet on Concrete & Timber Infill Above Timber Door.	No Sample Taken. No Asbestos Containing Material Sighted. 2548	A5	N/A
23 rd June 2018

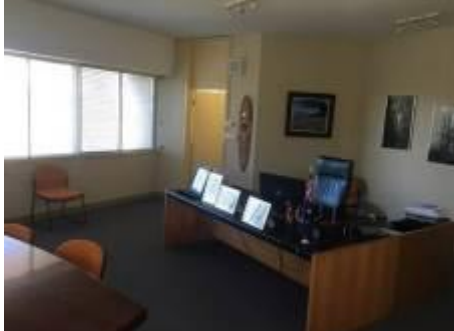
Second Floor Mayor's Office Plasterboard Ceiling, Concrete Rendered Walls, Carpet Floor.	No Sample Taken. No Asbestos Containing Material Sighted. 2549	A5	N/A

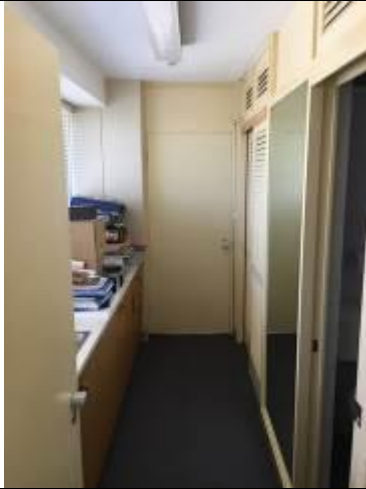
Second Floor Mayor's Void/ Cupboards Plasterboard Ceiling & Walls, Eastern Rendered Concrete Wall & Carpet Floor. 2550	No Sample Taken. No Asbestos Containing Material Sighted.	A5	N/A
23 rd June 2018

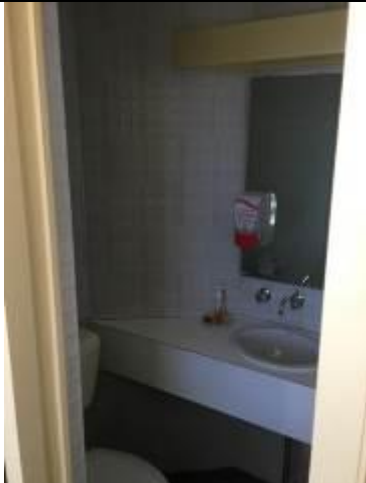
Second Floor Mayor's Toilet Plasterboard Ceiling, Ceramic Tile Walls & Floor. 2551	No Sample Taken. No Asbestos Containing Material Sighted.	A5	N/A

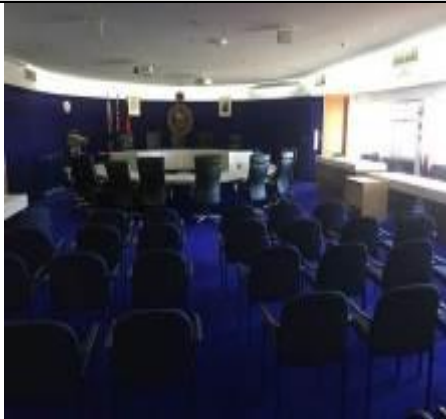
Second Floor Council Chambers Plasterboard Ceiling & Walls, Carpet on Compressed Timber Walls, Carpet on Concrete Floor, Timber Doors & Frames & Aluminium Windows & Frames.	No Sample Taken. No Asbestos Containing Material Sighted. 2552	A5	N/A
23 rd June 2018

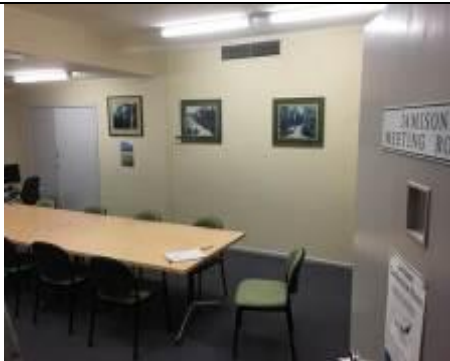
Second Floor Jamison Meeting Room Plasterboard Ceiling & Walls, Timber Doors & Architraves & Carpet on Concrete.	No Sample Taken. No Asbestos Containing Material Sighted. 2553	A5	N/A
23 rd June 2018

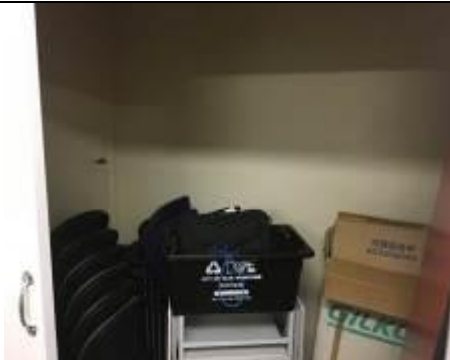
Second Floor Jamison Meeting Room Store Room Plasterboard Ceiling & Walls, Timber Doors & Architraves & Carpet on Concrete.	No Sample Taken. No Asbestos Containing Material Sighted. 2554	A5	N/A

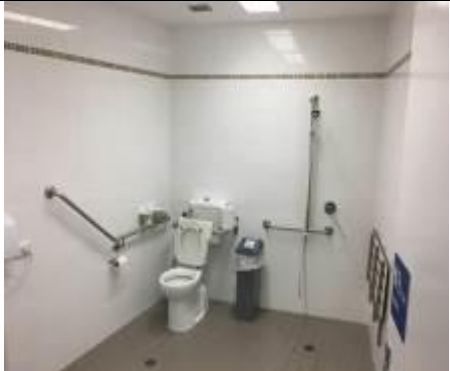
Second Floor – Disabled Toilet Plasterboard Ceiling, Ceramic Tile Walls & Floor. 2555	No Sample Taken. No Asbestos Containing Material Sighted.	A5	N/A
23 rd June 2018

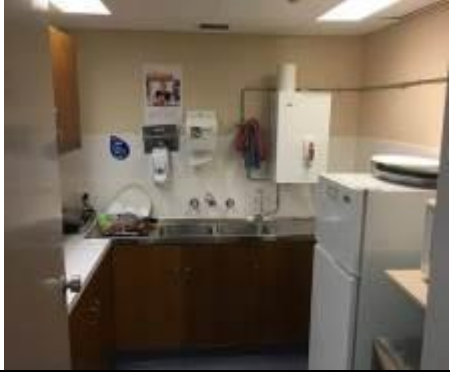
Second Floor – Kitchen Plasterboard Ceiling, Concrete Rendered Walls & Vinyl Floor. 2556	No Sample Taken. No Asbestos Containing Material Sighted.	A5	N/A
23 rd June 2018

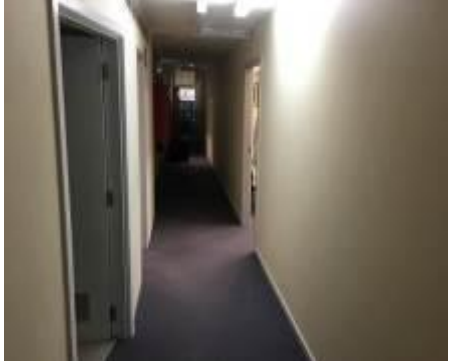
Second Floor – Northern Hallway Running East-West Plasterboard Ceiling, Plasterboard & Rendered Cement Walls & Carpet on Concrete. 2557	No Sample Taken. No Asbestos Containing Material Sighted. 2557	A5	N/A

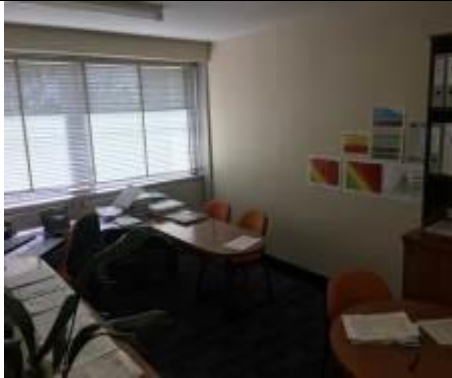
Second Floor Executive Office Plasterboard Ceiling & Walls, Carpet on Concrete, Timber Door & Architraves, Aluminium Windows.	No Sample Taken. No Asbestos Containing Material Sighted. 2558	A5	N/A
23 rd June 2018

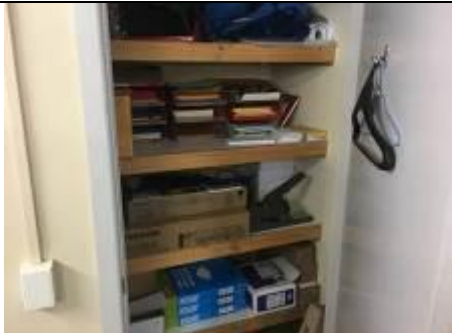
Second Floor Executive Office Cupboard Plasterboard Ceiling & Walls, Timber Shelves.	No Sample Taken. No Asbestos Containing Material Sighted. 2559	A5	N/A
23 rd June 2018

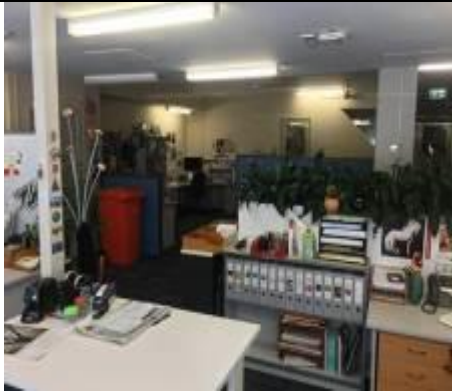
Second Floor Executive Services Plasterboard Ceiling & Walls, Rendered Northern Wall, Carpet on Concrete, Timber Architraves, Aluminium Windows.	No Sample Taken. No Asbestos Containing Material Sighted. 2560	A5	N/A

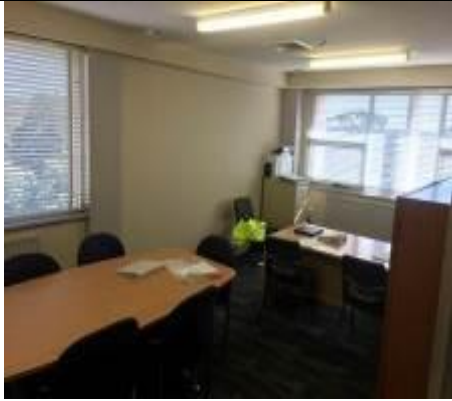
Second Floor Ext 5716 Office Plasterboard Ceiling & Walls, Rendered Northern & Western Walls, Carpet on Concrete, Timber Door & Architraves, Aluminium Windows.	No Sample Taken. No Asbestos Containing Material Sighted. 2561	A5	N/A
23 rd June 2018

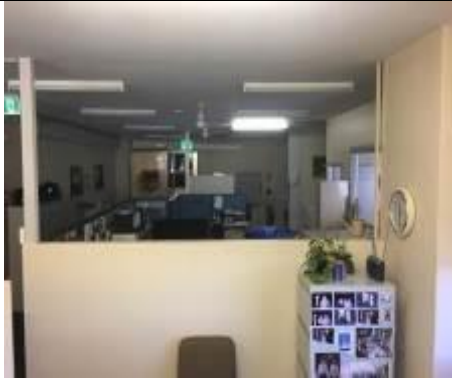
Second Floor Hot Desk Area Plasterboard Ceiling, Partition Walls, Plasterboard & Rendered Concrete Walls, Timber Architraves, Doors, Door Frames, Aluminium Window Frames & Carpet on Concrete.	No Sample Taken. No Asbestos Containing Material Sighted. 2562	A5	N/A

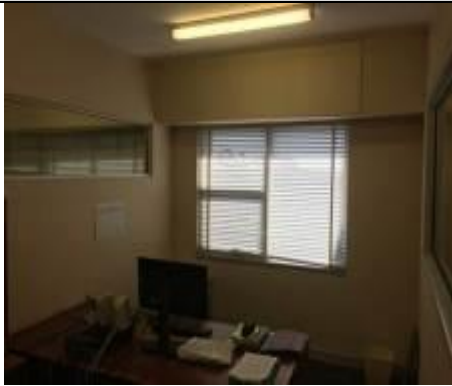
Second Floor Ext 5507 Office Plasterboard Ceiling & Walls, Carpet on Concrete, Timber Door & Architraves, Aluminium Windows, Timber Infill on Northern Wall.	No Sample Taken. No Asbestos Containing Material Sighted. 2563	A5	N/A
23 rd June 2018

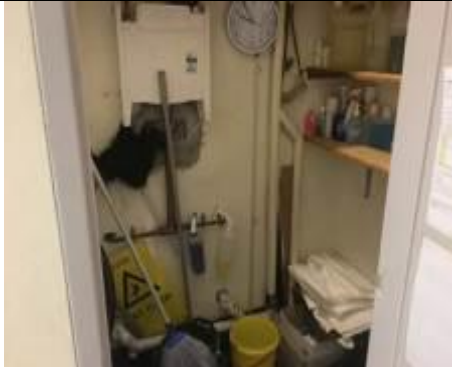
Second Floor Cleaning Room Plasterboard Ceiling, Concrete Rendered Walls & Tile Floor.	No Sample Taken. No Asbestos Containing Material Sighted. 2564	A5	N/A
23 rd June 2018

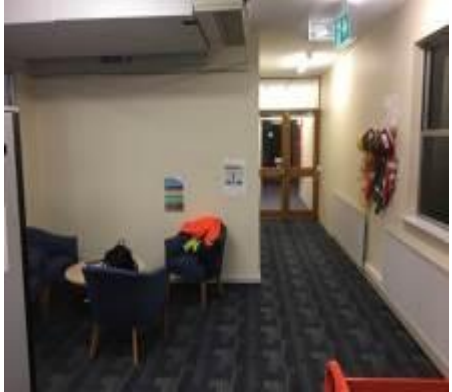
Second Floor South Western Hallway Plasterboard Ceiling & Walls, Carpet on Concrete, Timber Door & Architraves, Aluminium Windows.	No Sample Taken. No Asbestos Containing Material Sighted. 2565	A5	N/A

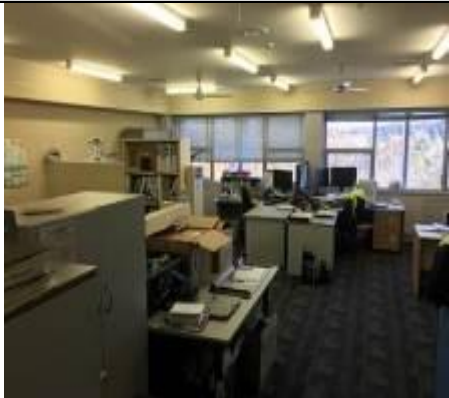
Second Floor Corporate Strategy Plasterboard Ceiling, Partition Walls, Plasterboard & Rendered Concrete Walls, Timber Architraves, Doors, Door Frames, Aluminium Window Frames & Carpet on Concrete.	No Sample Taken. No Asbestos Containing Material Sighted. 2566	A5	N/A
23 rd June 2018

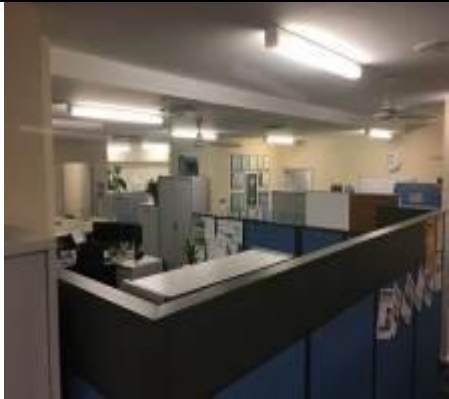
Second Floor Strategic Finance Plasterboard Ceiling, Partition Walls, Plasterboard & Rendered Concrete Walls, Timber Architraves, Doors, Door Frames, Aluminium Window Frames & Carpet on Concrete.	No Sample Taken. No Asbestos Containing Material Sighted. 2567	A5	N/A

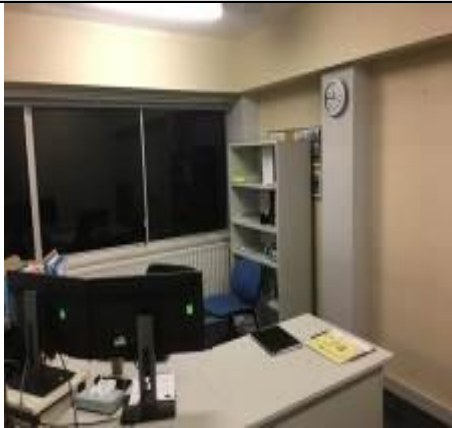
Second Floor Chief Financial Officer Plasterboard Ceiling, Plasterboard & Rendered Concrete Walls, Timber Architraves, Doors, Door Frames, Aluminium Window Frames & Carpet on Concrete.	No Sample Taken. No Asbestos Containing Material Sighted. 2568	A5	N/A
23 rd June 2018

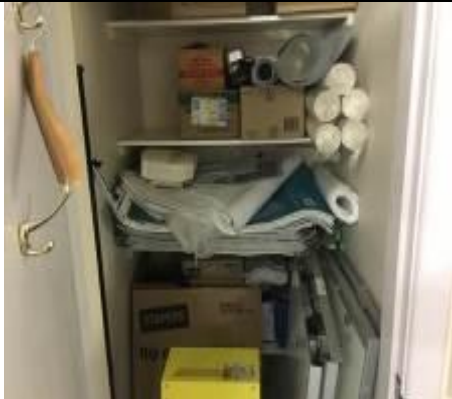
Second Floor Storage Plasterboard Ceiling & Walls, Timber Shelving & Carpet on Concrete.	No Sample Taken. No Asbestos Containing Material Sighted. 2569	A5	N/A

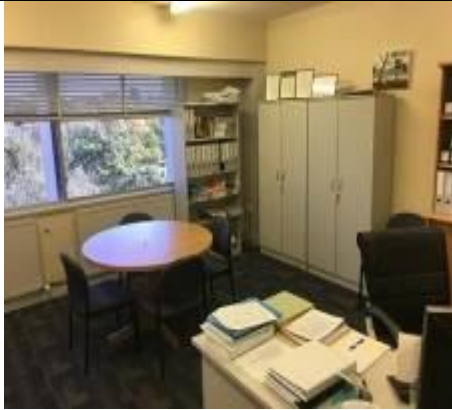
Second Floor Group Manager, Integrated Planning & Finance Plasterboard Ceiling, Plasterboard & Rendered Concrete Walls, Timber Architraves, Doors, Door Frames, Aluminium Window Frames & Carpet on Concrete.	No Sample Taken. No Asbestos Containing Material Sighted. 2570	A5	N/A
23 rd June 2018

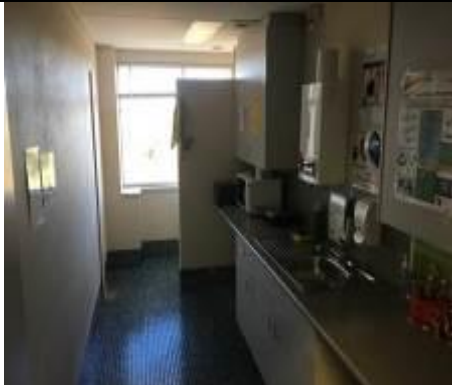
Second Floor Kitchen/ First Aid Plasterboard Drop Down Ceiling, Plasterboard & Rendered Concrete Walls & Ceramic Tile Floor.	No Sample Taken. No Asbestos Containing Material Sighted. 2571	A5	N/A

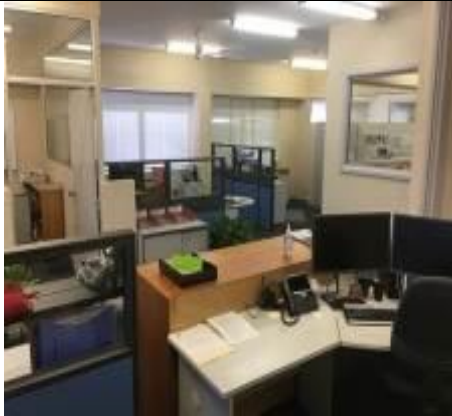
Second Floor Revenue Offices Plasterboard Ceiling, Plasterboard & Rendered Concrete Walls, Timber Architraves & Doors, Aluminium Window Frames, Plasterboard Partitions & Carpet on Concrete.	No Sample Taken. No Asbestos Containing Material Sighted. 2572	A5	N/A
23 rd June 2018

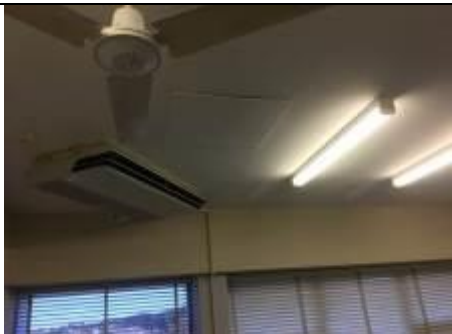
Second Floor Revenue Offices Timber Infill on Plasterboard Ceiling.	No Sample Taken. No Asbestos Containing Material Sighted. 2573	A5	N/A

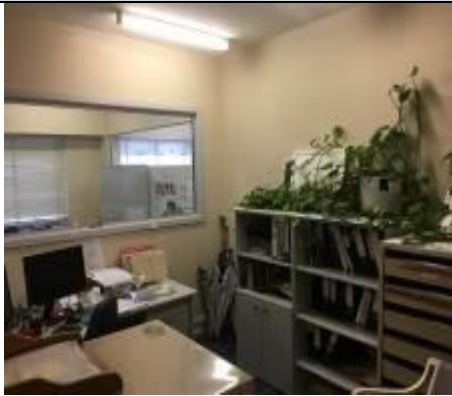
Second Floor Revenue Coordinator Plasterboard Ceiling, Plasterboard & Rendered Concrete Walls, Timber Architraves & Doors, Aluminium Window Frames, Plasterboard Partitions & Carpet on Concrete.	No Sample Taken. No Asbestos Containing Material Sighted. 2574	A5	N/A
23 rd June 2018

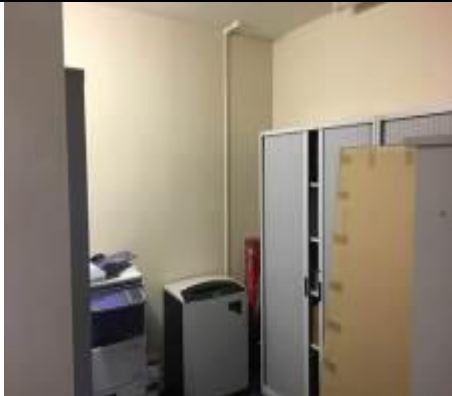
Second Floor – Printer Room Plasterboard Ceiling, Plasterboard & Rendered Concrete Walls, Timber Architraves & Doors, Aluminium Window Frames, Plasterboard Partitions & Carpet on Concrete.	No Sample Taken. No Asbestos Containing Material Sighted. 2575	A5	N/A

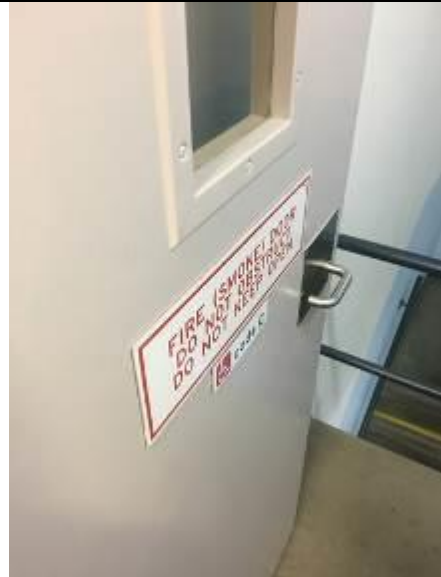
Second Floor Stairwell Doors Fire Door. Manufactured in 2005. 2576	No Sample Taken. No Asbestos Containing Materials Sighted.	A5	N/A

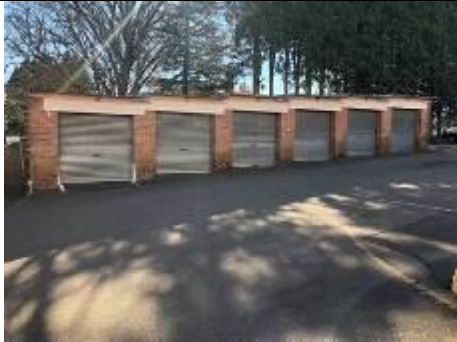
External Garages Southern Aspect Steel Roof, Brick Walls, 6x Steel Roller Doors, Timber Fascia, Rendered Concrete Infill Above Doors, Concrete Foundation	No Sample Taken No Asbestos Containing Materials Sighted 2577	A5	N/A
24 th June 2018

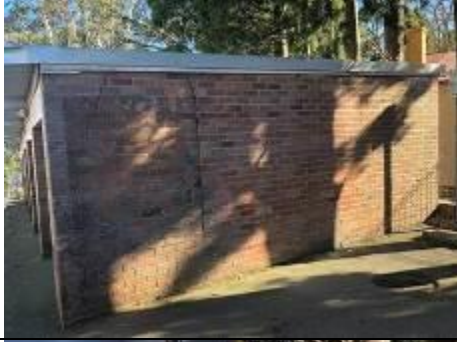
External Garages Eastern Aspect Steel Roof, Brick Walls & Timber Fascia	No Sample Taken No Asbestos Containing Materials Sighted 2578	A5	N/A
24 th June 2018

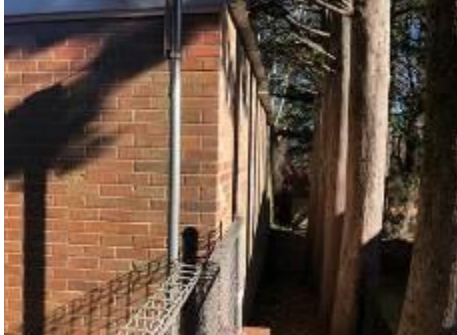
External Garages Northern Aspect Steel Roof, Brick Walls & Timber Fascia	No Sample Taken No Asbestos Containing Materials Sighted 2579	A5	N/A

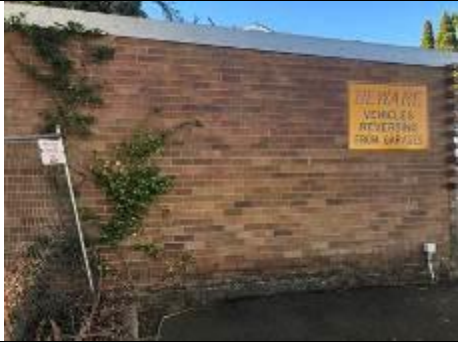
External Garages Western Aspect Steel Roof, Brick Walls & Timber Fascia 2581	No Sample Taken No Asbestos Containing Materials Sighted	A5	N/A
24 th June 2018

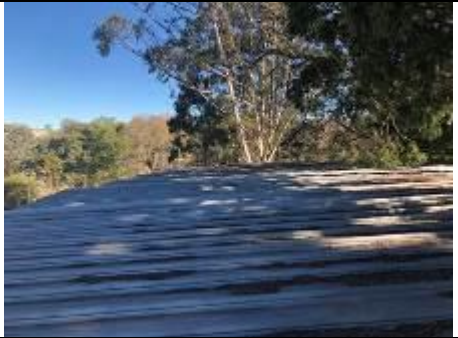
External Garages Roof Aspect Staggered Corrugated Steel Roof with No Guttering 2582	No Sample Taken No Asbestos Containing Materials Sighted	A5	N/A
24 th June 2018

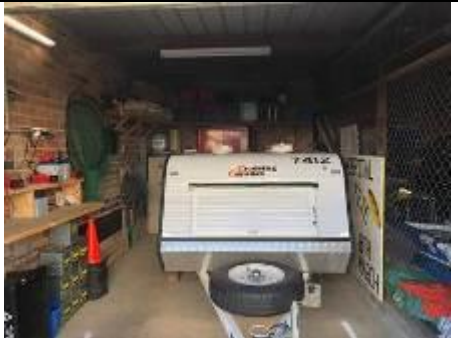
External Garages Unit 1 Steel Roof, Timber & Metal Supports, Northern & Western Brick Wall, Southern Roller Door, Eastern Wire Mesh Wall with Timber Framing, Concrete Floor 2583	No Sample Taken No Asbestos Containing Materials Sighted	A5	N/A

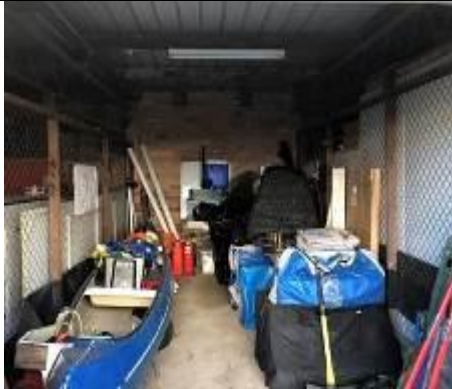
External Garages Unit 2 Steel Roof, Timber & Metal Supports, Northern Brick Wall, Southern Roller Door, Eastern & Western Wire Mesh Wall with Timber Framing, Concrete Floor	No Sample Taken No Asbestos Containing Materials Sighted 2584	A5	N/A
24 th June 2018

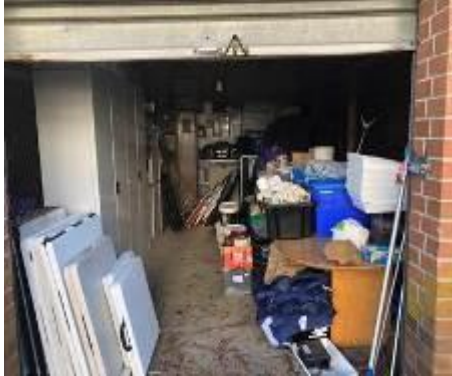
External Garages Unit 3 Steel Roof, Timber & Metal Supports, Northern Brick Wall, Southern Roller Door, Eastern & Western Wire Mesh Wall with Timber Framing, Concrete Floor	No Sample Taken No Asbestos Containing Materials Sighted 2585	A5	N/A
24 th June 2018

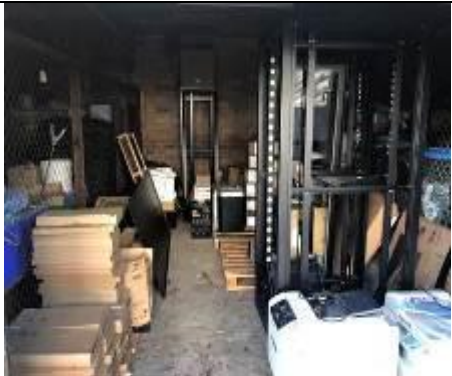
External Garages Unit 4 Steel Roof, Timber & Metal Supports, Northern Brick Wall, Southern Roller Door, Eastern & Western Wire Mesh Wall with Timber Framing, Concrete Floor	No Sample Taken No Asbestos Containing Materials Sighted 2586	A5	N/A

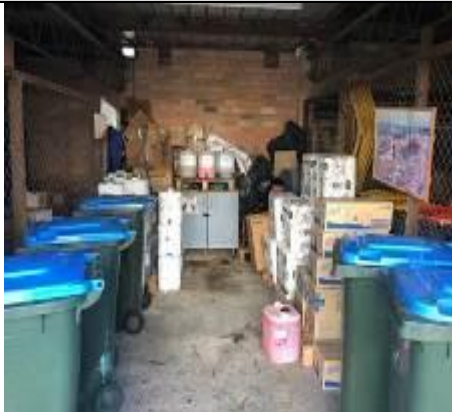
External Garages Unit 5 Steel Roof, Timber & Metal Supports, Northern Brick Wall, Southern Roller Door, Eastern & Western Wire Mesh Wall with Timber Framing, Concrete Floor	No Sample Taken No Asbestos Containing Materials Sighted 2587	A5	N/A
24 th June 2018

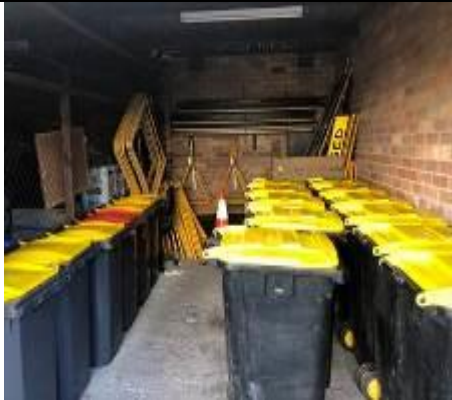
External Garages Unit 6 Steel Roof, Timber & Metal Supports, Northern Brick Wall, Southern Roller Door, Eastern & Western Wire Mesh Wall with Timber Framing, Concrete Floor	No Sample Taken No Asbestos Containing Materials Sighted 2588	A5	N/A

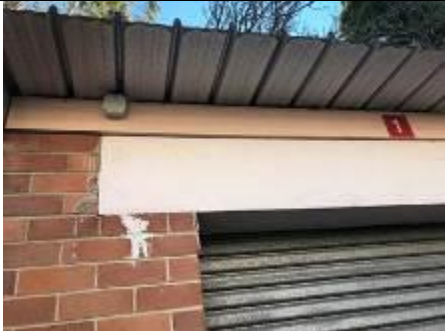
External Storage Garage – Pink Paint	2.3% w/w	A4	Paint classified as lead based as more than 0.1% w/w
Sample No 2 (194881-2)

Lead based paints were detected at the Council Headquarters Building located at 2 Civic Place, Katoomba and require remediation. However good practice would dictate that existing paint, even though is below the recognised standard, should not be sanded and that dust minimisation techniques should be adopted when undertaking renovation/repair works particularly in heritage period buildings. It would be good practice to wear a P1 dust mask during any paint removal even though it does not contain lead, however small particles of paint can still be inhaled or ingested.

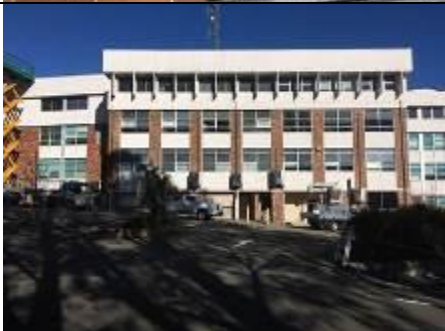
External Spandrel – Light Pink Paint	0.22% w/w	A4	Paint classified as lead based as more than 0.1% w/w
Sample No 3 (194881-3)

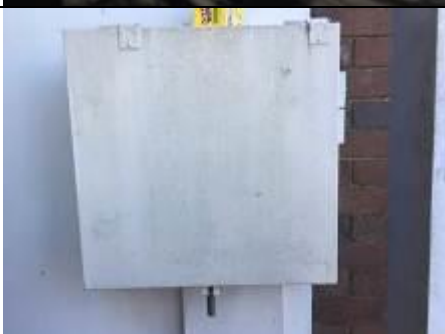
External South – East Lift Area Cream Paint	<0.005% w/w	A5	Paint not classified as lead based as less than or equal to 0.1% w/w

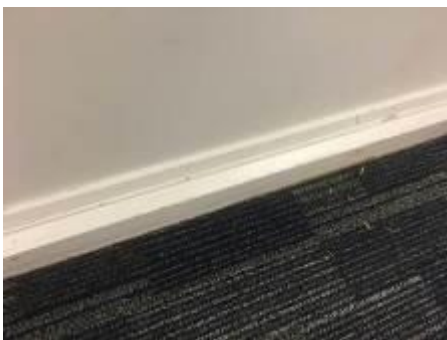
Lower Ground First Aid Room White Paint	0.063% w/w	A5	Paint not classified as lead based as less than or equal to 0.1% w/w
Sample No 5 (194881-5)

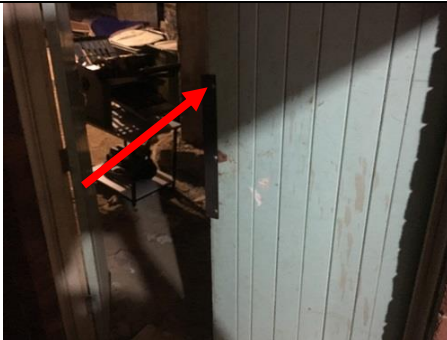
Lower Ground Sub-floor Space Green Paint	2.9% w/w	A4	Paint classified as lead based as more than 0.1% w/w
Sample No 6 (194881-6)

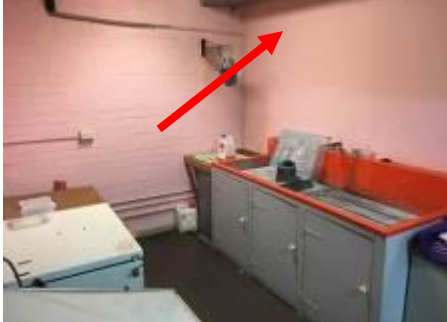
Lower Ground Print Storage Room Pink Paint	<0.005% w/w	A5	Paint not classified as lead based as less than or equal to 0.1% w/w

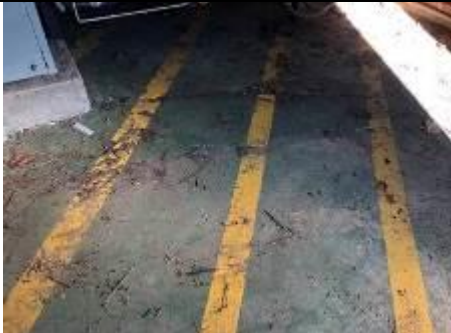
Lower Ground Main Switchboard Room Green Floor Paint	0.01% w/w	A5	Paint not classified as lead based as less than or equal to 0.1% w/w

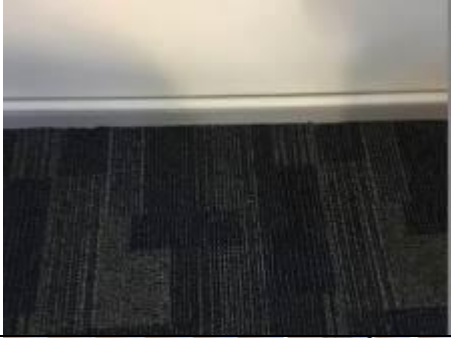
Ground Floor Purple Skirting and Architrave Paint	<0.005% w/w	A5	Paint not classified as lead based as less than or equal to 0.1% w/w
Sample No 9 (194881-9)

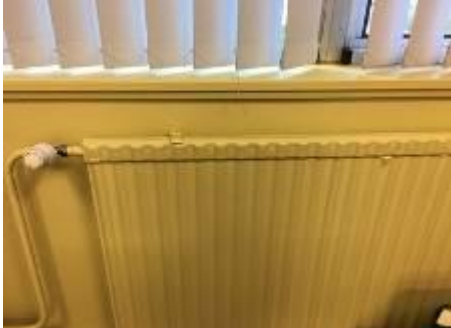
Ground Floor Yellow Skirting and Wall Paint in South East Offices	0.006% w/w	A5	Paint not classified as lead based as less than or equal to 0.1% w/w

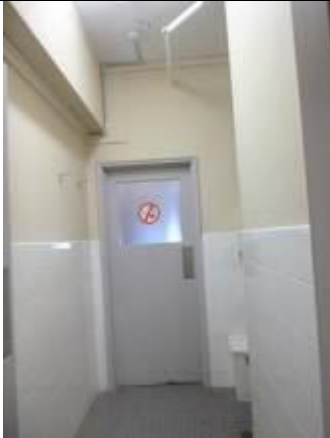
First Floor Male Toilet Door Light Mauve Paint	0.12% w/w	A4	Paint classified as lead based as more than 0.1% w/w	
Sample No 14 (194881-14)

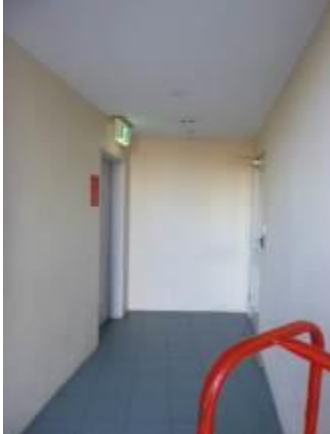
First Floor Landing Area Ceiling White Paint	0.005% w/w	A5	Paint not classified as lead based as less than or equal to 0.1% w/w

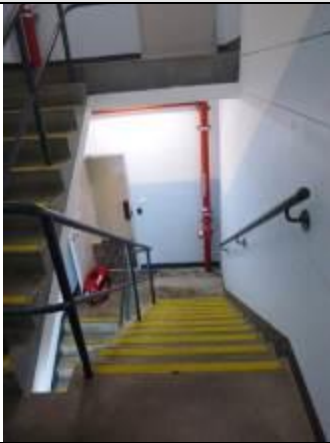
Southern Stairwell – Blue Paint	0.02% w/w	A5	Paint not classified as lead based as less than or equal to 0.1% w/w
Sample No 16 (194881-16)

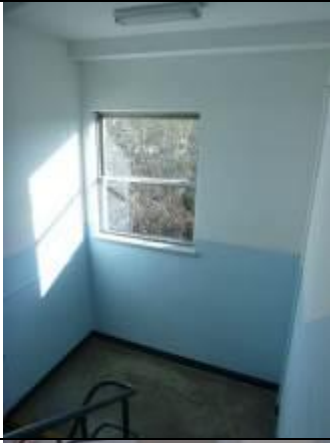
Southern Stairwell – Black Paint	0.04% w/w	A5	Paint not classified as lead based as less than or equal to 0.1% w/w
Sample No 17 (194881-17)

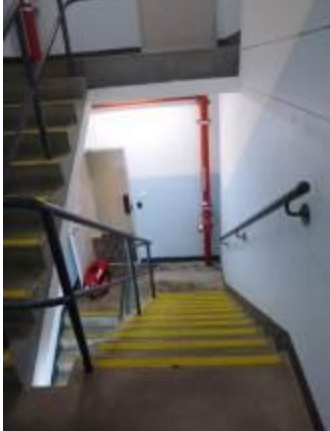
Southern Stairwell – Handrail Turquoise Paint	0.17% w/w	A4	Paint classified as lead based as more than 0.1% w/w

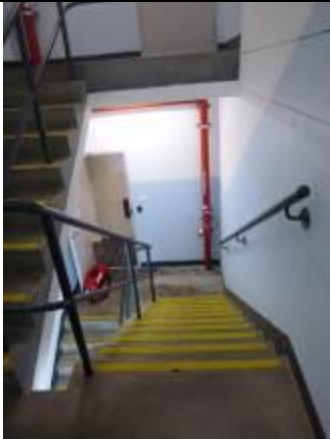
Southern Stairwell – White Paint	<0.005% w/w	A5	Paint not classified as lead based as less than or equal to 0.1% w/w
Sample No 19 (194881-19)

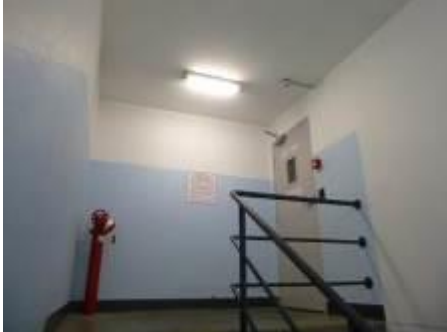
North-East Stairwell – Handrail Blue Paint	0.03% w/w	A5	Paint not classified as lead based as less than or equal to 0.1% w/w
Sample No 20 (194881-20)

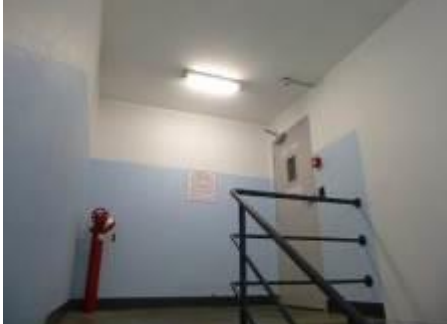
Stairwell – Fire Water Pipes Red Paint	0.48% w/w	A4	Paint classified as lead based as more than 0.1% w/w

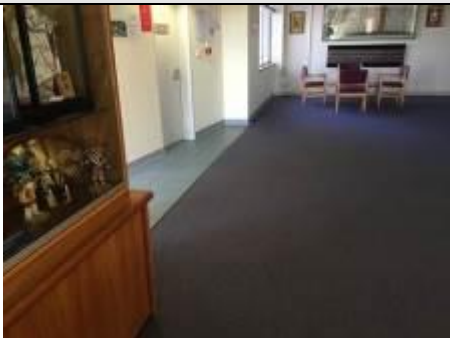
Second Floor Architraves Grey Paint	<0.005% w/w	A5	Paint not classified as lead based as less than or equal to 0.1% w/w
Sample No 22 (194881-22)

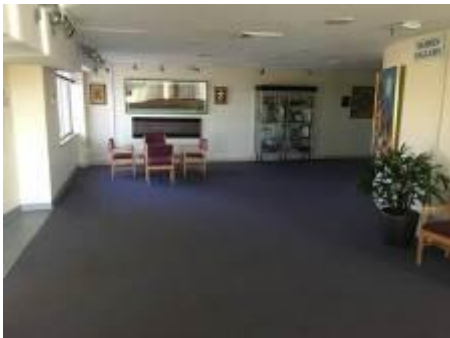
Second Floor Cream Wall Paint	<0.005% w/w	A5	Paint not classified as lead based as less than or equal to 0.1% w/w
Sample No 23 (194881-23)

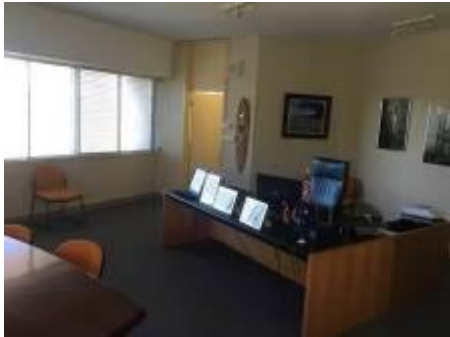
Second Floor Mayor's Office Green Skirting Paint	<0.005% w/w	A5	Paint not classified as lead based as less than or equal to 0.1% w/w

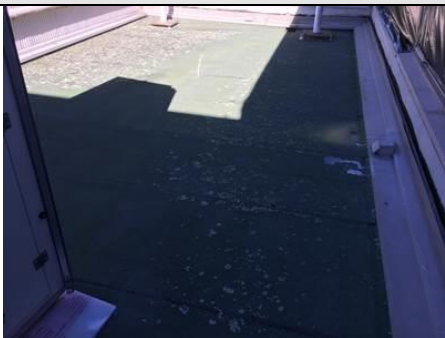
Roof Top Roof Entry Green Paint	<0.005% w/w	A5	Paint not classified as lead based as less than or equal to 0.1% w/w
Sample No 25 (194881-25)
