Asbestos Register

HAZARDOUS MATERIALS REGISTER

Regional EnviroScience Pty Ltd was requested by Mr. Jason Adams of Blue Mountains City Council to undertake a Hazardous Building Materials Register and to prepare a Hazardous Materials Management Plan of the property known as the Blue Mountains City Council Headquarters, 2-6 Civic Place, Katoomba, NSW, 2780. The purpose of the audit was to locate and identify asbestos based building materials and product within the building in accordance with the *NSW Work Health and Safety Act 2011* and *NSW Work Health and Safety Regulation 2017* and the *Code of Practice: How to Manage and Control Asbestos in the Workplace [Safe Work Australia: 2016]* and the *Code of Practice: How to Safely Remove Asbestos [Safe Work Australia: 2016]*.

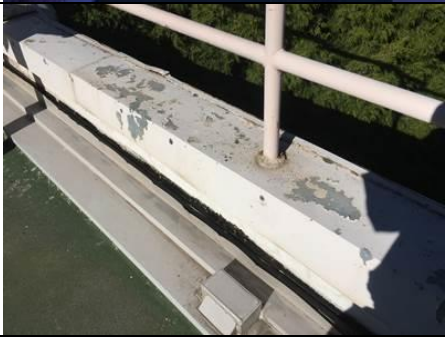
Roof Top Entry Rails Cream Paint	0.19% w/w	A4	Paint classified as lead based as more than 0.1% w/w
Sample No 26 (194881-26)

Lead based paints were detected at the Council Headquarters Building located at 2 Civic Place, Katoomba and require remediation. However good practice would dictate that existing paint, even though is below the recognised standard, should not be sanded and that dust minimisation techniques should be adopted when undertaking renovation/repair works particularly in heritage period buildings. It would be good practice to wear a P1 dust mask during any paint removal even though it does not contain lead, however small particles of paint can still be inhaled or ingested.

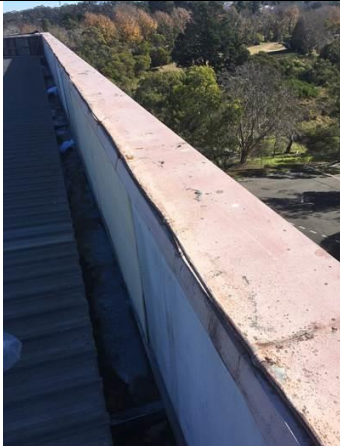
Roof Top North Edge Capping Pink Paint	0.008% w/w	A5	Paint not classified as lead based as less than or equal to 0.1% w/w

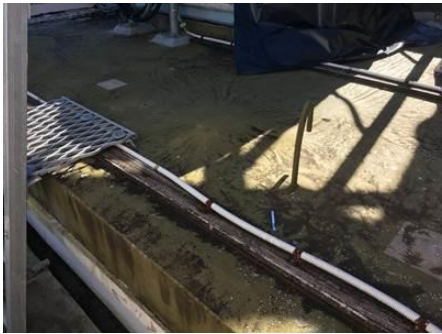
LEAD BASED PAINTS REGISTER Date Sampled 23 rd & 24 th June 2018		ASSET: Rooftop-Council Headquarters, 2-6 Civic Place, Katoomba, NSW, 2780			
Sample No 27 (194881-27)

Roof Top Platform 3 Dirty Green Paint	0.01% w/w	A5	Paint not classified as lead based as less than or equal to 0.1% w/w
Sample No 28 (194881-28)

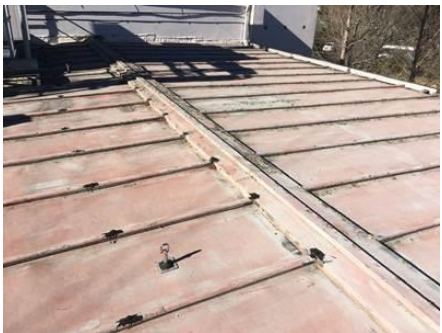
Roof Top 2 nd Platform Red Paint	<0.005% w/w	A5	Paint not classified as lead based as less than or equal to 0.1% w/w

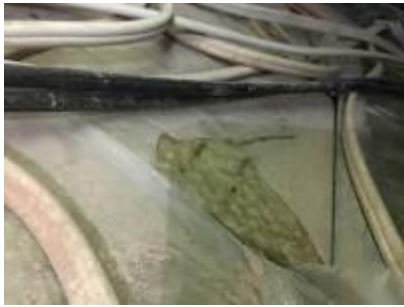
Lower Ground Floor Aluminium and Synthetic Mineral Fibre Ceiling Tile	Visual Inspection	A4	Good Condition Accessible to Tradespeople Refer to Management Plan
24 th June 2018

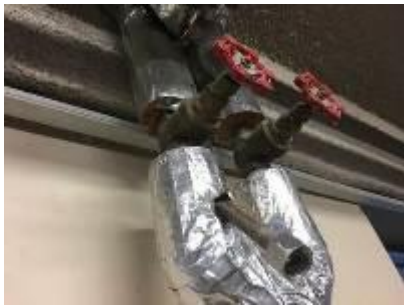
Lower Ground Floor Synthetic Mineral Fibre Pipe Insulation	Visual Inspection	A4	Good Condition Accessible to Tradespeople Refer to Management Plan
24 th June 2018

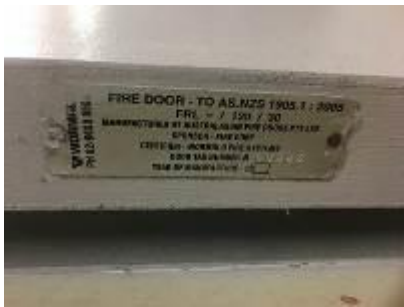
Lower Ground Floor Synthetic Mineral Fibre Insulation in Fire Doors	Visual Inspection	A4	Good Condition Accessible to Tradespeople Refer to Management Plan

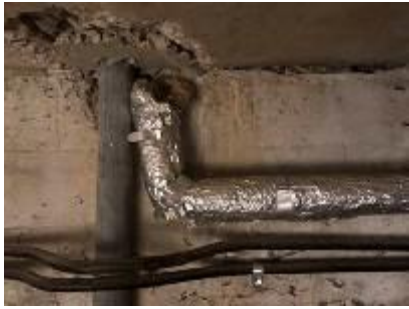
Lower Ground Floor Main Switchboard Room SMF Lagged Piping	Visual Inspection	A4	Good Condition Accessible to Tradespeople Refer to Management Plan

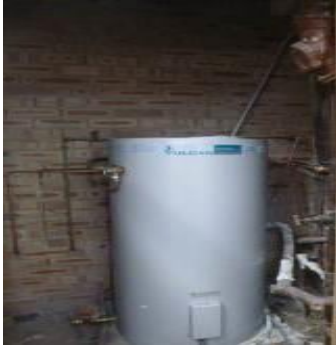
Internal - First Floor Female Toilet Hot Water Service Cupboard Assume SMF Insulation Jacket Inside	Visual Inspection	A4	Unknown Condition Accessible to Tradespeople Refer to Management Plan
23 rd June 2018

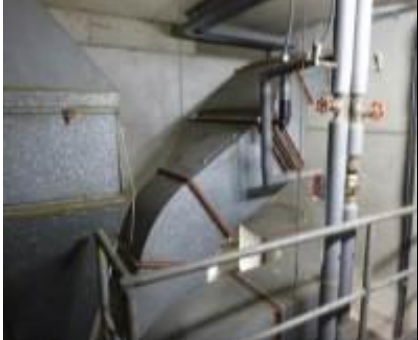
Internal - First Floor Plant Room SMF Lagged Pipes Inside Aluminium Pipe Covers	Visual Inspection	A4	Good Condition Accessible to Tradespeople Refer to Management Plan

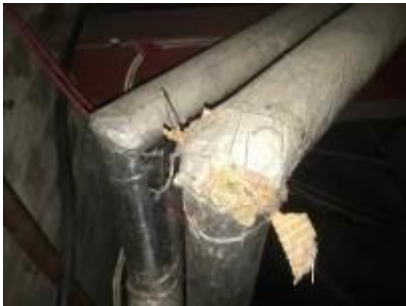
Second Floor Void Above Kitchen SMF Lagged Piping	Visual Inspection	A4	Good, Bonded Condition, Accessible to Tradespeople

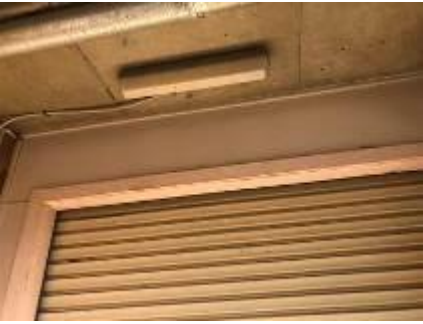
External Northern Aspect, 1x Fluorescent Light	Visual Observation No PCB's Present	A5	N/A
24 th June 2018

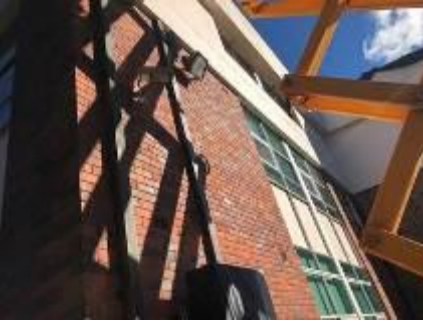
External Northern Aspect, 1x Incandescent Light	Visual Observation No PCB's Present	A5	N/A

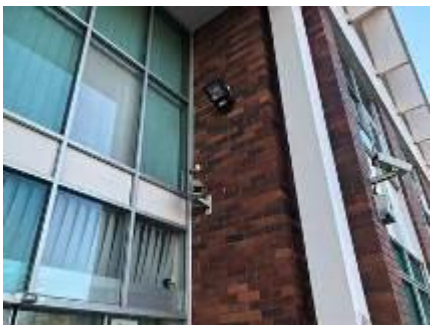
External Eastern Aspect, 1x Incandescent Light	Visual Observation No PCB's Present	A5	N/A
24 th June 2018

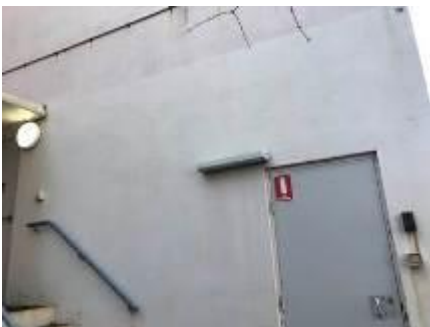
External Southern Aspect, 1x Fluorescent Light	Visual Observation No PCB's Present	A5	N/A
24 th June 2018

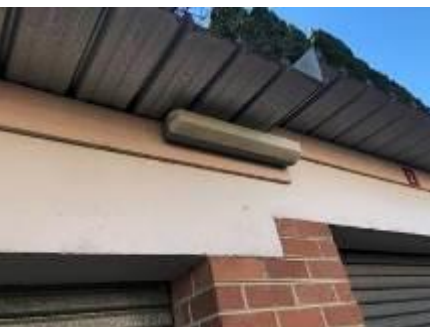
External Garages External, 3x Fluorescent Lights	Visual Observation No PCB's Present	A5	N/A

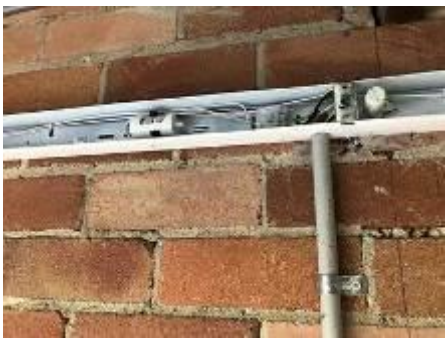
External Garages Garage Bays, 7x Fluorescent Lights ATCO CP4.0-06 Type Capacitor	Visual Observation No PCB's Present	A5	N/A

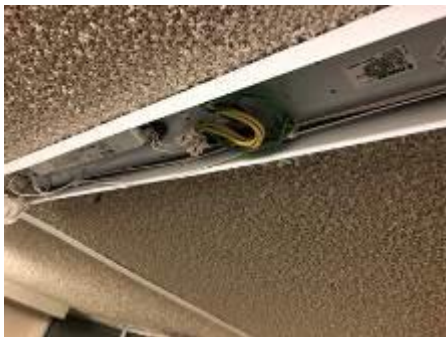
Lower Ground IT Help Desk, 8x Fluorescent Lights No Capacitor Present	Visual Observation No PCB's Present	A5	N/A

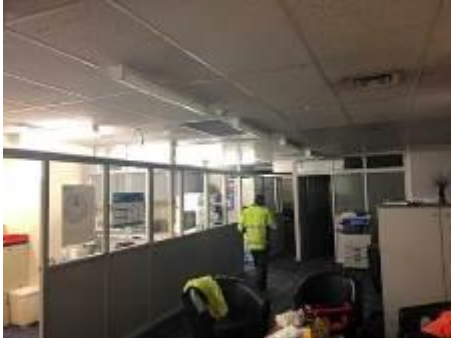
Lower Ground First Aid Area, 6x Fluorescent Lights	Visual Observation No PCB's Present	A5	N/A
24 th June 2018

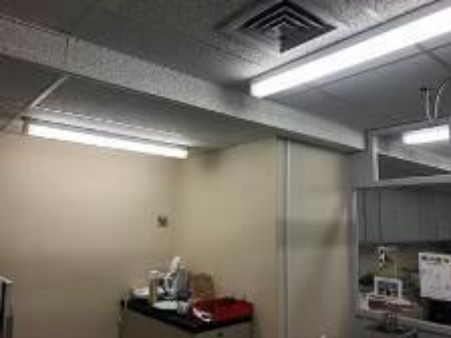
Lower Ground Kitchen, 2x Fluorescent Lights	Visual Observation No PCB's Present	A5	N/A
24 th June 2018

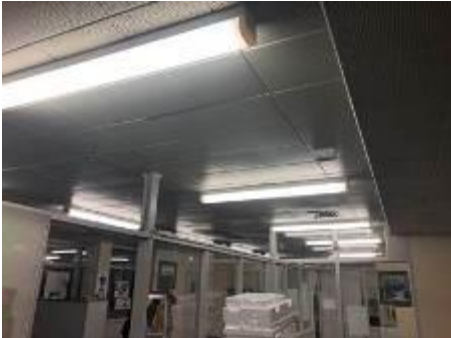
Lower Ground M Bronotee Office, 3 x Fluorescent Lights	Visual Observation No PCB's Present	A5	N/A

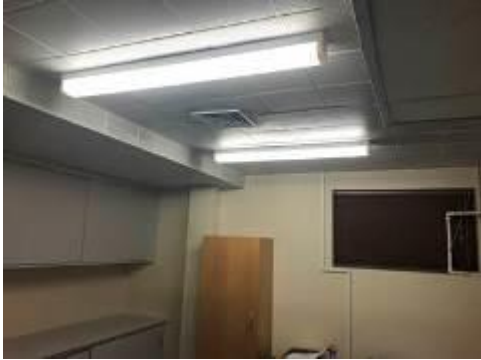
Lower Ground Team Leader Business Systems & Manager Information & Customer Services, 6x Fluorescent Lights	Visual Observation No PCB's Present	A5	N/A
24 th June 2018

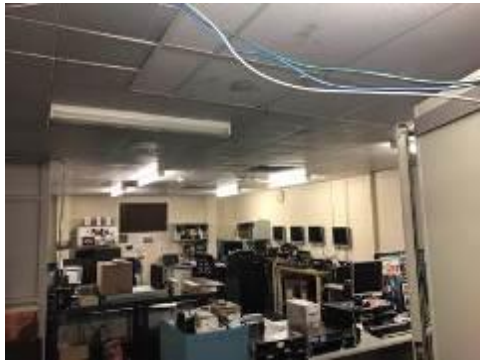
Lower Ground Information Technology, 9x Fluorescent Lights	Visual Observation No PCB's Present	A5	N/A
24 th June 2018

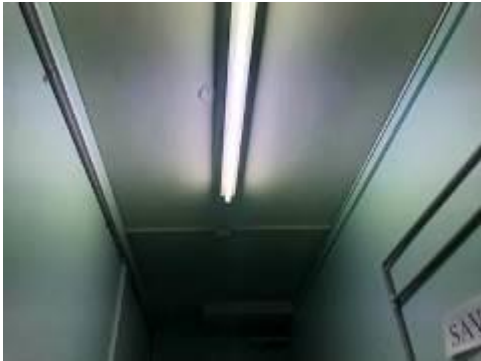
Lower Ground UPS Room, 1x Fluorescent Light UCC Fluoroseal PFS 2.7 Type Capacitor Present	Visual Observation No PCB's Present	A5	N/A

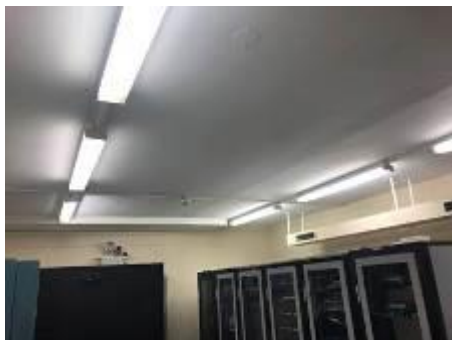
Lower Ground Main Computer Room, 6x Fluorescent Lights	Visual Observation No PCB's Present	A5	N/A
24 th June 2018

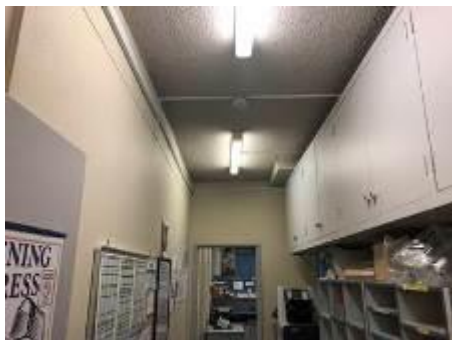
Lower Ground Pigeon Hole Hallway, 3x Fluorescent Lights	Visual Observation No PCB's Present	A5	N/A
24 th June 2018

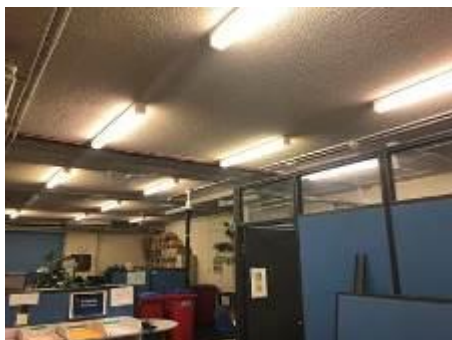
Lower Ground Records & Archives, 13x Fluorescent Lights	Visual Observation No PCB's Present	A5	N/A

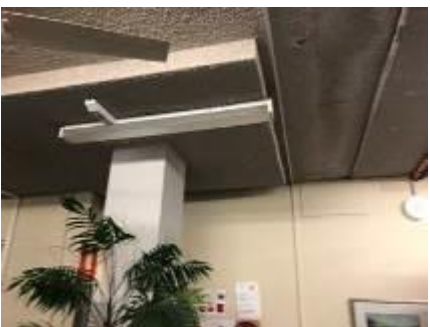
Lower Ground Records & Archives, 1x Fluorescent Light	Visual Observation No PCB's Present	A5	N/A
24 th June 2018

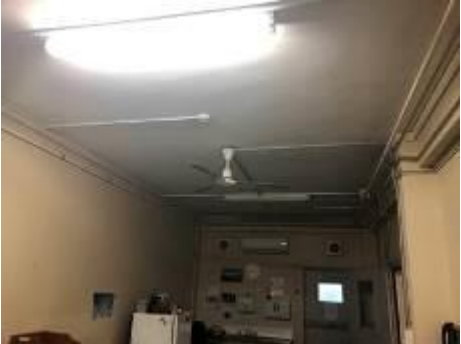
Lower Ground Mail Room, 2x Fluorescent Lights	Visual Observation No PCB's Present	A5	N/A
24 th June 2018

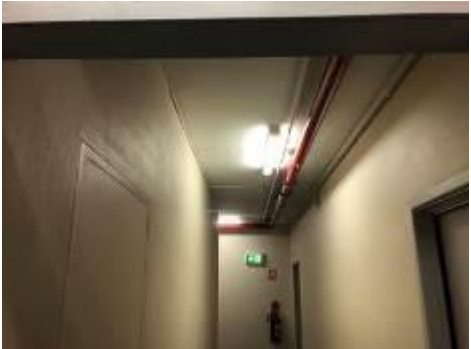
Lower Ground Hallway to Recreation Room, 3x Fluorescent Lights	Visual Observation No PCB's Present	A5	N/A

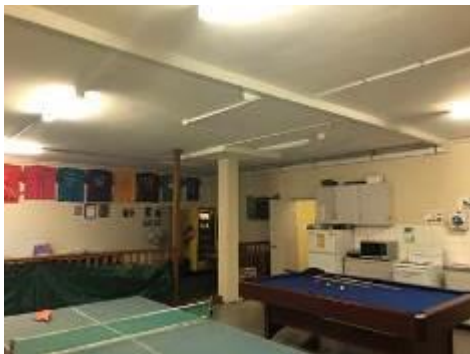
Lower Ground Recreation Room, 6x Fluorescent Lights	Visual Observation No PCB's Present	A5	N/A
24 th June 2018

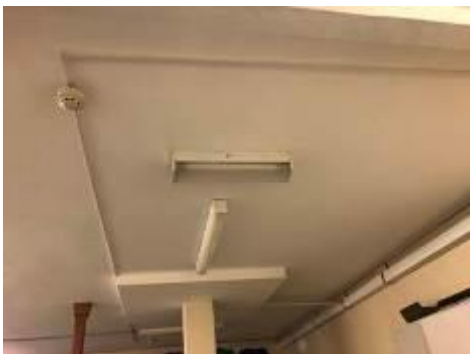
Lower Ground Recreation Room, 1x Fluorescent Lights ATCO CP 4.5-06 Type Capacitor Present	Visual Observation No PCB's Present	A5	N/A
24 th June 2018

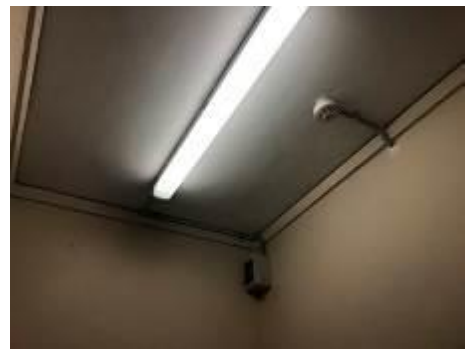
Lower Ground Male Toilets, 1x Fluorescent Lights 2x Incandescent Lights	Visual Observation No PCB's Present	A5	N/A

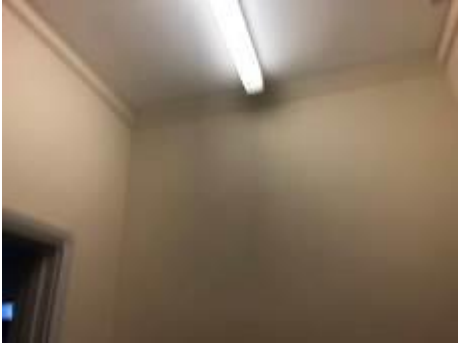
Lower Ground Female Toilets, 1x Fluorescent Lights	Visual Observation No PCB's Present	A5	N/A
24 th June 2018

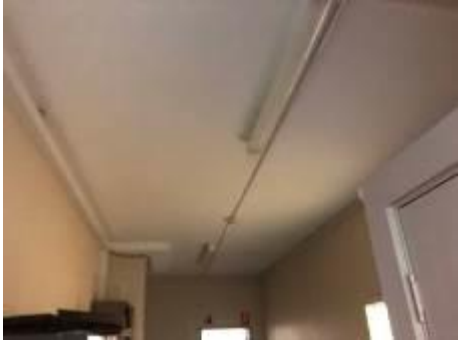
Lower Ground Hallway to Radio Workshop, 2x Fluorescent Lights	Visual Observation No PCB's Present	A5	N/A
24 th June 2018

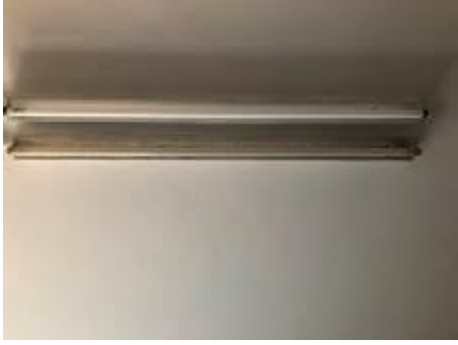
Lower Ground Recreation Room, 6x Fluorescent Lights Similar to UPS Room Light	Visual Observation Assume No PCB's Present	A5	N/A

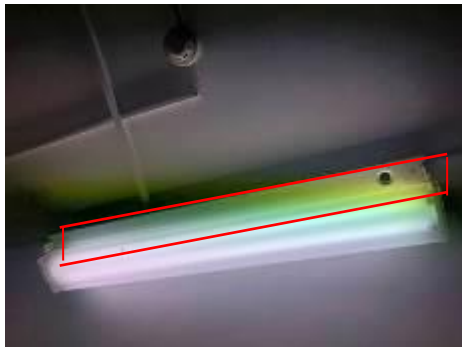
Lower Ground Radio Workshop, 1x Fluorescent Light Similar to UPS Room Light	Visual Observation No PCB's Present Assume No PCB's Present	A5	N/A
24 th June 2018

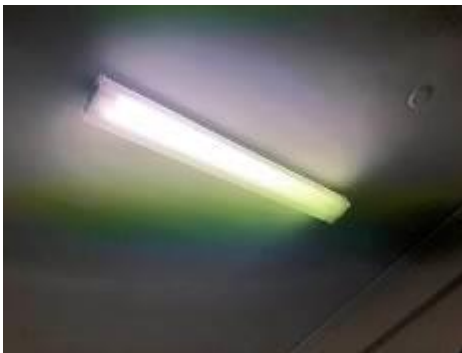
Lower Ground Radio Workshop, 2x Fluorescent Lights ATCO CP 8.0-06 Type Capacitor	Visual Observation No PCB's Present	A5	N/A
24 th June 2018

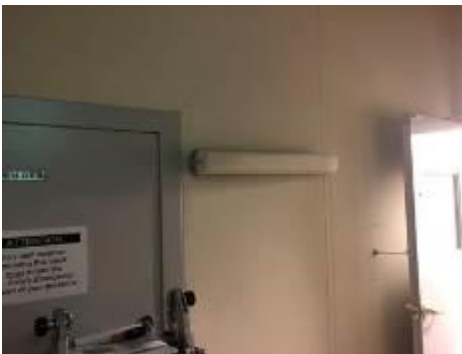
Lower Ground Outside Archives Vault, 1x Fluorescent Light	Visual Observation No PCB's Present	A5	N/A

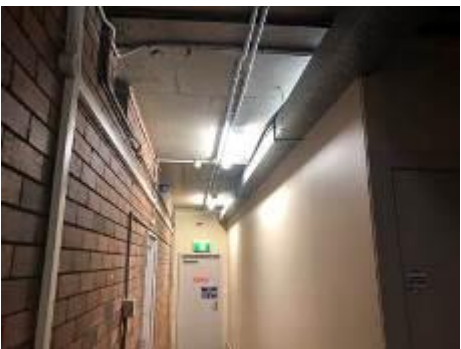
Lower Ground Hallway to IT Store, 2x Fluorescent Lights	Visual Observation No PCB's Present	A5	N/A
24 th June 2018

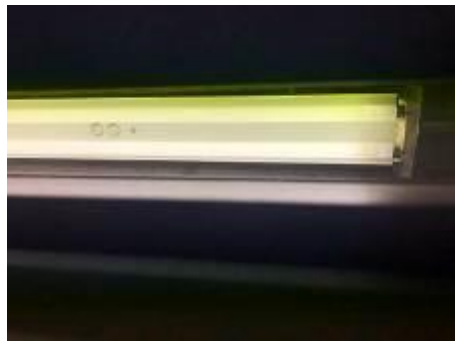
Lower Ground IT Store Northern Garage Door, 1x Fluorescent Light	Visual Observation No PCB's Present	A5	N/A
24 th June 2018

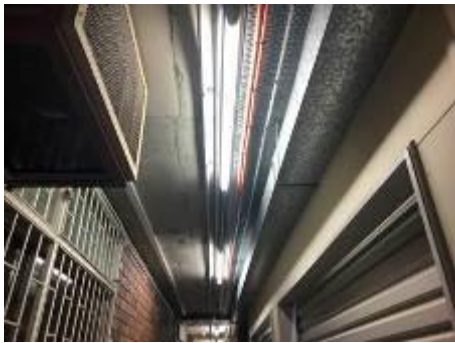
Lower Ground Hallway Outside IT Store, 2x Fluorescent Lights ATOC CP 4.0-06 Type Capacitor Present	Visual Observation No PCB's Present	A5	N/A

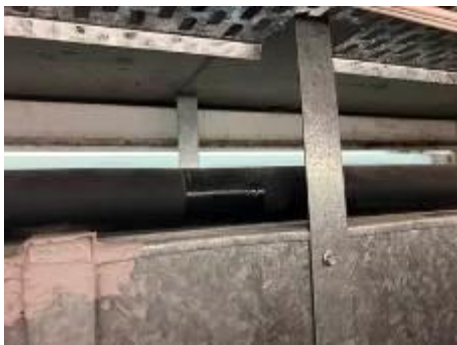
Lower Ground Southern Roller Door, 1x Fluorescent Lights	Restricted Access, Aged Light Assume PCB's Present	A4	Unknown Condition Accessible to Tradespeople Refer to Management Plan
24 th June 2018

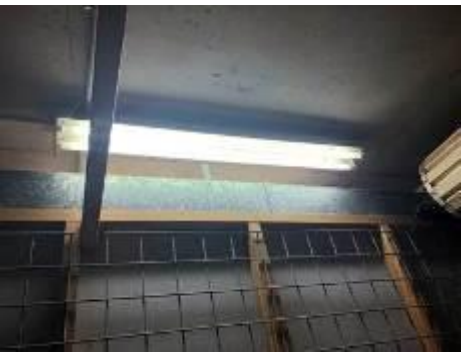
Lower Ground IT Store, 3x Fluorescent Lights	Visual Observation No PCB's Present	A5	N/A
24 th June 2018

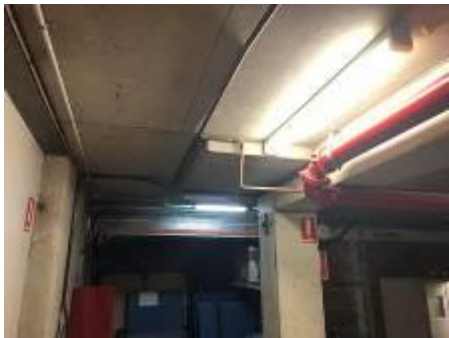
Lower Ground Outside Boiler Room, 2x Fluorescent Lights	Visual Observation No PCB's Present	A5	N/A

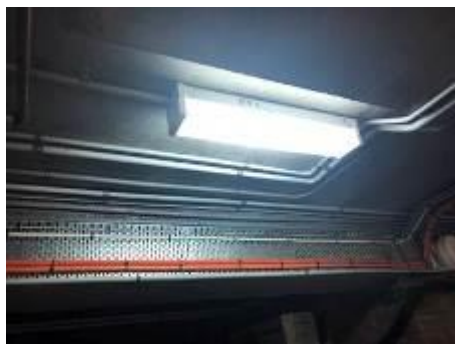
Lower Ground Outside Boiler Room, 1x Fluorescent Light	Visual Observation No PCB's Present	A5	N/A
24 th June 2018

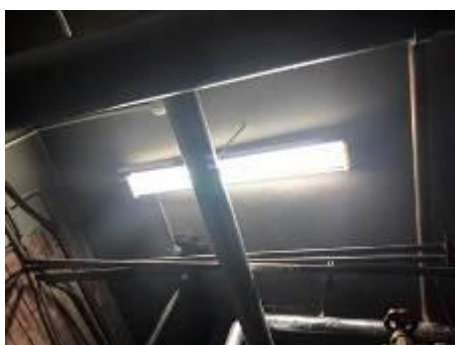
Lower Ground Boiler Room, 1x Fluorescent Light	Restricted Access Due to Height & Obstructions Assume May Contain PCB's	A4	Unknown Condition Accessible to Tradespeople Refer to Management Plan
24 th June 2018

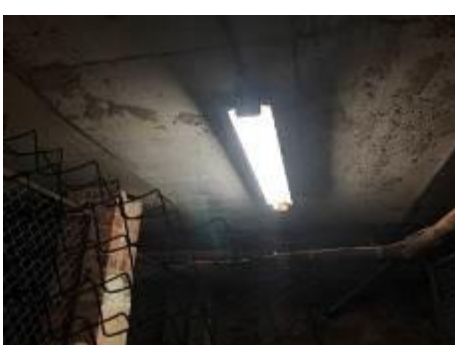
Lower Ground Subfloor Space, 1x Fluorescent Light	Restricted Access Assume May Contain PCB's	A4	Unknown Condition Accessible to Tradespeople Refer to Management Plan

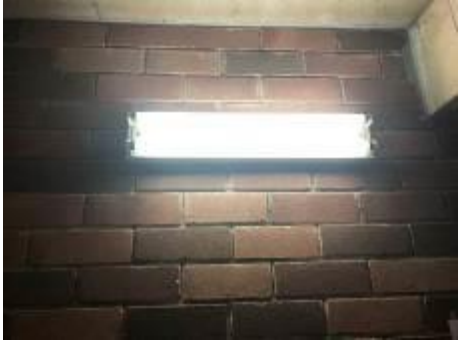
Lower Ground Access Hallway to Central Stairwell, 4x Fluorescent Lights No Capacitors Present	Visual Observation No PCB's Present	A5	N/A
24 th June 2018

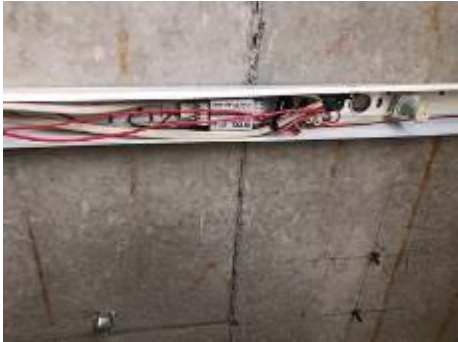
Lower Ground Main Switchboard Room, 3x Fluorescent Lights No Capacitors Present	Visual Observation No PCB's Present	A5	N/A
24 th June 2018

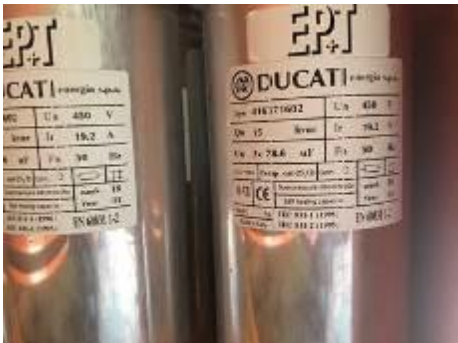
Lower Ground Main Switchboard Room, Capacitor Bank, 10x Ducati Capacitors	Visual Observation No PCB's Present	A5	N/A

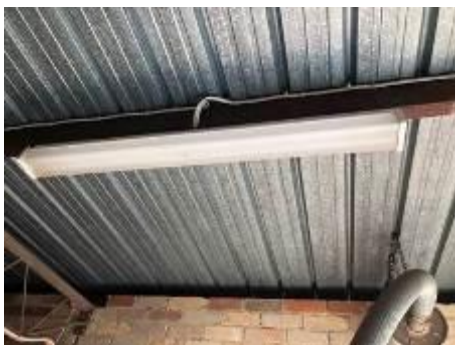
Lower Ground Generator Garage, 2x Fluorescent Lights No Capacitors Present	Visual Observation No PCB's Present	A5	N/A
24 th June 2018

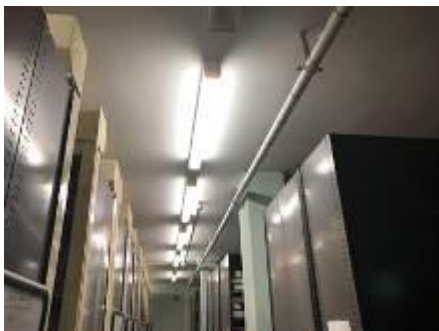
Lower Ground Archives Vault, 13x Fluorescent Lights No Capacitors Present	Visual Observation No PCB's Present	A5	N/A
24 th June 2018

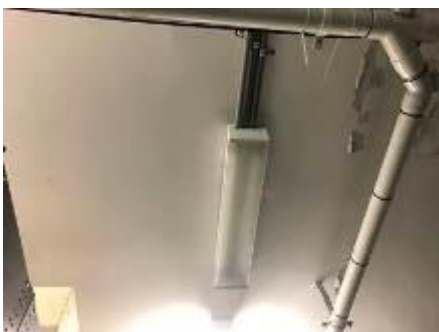
Lower Ground Archives Vault, 1x Fluorescent Lights ATCO CP 4.5-06 Type Capacitor Present	Visual Observation No PCB's Present	A5	N/A

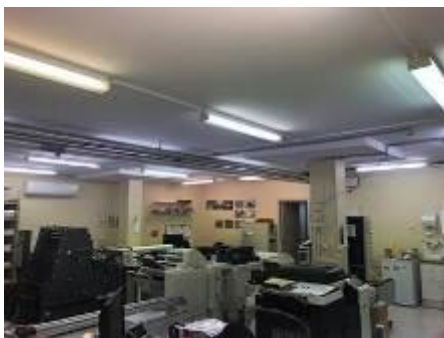
Lower Ground Print Room, 16x Fluorescent Lights Plessey P102 Type Capacitor	Visual Observation No PCB's Present	A5	N/A
24 th June 2018

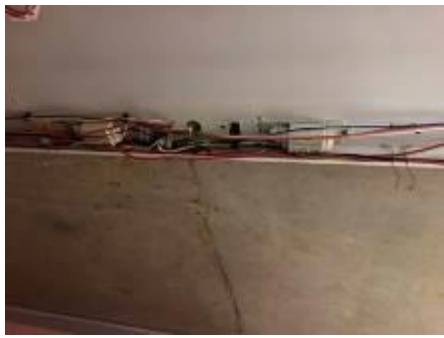
Lower Ground Dark Room, 2x Fluorescent Lights No Capacitors Present	Visual Observation No PCB's Present	A5	N/A
24 th June 2018

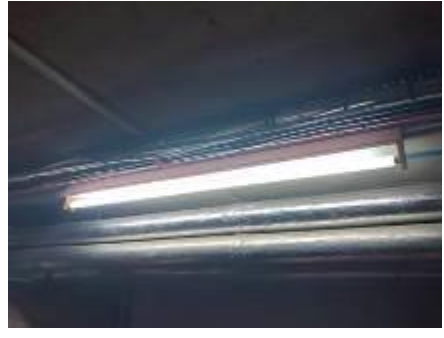
Lower Ground Subfloor Space Adjacent Dark Room, 2x Fluorescent Lights No Capacitors Present	Visual Observation No PCB's Present	A5	N/A

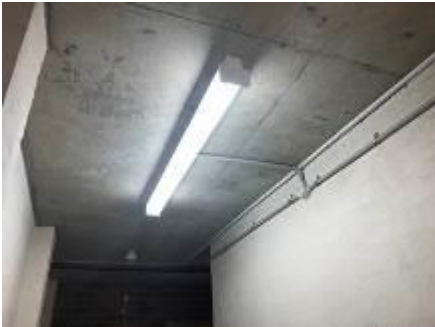
Lower Ground PABX Hallway, 1x Fluorescent Lights No Capacitors Present	Visual Observation No PCB's Present	A5	N/A
24 th June 2018

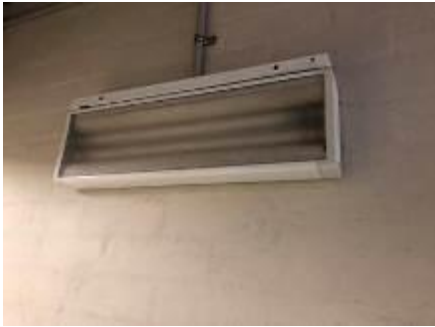
Lower Ground PABX Hallway, 1x Fluorescent Lights No Capacitor Present	Visual Observation No PCB's Present	A5	N/A
24 th June 2018

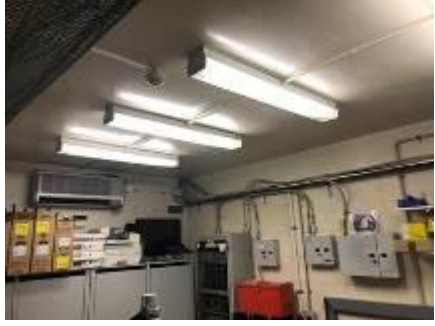
Lower Ground PABX Room, 4x Fluorescent Lights AEE Type PMN 5417	Visual Observation PCB's Present	A4	Good Condition Accessible to Tradespeople Refer to Management Plan

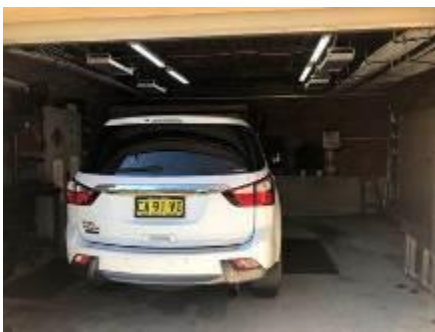
Lower Ground Garage Adjacent Generator Garage, 4x New Fluorescent Lights	Visual Observation No PCB's Present	A5	N/A
24 th June 2018

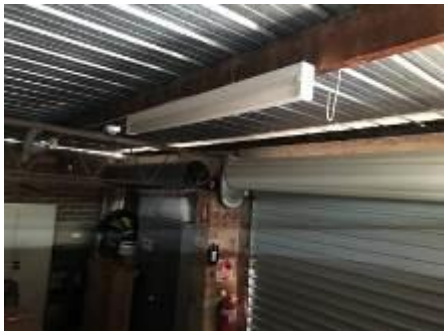
Lower Ground Surveyors Garage, 4x Fluorescent Lights	No Access to Locked Garage Assume PCB's Present	A4	Unknown Condition Accessible to Tradespeople Refer to Management Plan

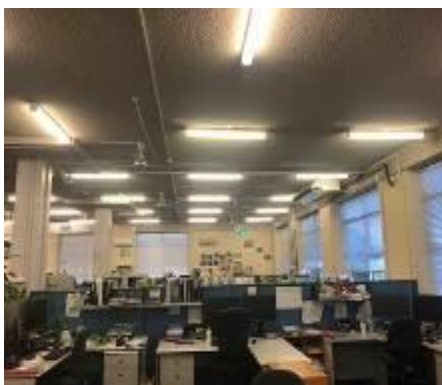
Ground Floor Building & Construction, Development & Planning & Certification Unit, 40x Fluorescent Lights No Capacitors Present	Visual Observation No PCB's Present	A5	N/A
23 rd June 2018

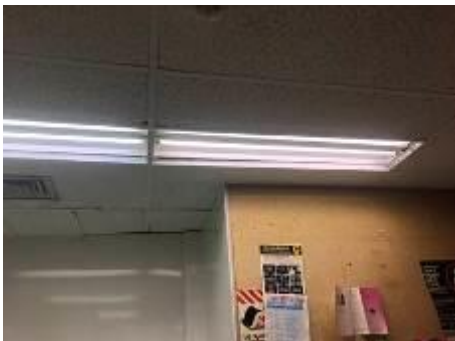
Ground Floor Kitchen Area, 5x Fluorescent Lights AEE PMN 5417 Type Capacitor	Visual Observation PCB's Present	A4	Good Condition Accessible to Tradespeople Refer to Management Plan
23 rd June 2018

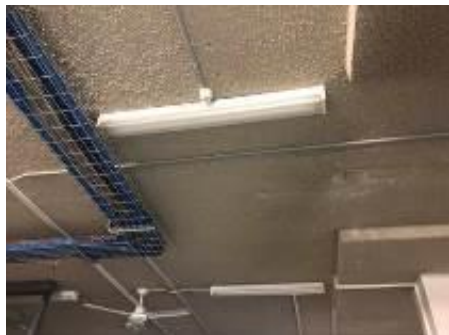
Ground Floor Rangers Area, 5x Fluorescent Lights No Capacitors Present	Visual Observation No PCB's Present	A5	N/A

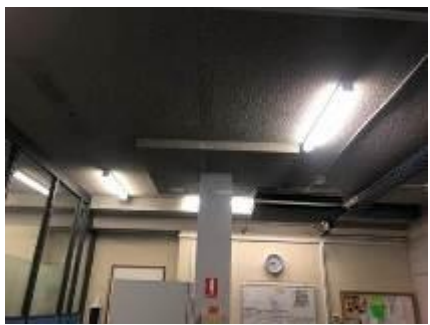
Ground Floor Land Use Planning, Environment & Engineering, Development Planning, Health & Compliance, 16x Fluorescent Lights	Visual Observation No PCB's Present	A5	N/A
23 rd June 2018

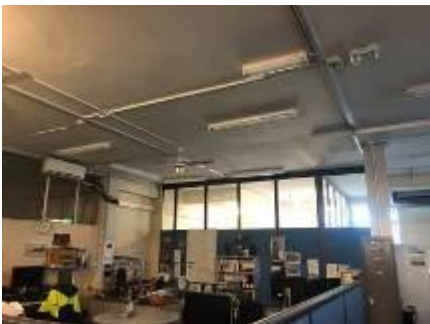
Ground Floor Executive Principal Building & Construction Services, 2x Fluorescent Lights	Visual Observation No PCB's Present	A5	N/A
23 rd June 2018

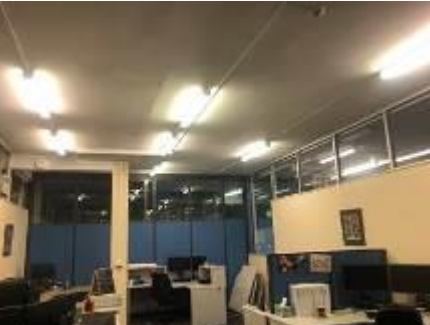
Ground Floor Services Delivery Office 8x Fluorescent Lights	Visual Observation No PCB's Present	A5	N/A

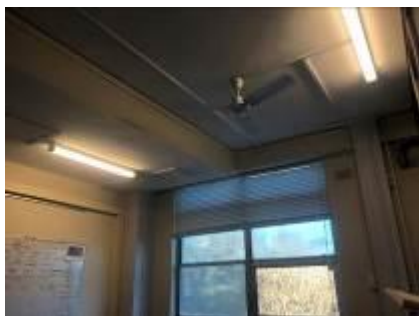
Ground Floor Director of City Services, 2x Fluorescent Lights	Visual Observation No PCB's Present	A5	N/A
23 rd June 2018

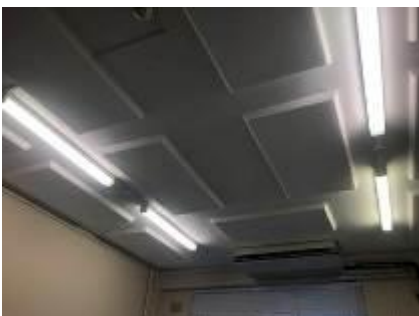
Ground Floor Governance & Risk Office, 12x Fluorescent Lights	Visual Observation No PCB's Present	A5	N/A
23 rd June 2018

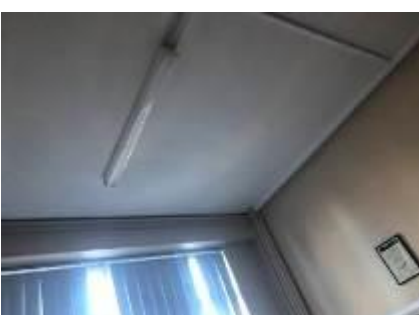
Ground Floor Governance & Risk Offices, 1x Fluorescent Lights	Visual Observation No PCB's Present	A5	N/A
23 rd June 2018

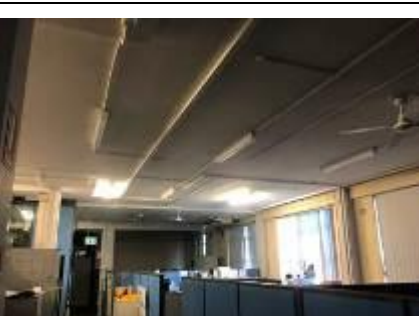
Ground Floor HR Services & Risk Management, 9x Fluorescent Lights	Visual Observation No PCB's Present	A5	N/A

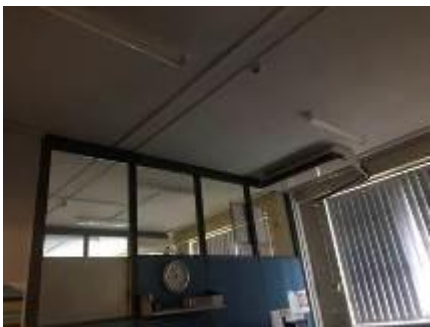
Ground Floor Payroll Services, 6x Fluorescent Lights	Visual Observation No PCB's Present	A5	N/A
23 rd June 2018

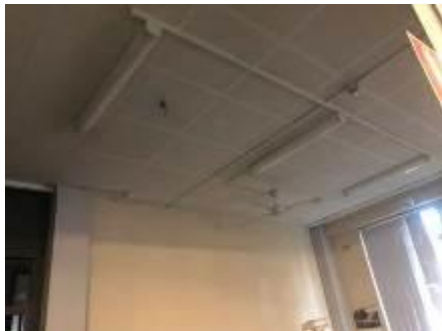
Ground Floor Organisation Development, 6x Fluorescent Lights	Visual Observation No PCB's Present	A5	N/A
23 rd June 2018

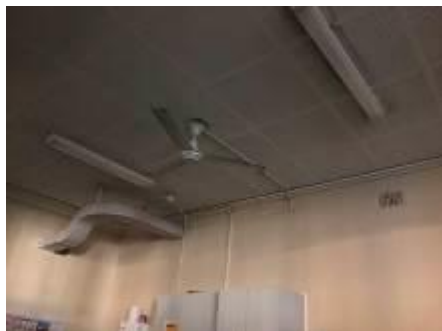
Ground Floor Kitchen of Human Resources, 2x Fluorescent Lights	Visual Observation No PCB's Present	A5	N/A

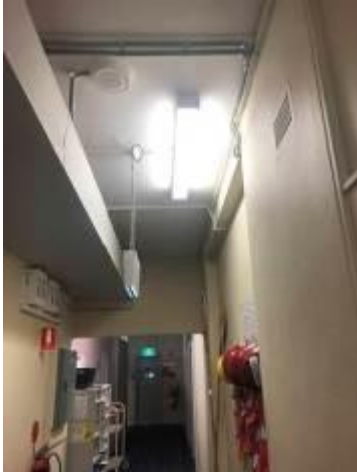
Ground Floor Hallway of Human Resources, 5x Fluorescent Lights	Visual Observation No PCB's Present	A5	N/A
23 rd June 2018

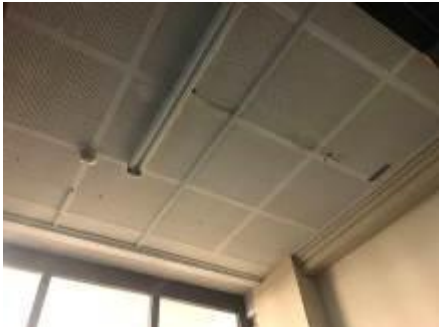
Ground Floor Breastfeeding Room, 1x Fluorescent Lights	Visual Observation No PCB's Present	A5	N/A
23 rd June 2018

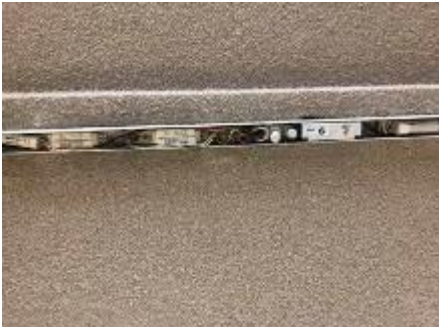
Ground Floor Building & Construction, 1x Fluorescent Lights No Capacitor Present	Visual Observation No PCB's Present	A5	N/A

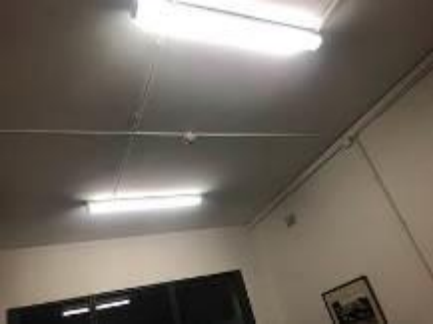
Ground Floor Kedumba Meeting Room, 2x Fluorescent Lights	Visual Observation No PCB's Present	A5	N/A
23 rd June 2018

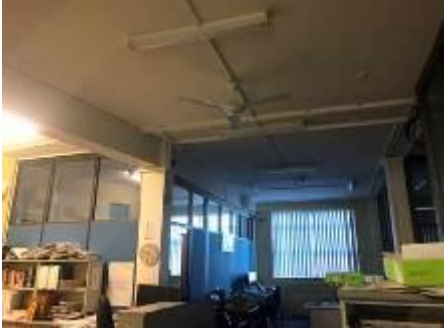
Ground Floor South-East Open Plan Offices, 10x Fluorescent Lights	Visual Observation No PCB's Present	A5	N/A
23 rd June 2018

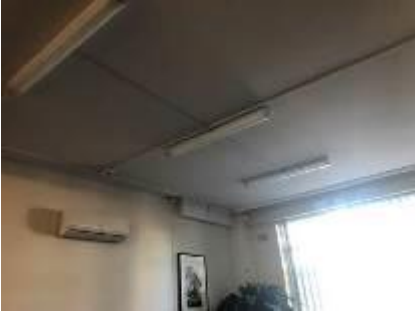
Ground Floor Development Health & Customer Services, 3x Fluorescent Lights	Visual Observation No PCB's Present	A5	N/A
23 rd June 2018

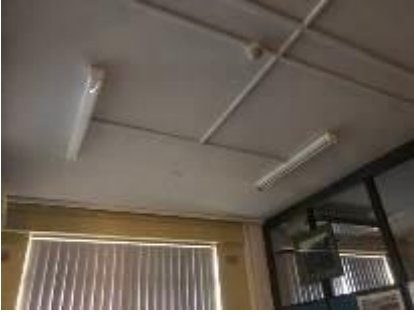
Ground Floor Building & Compliance Services, 2x Fluorescent Lights	Visual Observation No PCB's Present	A5	N/A

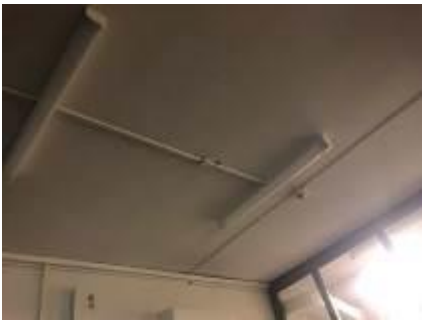
Ground Floor Development Planning, 2x Fluorescent Lights	Visual Observation No PCB's Present	A5	N/A
23 rd June 2018

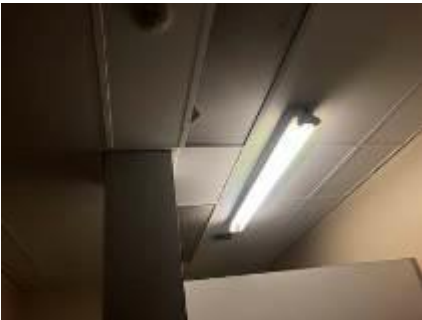
Ground Floor West Disabled Toilet, 3x Fluorescent Lights AEE PMN 5417 Type Capacitor	Visual Observation PCB's Present	A4	Good Condition Accessible to Tradespeople Refer to Management Plan
23 rd June 2018

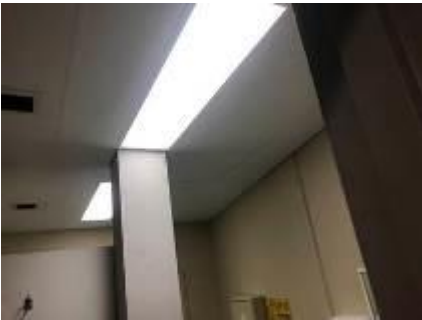
Ground Floor East Disabled Toilet, 2x Fluorescent Lights AEE PMN 5417 Type Capacitor	Visual Observation PCB's Present	A4	Good Condition Accessible to Tradespeople Refer to Management Plan
23 rd June 2018

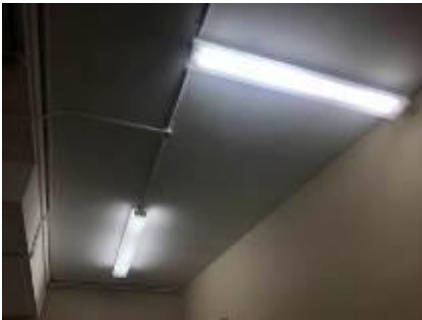
Ground Floor First Aid Room, 2x Fluorescent Lights	Visual Observation No PCB's Present	A5	N/A

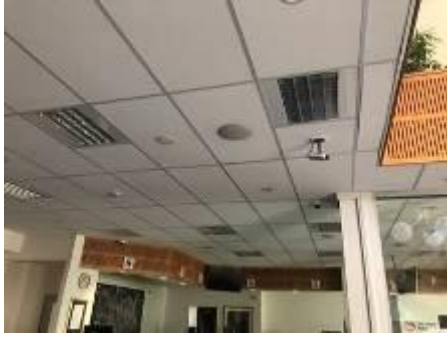
Ground Floor Reception/ Waiting Room, Numerous Fluorescent Lights	No Access Assume No PCB's Present	A5	N/A
23 rd June 2018

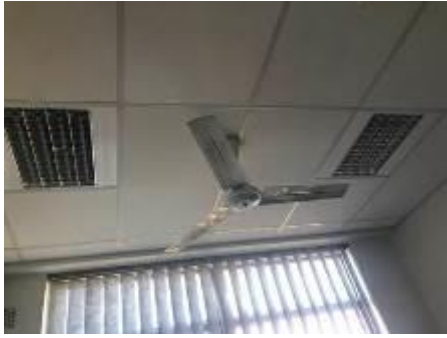
Ground Floor Customer Service Coordinates Office, 2x Fluorescent Lights	No Access Assume No PCB's Present	A5	N/A
23 rd June 2018

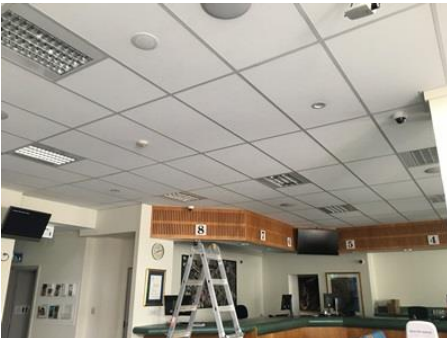
Ground Floor Customer Service Area, 18x Fluorescent Lights	Visual Observation No PCB's Present	A5	N/A

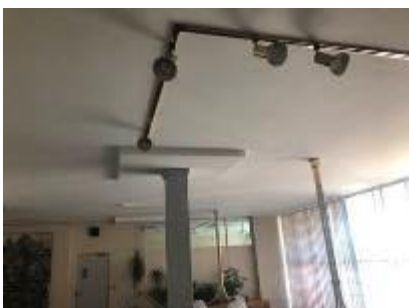
First Floor Foyer Area, 2x Fluorescent Lights	Visual Observation No PCB's Present	A5	N/A
23 rd June 2018

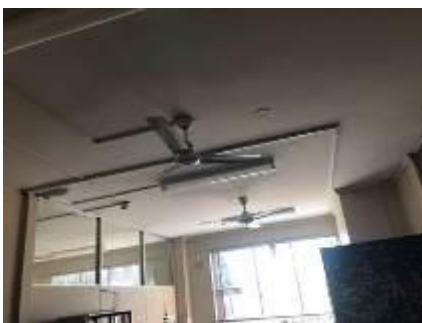
First Floor Manager Built Assets Office, 3x Fluorescent Lights	Visual Observation No PCB's Present	A5	N/A
23 rd June 2018

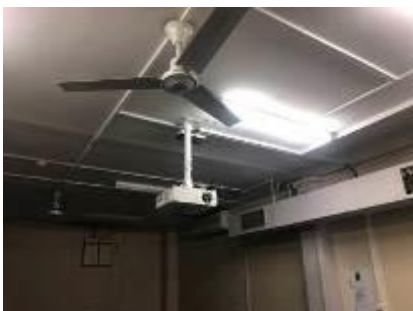
First Floor Training Room, 6x Fluorescent Lights	Visual Observation No PCB's Present	A5	N/A

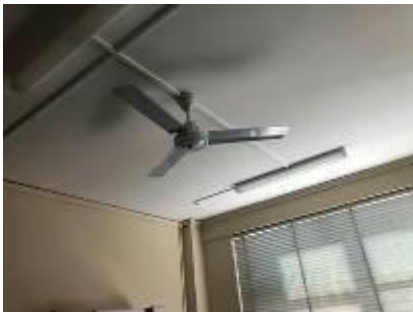
First Floor Small Office to East, 2x Fluorescent Lights	Visual Observation No PCB's Present	A5	N/A
23 rd June 2018

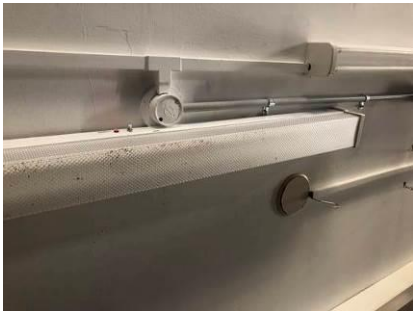
First Floor Waste & Resources, 1x Fluorescent Lights No Capacitor Present	Visual Observation No PCB's Present	A5	N/A
23 rd June 2018

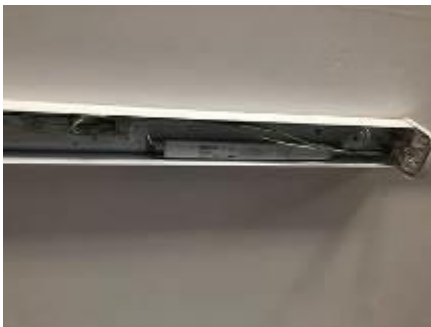
First Floor Waste & Resources, 1x Fluorescent Lights No Capacitor Present	Visual Observation No PCB's Present	A5	N/A
23 rd June 2018

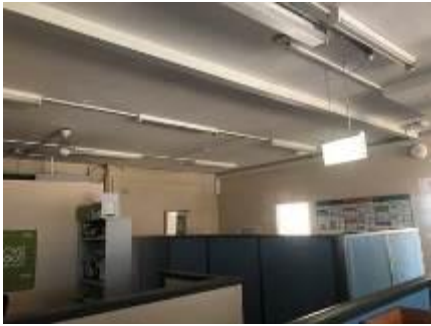
First Floor Waste & Resources, 15x Fluorescent Lights	Visual Observation No PCB's Present	A5	N/A

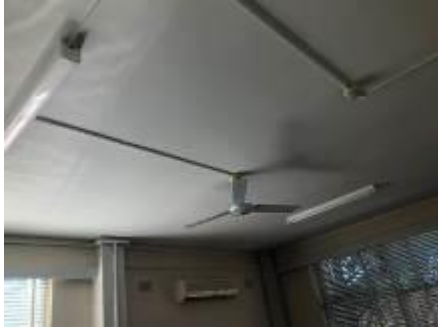
First Floor Director of City & Commercial Outcomes, 2x Fluorescent Lights	Visual Observation No PCB's Present	A5	N/A
23 rd June 2018

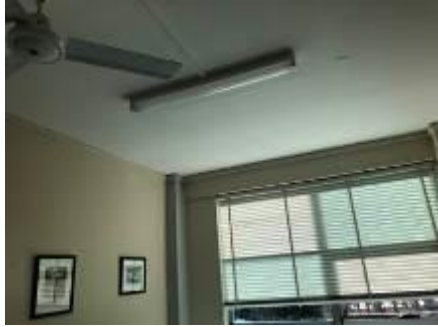
First Floor Manager of Strategic Outcomes, 1x Fluorescent Lights	Visual Observation No PCB's Present	A5	N/A
23 rd June 2018

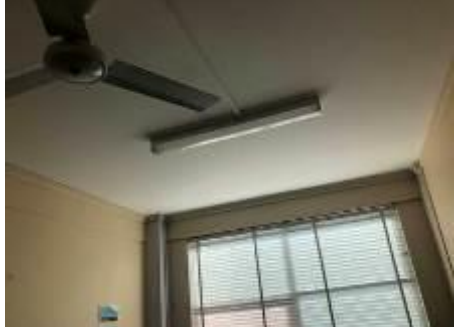
First Floor Program Leader Asset Planning, 1x Fluorescent Lights	Visual Observation No PCB's Present	A5	N/A

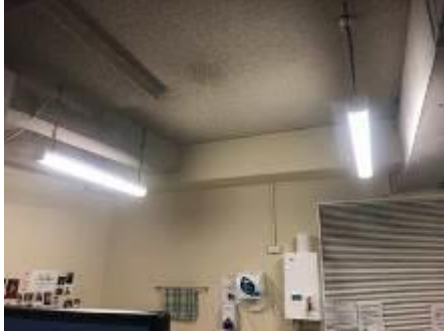
First Floor Kitchen, 2x Fluorescent Lights	Visual Observation No PCB's Present	A5	N/A
23 rd June 2018

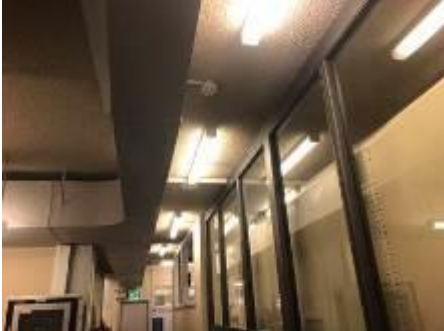
First Floor Infrastructure & Strategic Assets Branch Hallway, 5x Fluorescent Lights	Visual Observation No PCB's Present	A5	N/A
23 rd June 2018

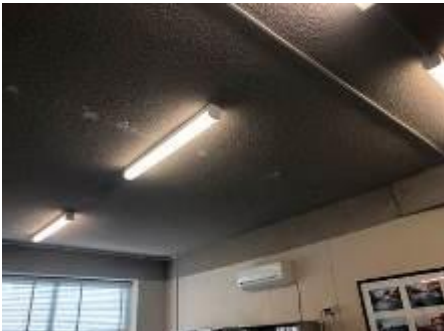
First Floor Infrastructure & Strategic Assets Branch, 4x Fluorescent Lights	Visual Observation No PCB's Present	A5	N/A

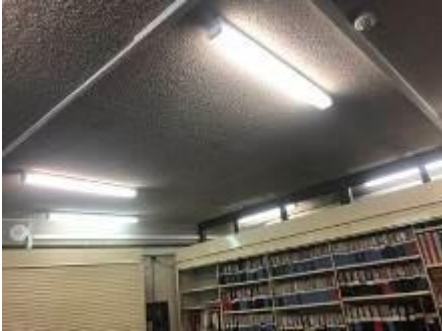
First Floor Plans Room, 5x Fluorescent Lights	Visual Observation No PCB's Present	A5	N/A
23 rd June 2018

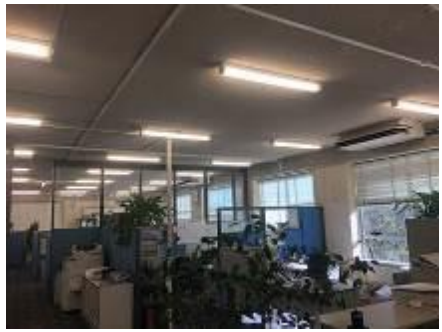
First Floor Project/ Project Manager, 13x Fluorescent Lights	Visual Observation No PCB's Present	A5	N/A
23 rd June 2018

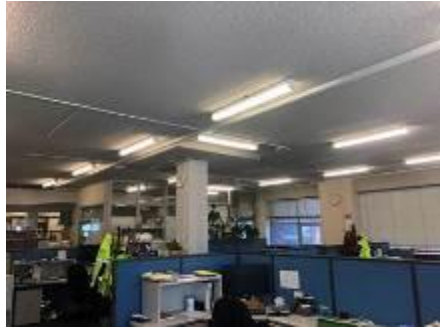
First Floor Survey 7 Design, 19x Fluorescent Lights	Visual Observation No PCB's Present	A5	N/A

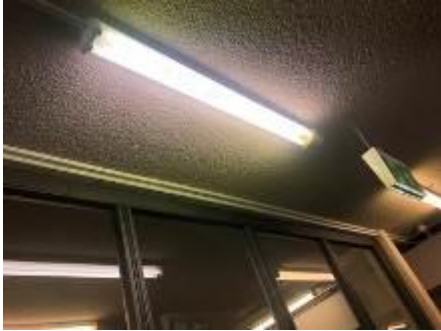
First Floor Infrastructure Hallway, 1x Fluorescent Lights	Visual Observation No PCB's Present	A5	N/A
23 rd June 2018

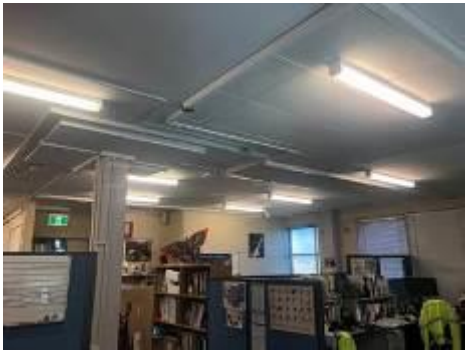
First Floor Natural Waterways, 9x Fluorescent Lights	Visual Observation No PCB's Present	A5	N/A
23 rd June 2018

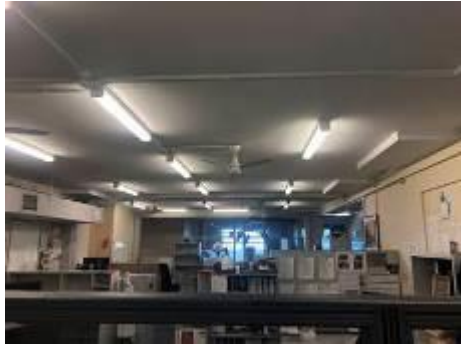
First Floor Civil Assets & Traffic/ Bush Fire, 15x Fluorescent Lights	Visual Observation No PCB's Present	A5	N/A

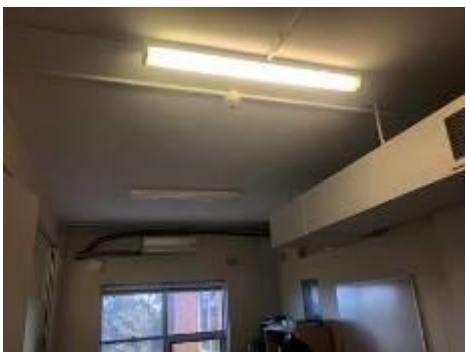
First Floor Manager Environment & Culture, 2x Fluorescent Lights	Visual Observation No PCB's Present	A5	N/A
23 rd June 2018

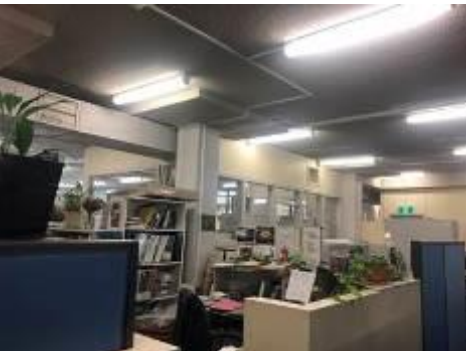
First Floor Natural Areas, 11x Fluorescent Lights	Visual Observation No PCB's Present	A5	N/A
23 rd June 2018

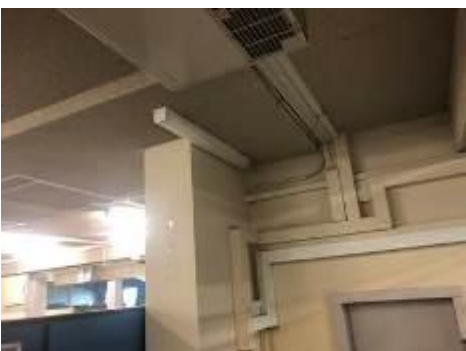
First Floor Photo Copy Area, 1x Fluorescent Lights	Visual Observation No PCB's Present	A5	N/A

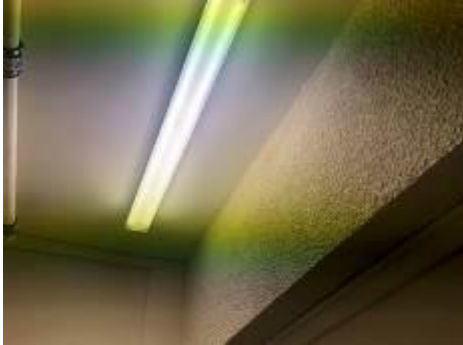
First Floor Male Toile, 1x Fluorescent Lights	Visual Observation No PCB's Present	A5	N/A
23 rd June 2018

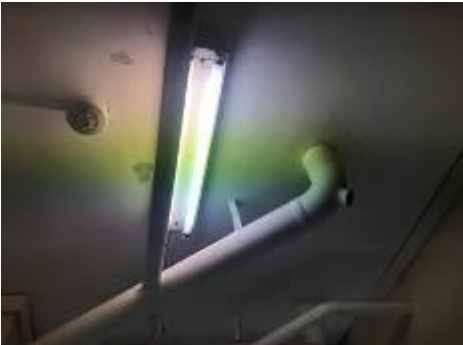
First Floor Male Toilet, 1x Fluorescent Lights No Capacitor Present	Visual Observation No PCB's Present	A5	N/A
23 rd June 2018

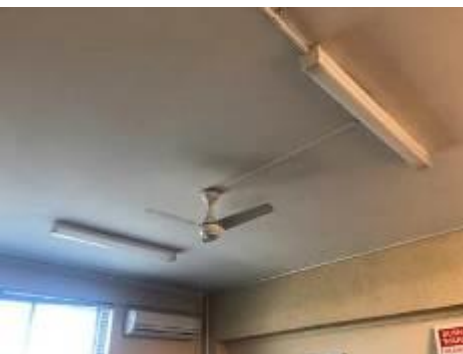
First Floor Bushfire Management, 2x Fluorescent Lights	Visual Observation No PCB's Present	A5	N/A

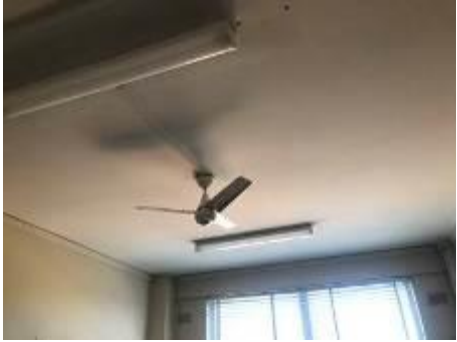
First Floor Buildings & Facilities, 2x Fluorescent Lights	Visual Observation No PCB's Present	A5	N/A
23 rd June 2018

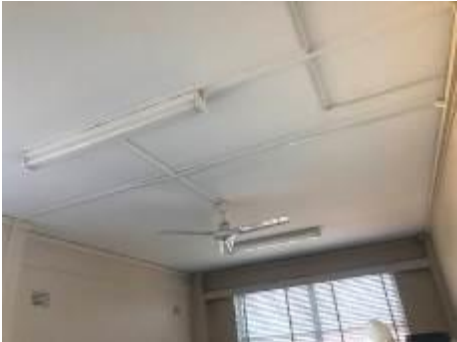
First Floor Property, 2x Fluorescent Lights	Visual Observation No PCB's Present	A5	N/A
23 rd June 2018

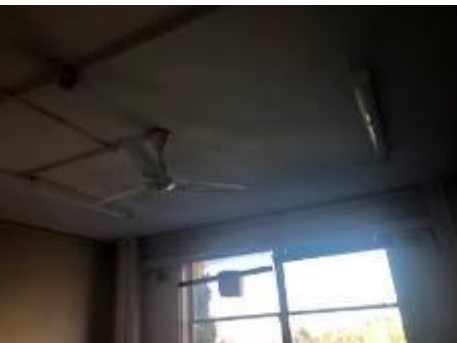
First Floor Program Leader, 2x Fluorescent Lights	Visual Observation No PCB's Present	A5	N/A

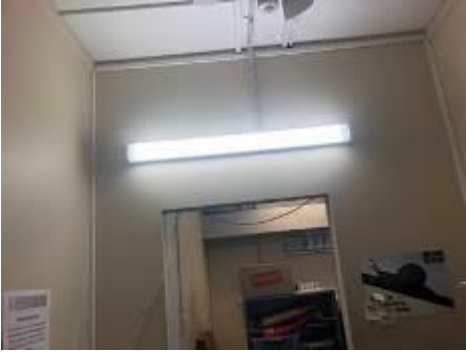
First Floor Printer Copier, 1x Fluorescent Lights	Visual Observation No PCB's Present	A5	N/A
23 rd June 2018

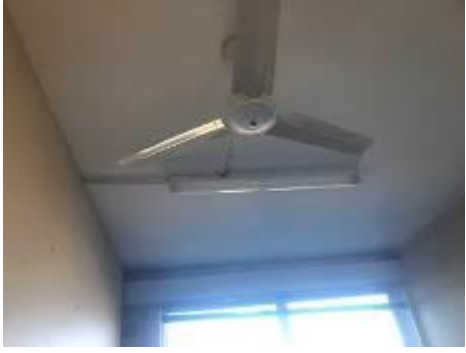
First Floor Program Leader Community Outcomes, 1x Fluorescent Lights	Visual Observation No PCB's Present	A5	N/A
23 rd June 2018

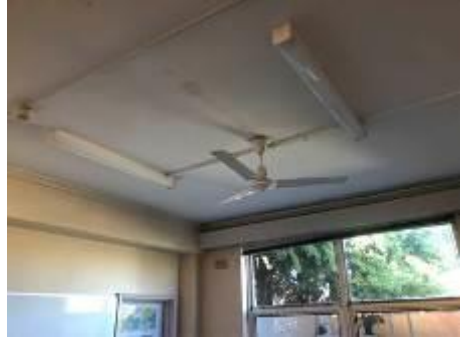
First Floor Manager Community Economics Branch, 2x Fluorescent Lights	Visual Observation No PCB's Present	A5	N/A

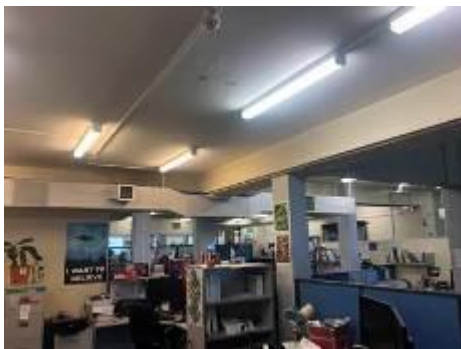
First Floor Community Outcomes, Cultural & Heritage, 31x Fluorescent Lights	Visual Observation No PCB's Present	A5	N/A
23 rd June 2018
