Asbestos Register

HAZARDOUS MATERIALS REGISTER

Regional EnviroScience Pty Ltd was requested by Mr. Jason Adams of Blue Mountains City Council to undertake a Hazardous Building Materials Register and to prepare a Hazardous Materials Management Plan of the property known as the Blue Mountains City Council Headquarters, 2-6 Civic Place, Katoomba, NSW, 2780. The purpose of the audit was to locate and identify asbestos based building materials and product within the building in accordance with the *NSW Work Health and Safety Act 2011* and *NSW Work Health and Safety Regulation 2017* and the *Code of Practice: How to Manage and Control Asbestos in the Workplace [Safe Work Australia: 2016]* and the *Code of Practice: How to Safely Remove Asbestos [Safe Work Australia: 2016]*.

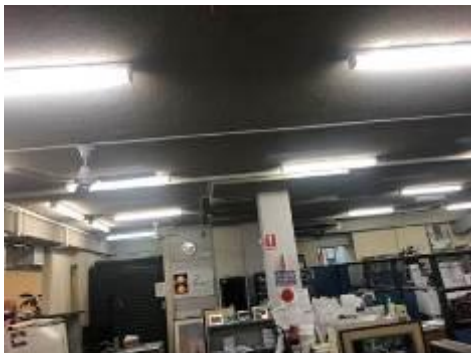
First Floor Recreation assets & Land Use Outcomes Area, 16x Fluorescent Lights	Visual Observation No PCB's Present	A5	N/A
23 rd June 2018

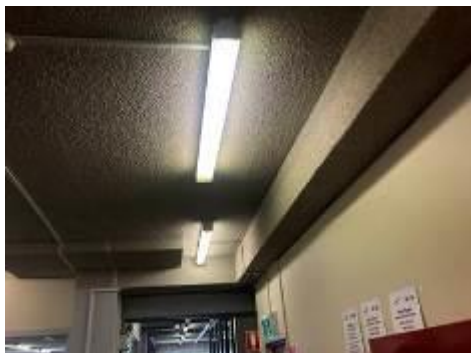
First Floor Hallway, 2x Fluorescent Lights	Visual Observation No PCB's Present	A5	N/A

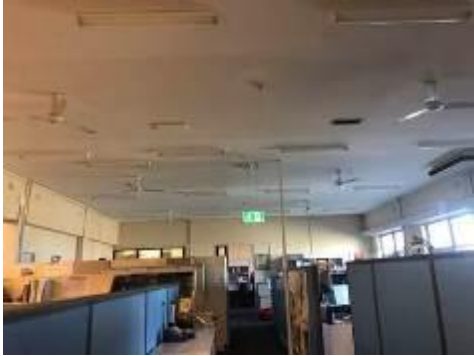
First Floor Recreation Assets & Land Use Outcomes, 16x Fluorescent Lights	Visual Observation No PCB's Present	A5	N/A
23 rd June 2018

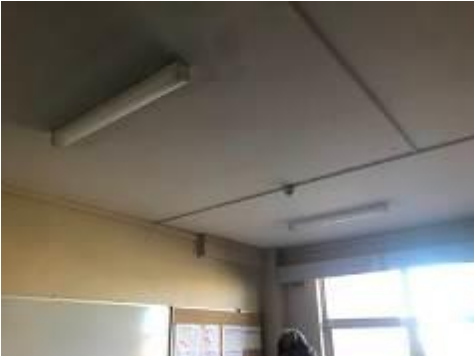
First Floor Program Leader Outcomes, 5x Fluorescent Lights	Visual Observation No PCB's Present	A5	N/A
23 rd June 2018

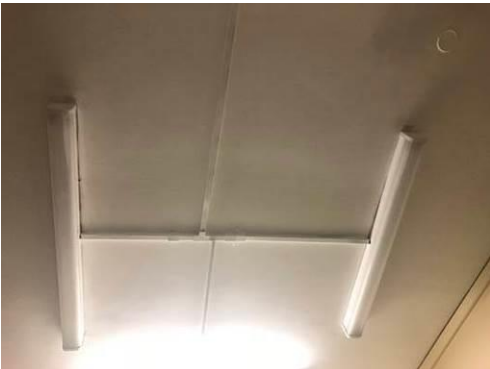
First Floor Recreation Assets & Land Use Outcomes Area, 16x Fluorescent Lights	Visual Observation No PCB's Present	A5	N/A

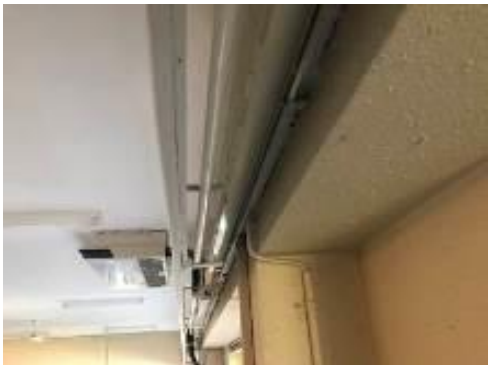
First Floor Recreation Assets & Land Use Outcomes Beneath Windows, 12x Fluorescent Lights	No Access Assume May Contain PCB's	A4	Unknown Condition Accessible to Tradespeople Refer to Management Plan
23 rd June 2018

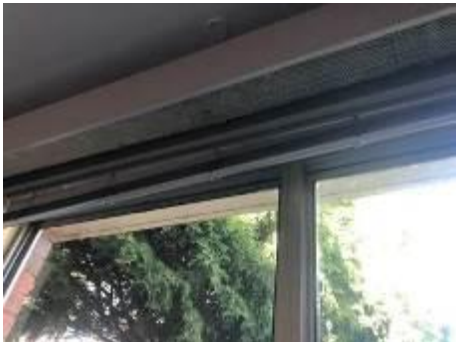
First Floor Manager Community & Economic Branch, Fluorescent Lights	No Access Assume PCB's Present	A4	Unknown Condition Accessible to Tradespeople Refer to Management Plan
23 rd June 2018

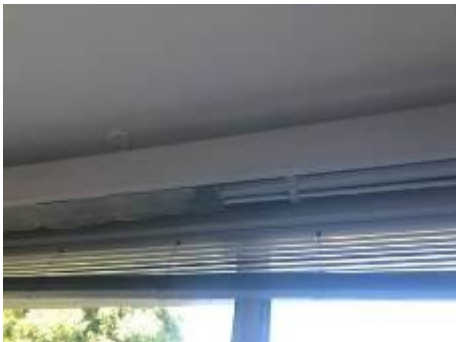
First Floor Program Leader Community Outcomes, Fluorescent Lights	No Access Assume PCB's Present	A4	Unknown Condition Accessible to Tradespeople Refer to Management Plan

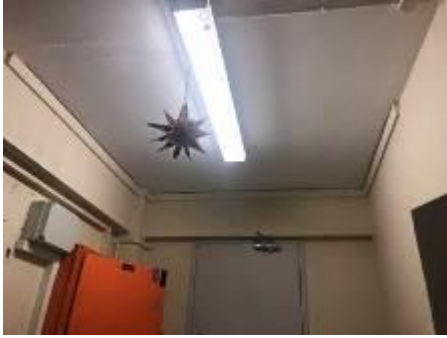
First Floor Cleaners Room, 1x Fluorescent Lights Plessey BS4017 Type Capacitor	Visual Observation Capacitors Not Found on 1997 ANZECC Register Potential PCB's Present	A4	Good Condition Accessible to Tradespeople Refer to Management Plan
23 rd June 2018

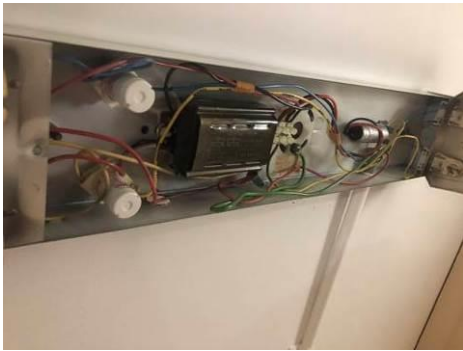
First Floor Kitchen, 1x Fluorescent Lights Alpha MPP Type Capacitor	Visual Observation No PCB's Present	A5	N/A
23 rd June 2018

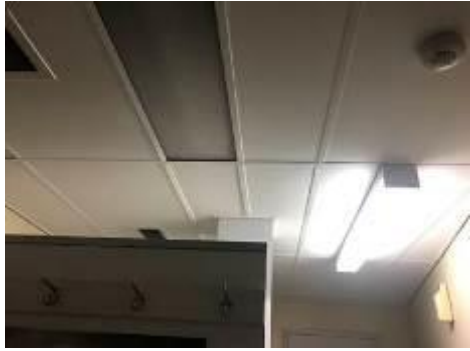
First Floor Female Toilet, 2x Fluorescent Lights in Suspended Tile Ceiling	No Access Without Damage to Casing Potential PCB's Present	A4	Unknown Condition Accessible to Tradespeople Refer to Management Plan

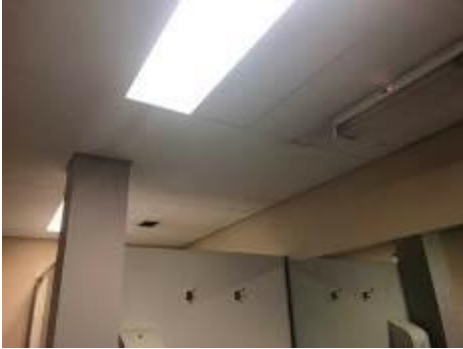
First Floor Male Toilet, 2x Fluorescent Lights in Suspended Tile Ceiling	No Access Without Damage to Casing Potential PCB's Present	A4	Unknown Condition Accessible to Tradespeople Refer to Management Plan
23 rd June 2018

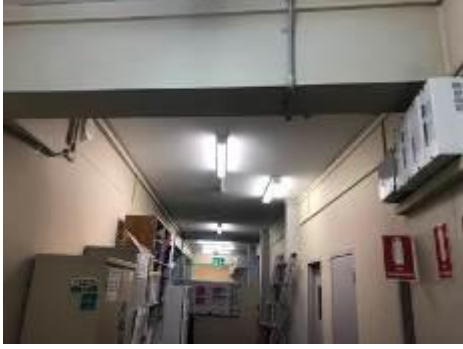
First Floor Hallway, 4x Fluorescent Lights	Visual Observation No PCB's Present	A5	N/A

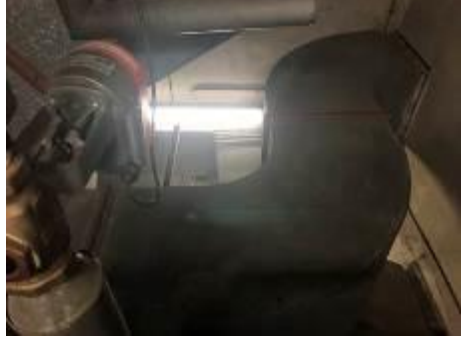
First Floor Ventilation Plant Room, 2x Fluorescent Lights Plessey BS4017 Type Capacitor	Visual Observation Capacitors Not Found on 1997 ANZECC Register Potential PCB's Present	A4	Good Condition Accessible to Tradespeople Refer to Management Plan

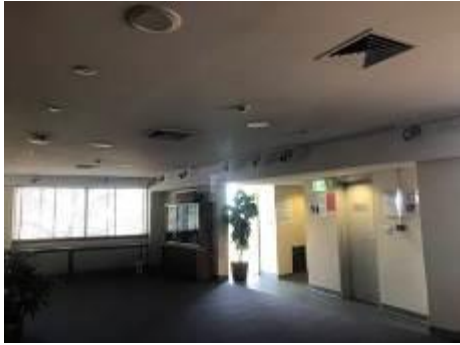
Second Floor Darwin Gallery, All Incandescent Lights	Visual Observation No PCB's Present	A5	N/A

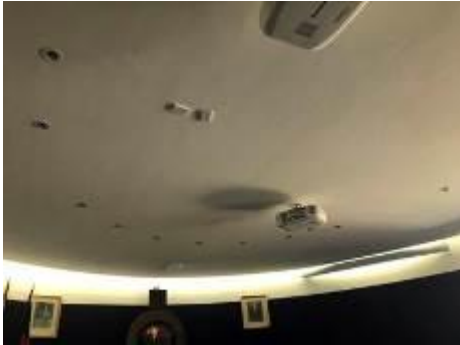
Second Floor Council Chambers, Incandescent Lights	Visual Observation No PCB's Present	A5	N/A

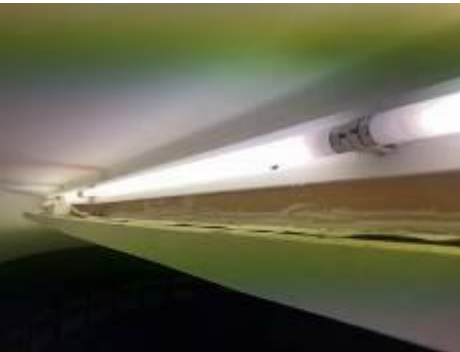
Second Floor Council Chambers, Ring of Fluorescent Lights Plessey BS 4017 Type Capacitor	Visual Observation Capacitors Not Found on 1997 ANZECC Register Potential PCB's Present	A4	Good Condition Accessible to Tradespeople Refer to Management Plan

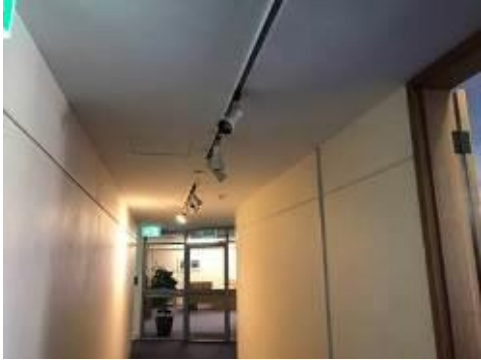
Second Floor Hallway Outside Council Chambers, Incandescent Lights	Visual Observation No PCB's Present	A5	N/A

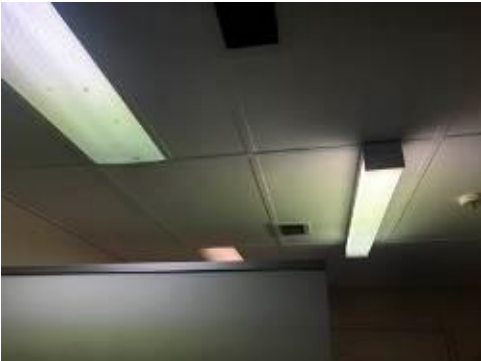
Second Floor Female Toilet, 2x Fluorescent Lights in Suspended Ceiling Tiles	No Access Potential PCB's Present	A4	Unknown Condition Accessible to Tradespeople Refer to Management Plan
23 rd June 2018

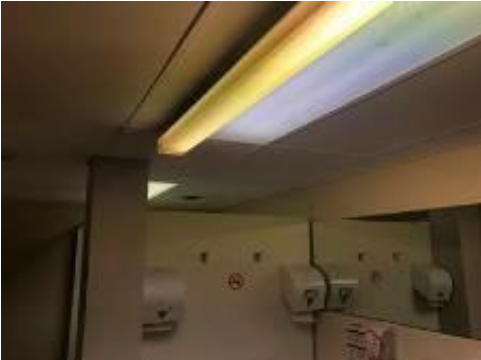
Second Floor Female Toilet, 1x Fluorescent Light	Visual Observation No PCB's Present	A5	N/A

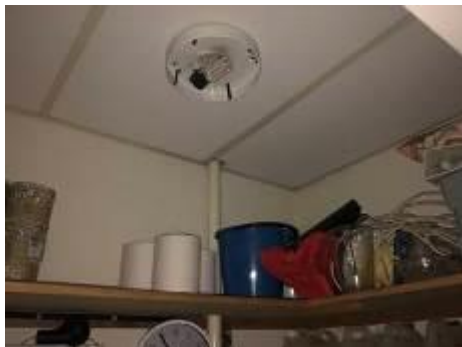
Second Floor Cleaners Closet, 1x Incandescent Light	Visual Observation No PCB's Present	A5	N/A
23 rd June 2018

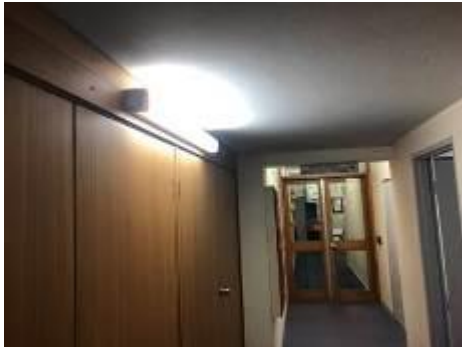
Second Floor Hallway Adjacent Toilets, 2x Fluorescent Light No Capacitors Present	Visual Observation No PCB's Present	A5	N/A
23 rd June 2018

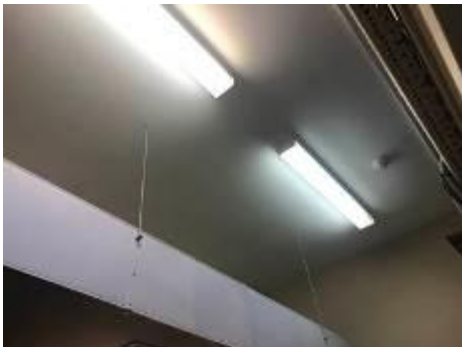
Second Floor Large Kitchen, 4x Fluorescent Light AEE PMN 5417 Type Capacitor	Visual Observation PCB's Present	A4	Good Condition Accessible to Tradespeople Refer to Management Plan

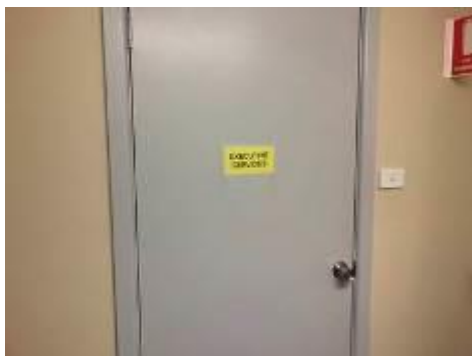
Second Floor Executive Services, Potential Fluorescent Light	No Access - Locked Potential PCB's Present	A4	Unknown Condition Refer to Management Plan
23 rd June 2018

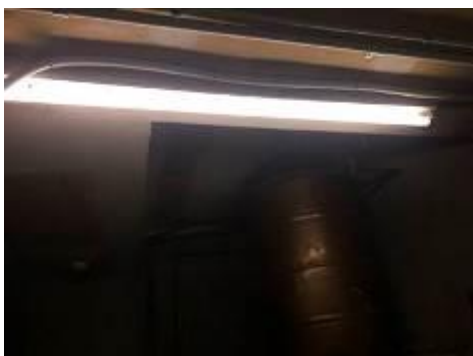
Second Floor Upper Plant Room, 1x Fluorescent Light	Visual Observation No PCB's Present	A5	N/A
23 rd June 2018

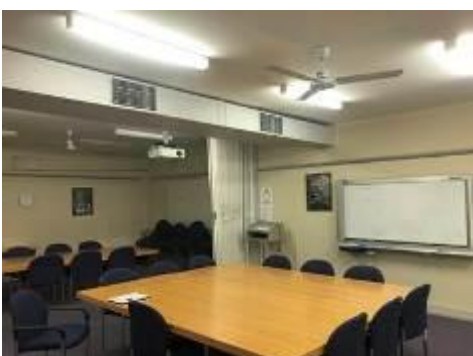
Second Floor Megalong/ Grose Valley Meeting Room, 15x Fluorescent Lights	Visual Observation No PCB's Present	A5	N/A

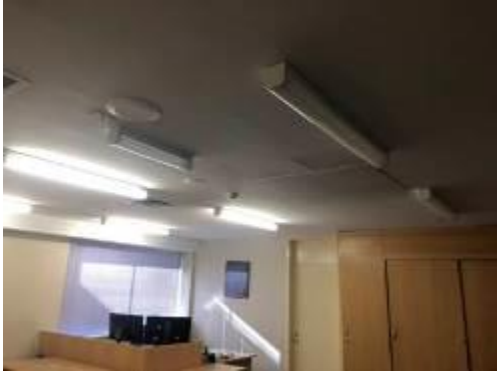
Second Floor GM Reception Area, 12x Fluorescent Light	Visual Observation No PCB's Present	A5	N/A
23 rd June 2018

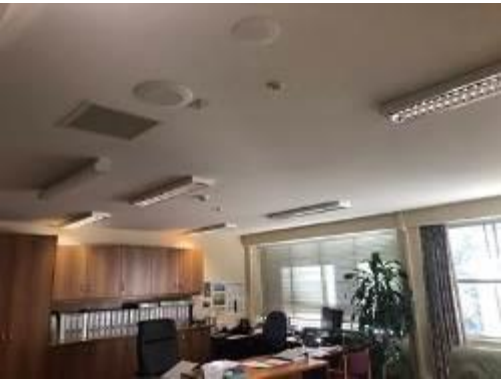
Second Floor GM Office Area, 9x Fluorescent Light	No Access New Lights Therefore Assume No PCB's Present	A5	N/A
23 rd June 2018

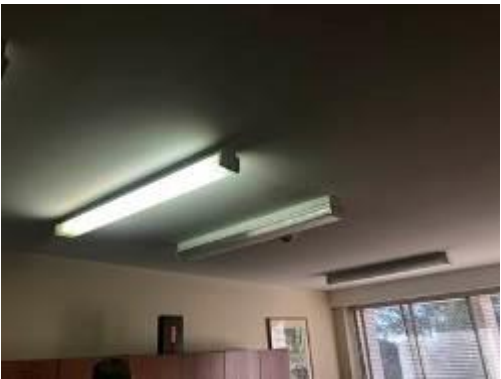
Second Floor Councillors Room, 4x Fluorescent Light	Visual Observation No PCB's Present	A5	N/A

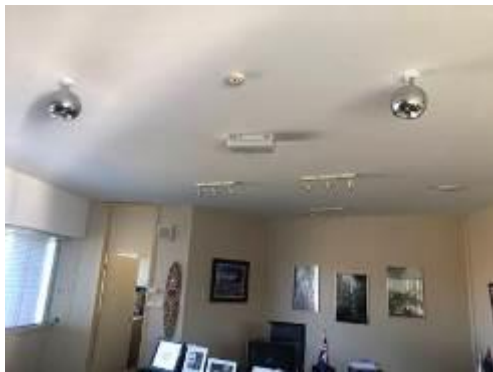
Second Floor Mayor's Office, All Incandescent Lights	Visual Observation No PCB's Present	A5	N/A
23 rd June 2018

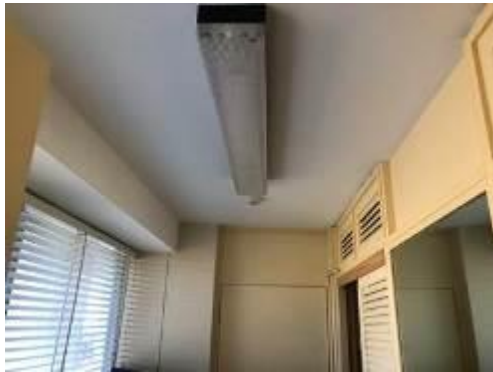
Second Floor Mayor's Office Bathroom Hallway, 11x Fluorescent Light	No Access to Light Without Damaging Casing Potential PCB's Present	A4	Unknown Condition Accessible to Tradespeople Refer to Management Plan
23 rd June 2018

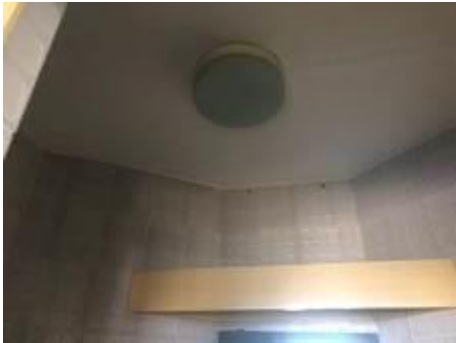
Second Floor Mayor's Bathroom, 1x Incandescent Lights	Visual Observation No PCB's Present	A5	N/A

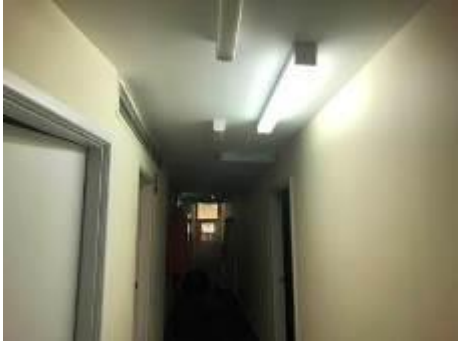
Second Floor Hallway Adjacent Disabled Toilet, 5x Fluorescent Lights	Visual Observation No PCB's Present	A5	N/A
23 rd June 2018

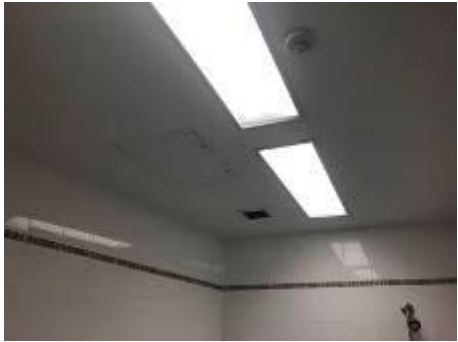
Second Floor Disabled Toilet, 2x Fluorescent Lights	No Access to Lights Without Damage to Casing Potential PCB's Present	A4	Unknown Condition Accessible to Tradespeople Refer to Management Plan
23 rd June 2018

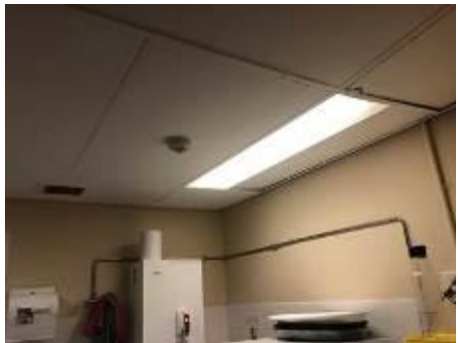
Second Floor Small Kitchen, 2x Fluorescent Lights in Suspended Ceiling Tiles	No Access to Lights Without Damage to Casing Potential PCB's Present	A4	Unknown Condition Accessible to Tradespeople Refer to Management Plan

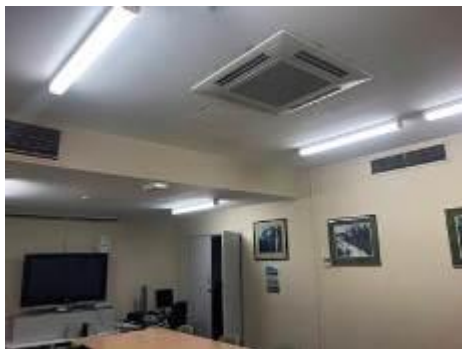
Second Floor Jamison Meeting Room, 7x Fluorescent Light	Visual Observation No PCB's Present	A5	N/A
23 rd June 2018

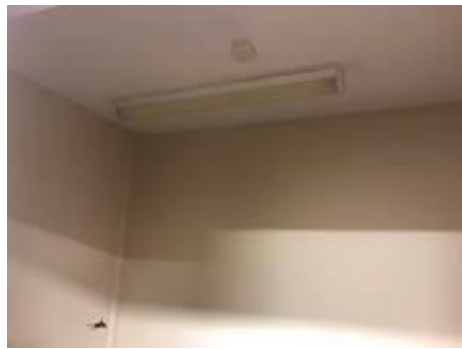
Second Floor Jamison Meeting Room Store Room, 1x Fluorescent Light	Visual Observation No PCB's Present	A5	N/A
23 rd June 2018

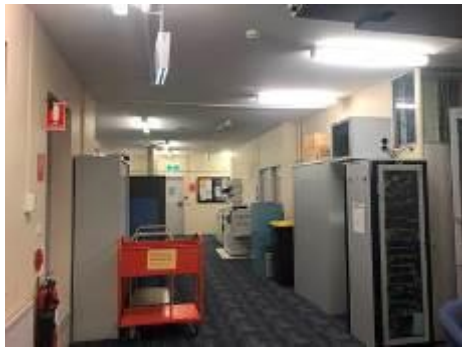
Second Floor Operation Finance, 8x Fluorescent Light	Visual Observation No PCB's Present	A5	N/A

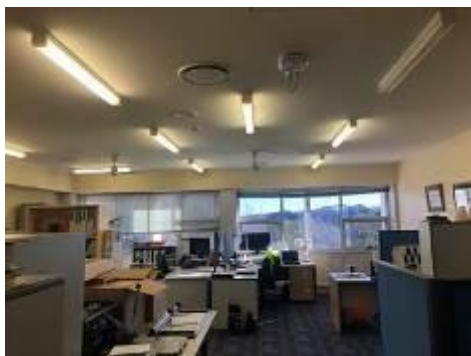
Second Floor Corporate Strategy, 10x Fluorescent Light	Visual Observation No PCB's Present	A5	N/A
23 rd June 2018

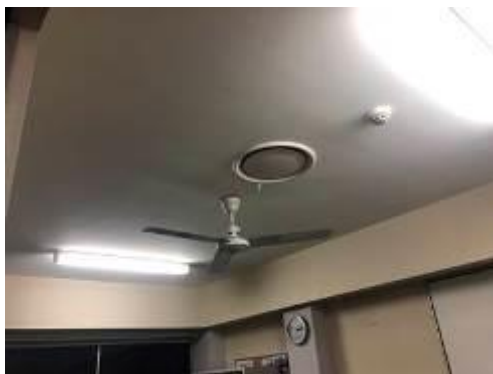
Second Floor Strategic Finance & Corporate Finance, 2x Fluorescent Light	Visual Observation No PCB's Present	A5	N/A
23 rd June 2018

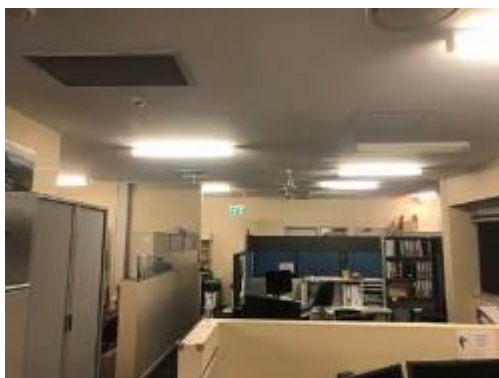
Second Floor Strategic Finance & Corporate Strategy, 7x Fluorescent Lights	Visual Observation No PCB's Present	A5	N/A

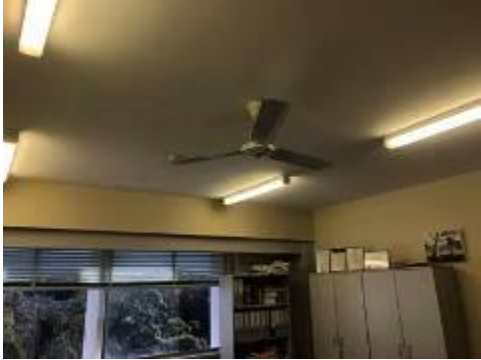
Second Floor Group Manager, Integrated Planning & Finance, 4x Fluorescent Lights	Visual Observation No PCB's Present	A5	N/A
23 rd June 2018

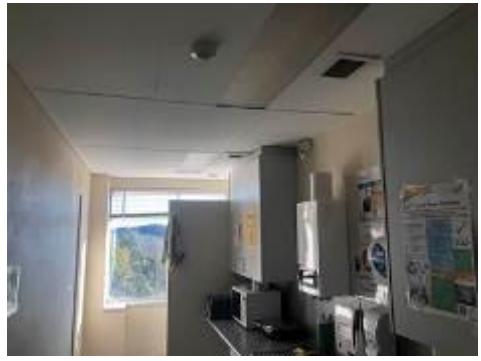
Second Floor Kitchen, 2x Fluorescent Lights in Suspended Ceiling Tiles	No Access Without Damage to Casing Potential PCB's Present	A4	Unknown Condition Accessible to Tradespeople Refer to Management Plan
23 rd June 2018

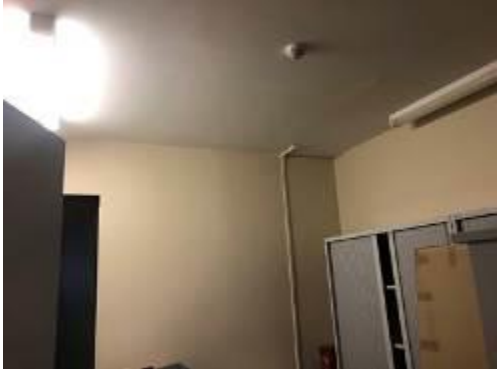
Second Floor Printer Room, 2x Fluorescent Lights	Visual Observation No PCB's Present	A5	N/A

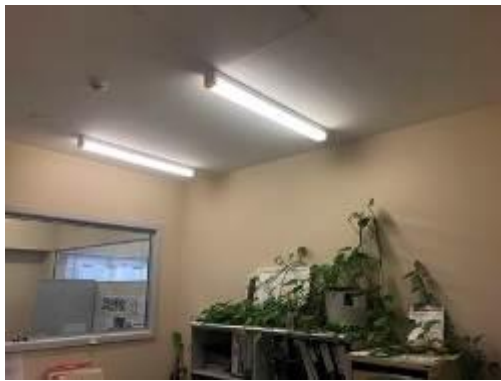
Second Floor Revenue, 2x Fluorescent Lights	Visual Observation No PCB's Present	A5	N/A
23 rd June 2018

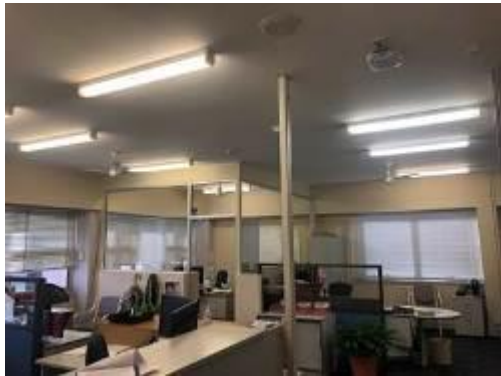
Second Floor Revenue, 11x Fluorescent Lights	Visual Observation No PCB's Present	A5	N/A
23 rd June 2018

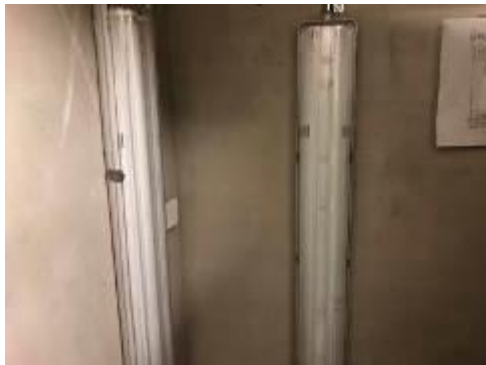
Second Floor Hoist Plant Room, 2x Fluorescent Lights No Capacitors Present	Visual Observation No PCB's Present	A5	N/A

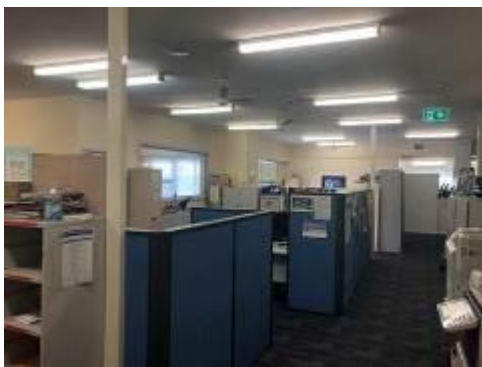
Second Floor Operational Finance, 12x Fluorescent Lights	Visual Observation No PCB's Present	A5	N/A
23 rd June 2018

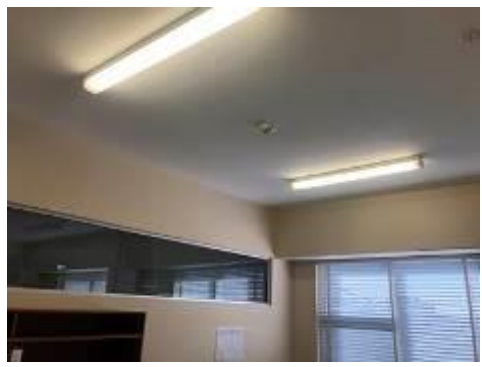
Second Floor Finance Office, 2x Fluorescent Lights	Visual Observation No PCB's Present	A5	N/A
23 rd June 2018

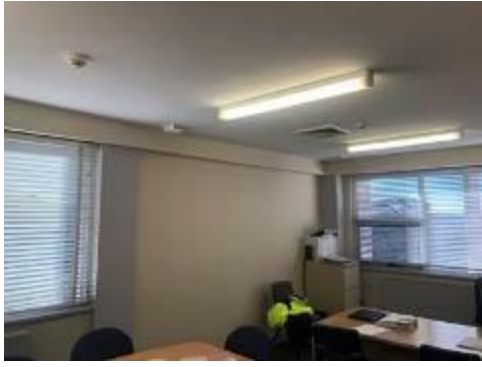
Second Floor Northern Office, 3x Fluorescent Lights	Visual Observation No PCB's Present	A5	N/A

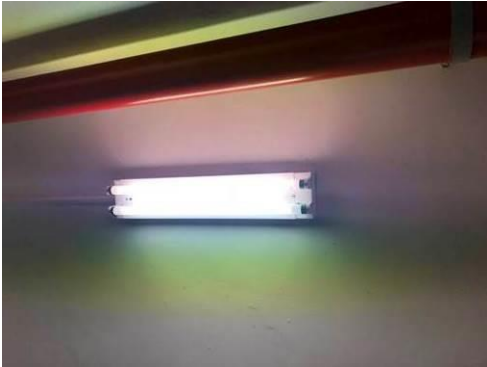
Stairwell Western Stairs, 8x Fluorescent Lights Comar MFE4 Type Capacitor	Visual Observation No PCB's Present	A5	N/A
23 rd June 2018

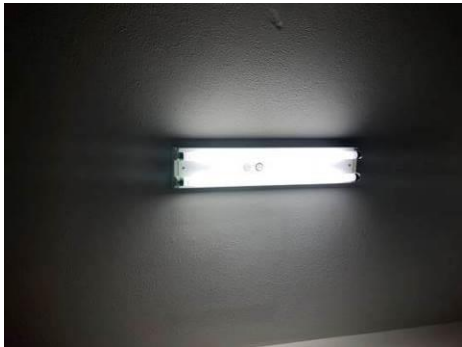
Stairwell Eastern Stairs, 8x Fluorescent Lights	Restricted Access Due to Height Assume Similar to Western Stairwell Lights Assume No PCB's Present	A5	N/A
23 rd June 2018

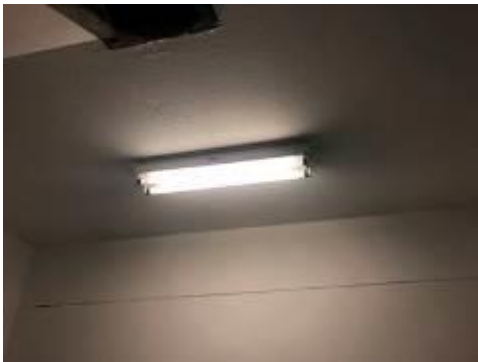
Stairwell Central Stairs, 8x Fluorescent Lights	Restricted Access Due to Height Assume Similar to Western Stairwell Lights Assume No PCB's Present	A5	N/A

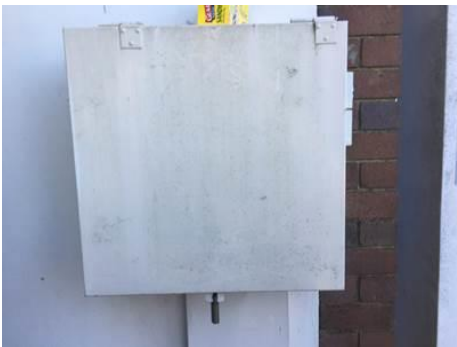
External Eastern Aspect Meter Box Backing Board	Assume Contains Phenols, Visual Inspection	A4	Good Condition, Refer to Management Plan

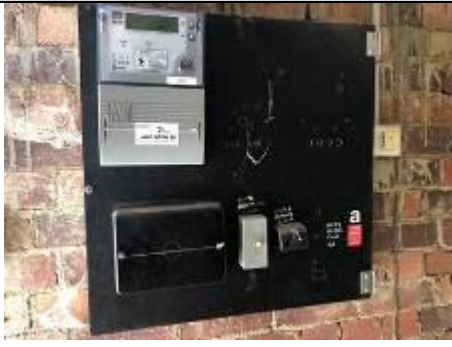
Lower Ground Main Switchboard Room Bakelite Electrical Board on Northern Wall Adjacent Door.	Assume Contains Phenols, Visual Inspection	A4	Good Condition, Refer to Management Plan
24 th June 2018

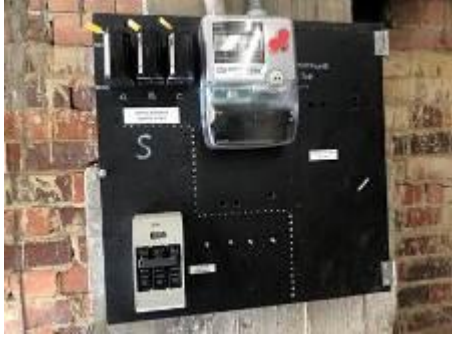
Lower Ground Main Switchboard Room Bakelite Vodafone Meter Board on Northern Wall.	Assume Contains Phenols, Visual Inspection	A4	Good Condition, Refer to Management Plan
24 th June 2018

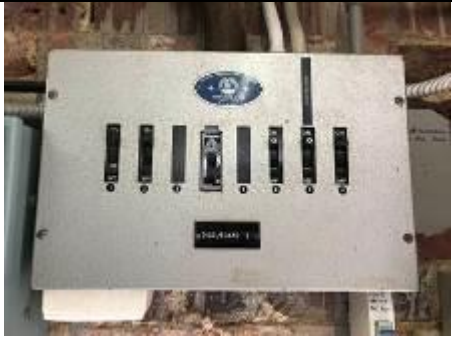
Lower Ground Main Switchboard Room Distribution Board "E" Bakelite Fuse Switches.	Assume Contains Phenols, Visual Inspection	A4	Good Condition, Refer to Management Plan

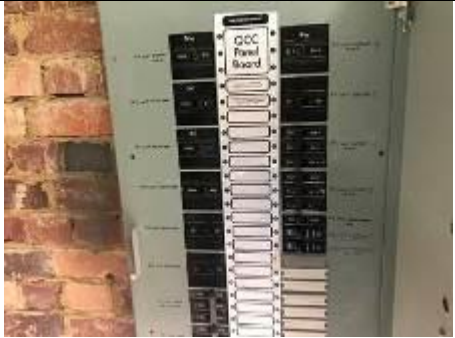
Lower Ground Main Switchboard Room QCC Air Conditioning Switchboard Bakelite Switches.	Assume Contains Phenols, Visual Inspection	A4	Good Condition, Refer to Management Plan
24 th June 2018

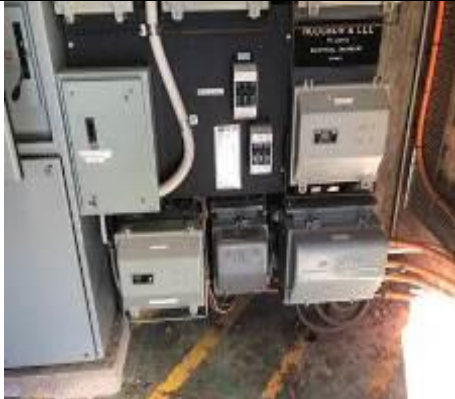
Lower Ground Main Switchboard Room Section 2 Fuse Switches Bakelite Backing Board.	Assume Contains Phenols, Visual Inspection	A4	Good Condition, Refer to Management Plan
24 th June 2018

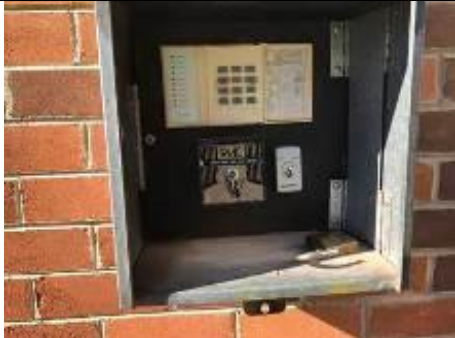
Lower Ground Garage Adjacent Generator Garage Roller Door Access Point with Bakelite Backing Board.	Assume Contains Phenols, Visual Inspection	A4	Good Condition, Refer to Management Plan

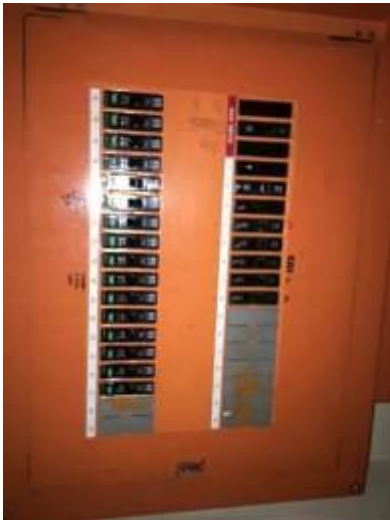
Ground Floor Meter board in Cleaner's Cupboard	Assume Contains Phenols, Visual Inspection	A4	Good Condition, Refer to Management Plan
23 rd June 2018

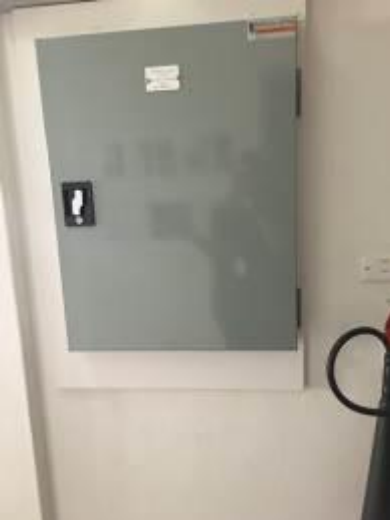
Ground Floor Distribution Board in Reception/Waiting Area Could not Access	Assume Contains Phenols, Visual Inspection	A4	Good Condition, Refer to Management Plan

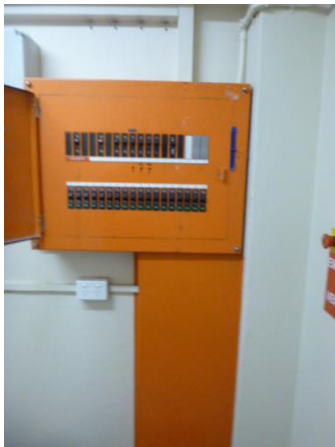
First Floor Cleaners Room Distribution Board	Assume Contains Phenols, Visual Inspection	A4	Good Condition, Refer to Management Plan

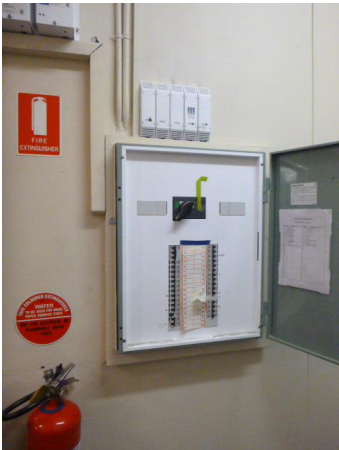
First Floor Cleaners Room Distribution Board	Assume Contains Phenols, Visual Inspection	A4	Good Condition, Refer to Management Plan

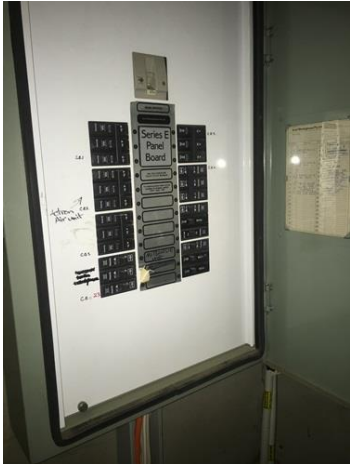
Second Floor – Kitchen Meter Box Backing Board	Assume Contains Phenols, Visual Inspection	A4	Good Condition, Refer to Management Plan
