HAZARDOUS BUILDING MATERIALS

SURVEY REPORT

Springwood Library
104 Macquarie Road
Springwood NSW 2777

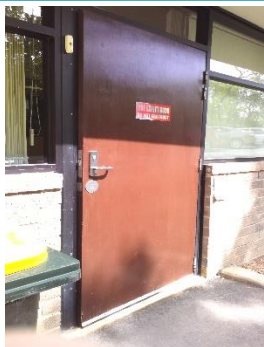
Sample No./ Visual Observation	Photo	Location	Interior / Exterior Floor Specific Location	Material Application	Analysis Result	Additional Comments
AS07

Springwood Library	Ground Floor Exterior	Fire door, Insulation	NAD	
Similar to AS07
