Asbestos Register

Regional EnviroScience Pty Ltd was requested by Mr. Rick Harris of Blue Mountain City Council to undertake a Hazardous Building Materials Survey and to prepare a Hazardous Materials Register and Management Plan of the Community Hall at the property known as Lawson Mechanics Institute, located at 284 Great Western Highway, Lawson, NSW, 2783. The purpose of the audit was to locate and identify asbestos based building materials and product within the building in accordance with the *NSW Work Health and Safety Act and Regulation 2017* and the *Code of Practice; How to Manage and Control Asbestos in the Workplace* [Safe Work Australia: 2016] and the *Code of Practice; How to Safely Remove Asbestos* [Safe Work Australia: 2016].

On the 21st March 2018, an Asbestos Audit was conducted at the Lawson Mechanics Institute and asbestos containing materials were found to be present at the premises. Please refer Appendix I for results of products that were considered and consequently analysed but did not contain asbestos.

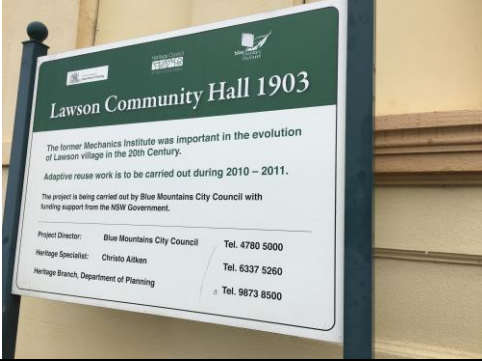
| ASBESTOS MATERIALS REGISTER | | ASSET: Lawson Mechanics Institute, 284 Great Western Highway, Lawson, NSW, 2783 | | | |
|---|---|--|--|---|---|
| 21 st March 2018 | | Lawson Mechanics Institute. | N/A | N/A | N/A |

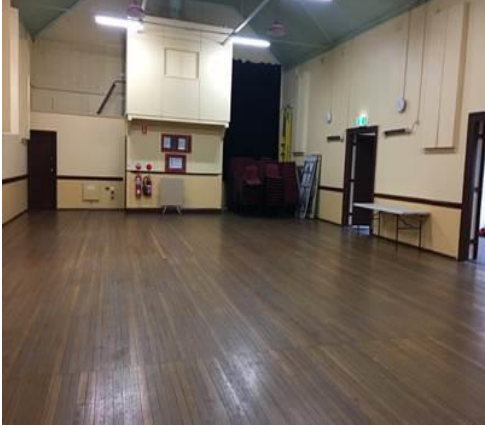
| ASBESTOS MATERIALS REGISTER | | ASSET: Lawson Mechanics Institute, 284 Great Western Highway, Lawson, NSW, 2783 | | | |
|---|---|---|--|---|---|
| 21 st March 2018 | | Main Hall. Timber Floor Boards, Rendered Cement Western and Eastern Walls, Timber Window Shutters, Timber Skirting & Architraves, Timber Doors and Timber Board Panelling to Lower Portion of North Wall. | No Sample Taken No Asbestos Containing Materials Sighted 81 | A5 | N/A |

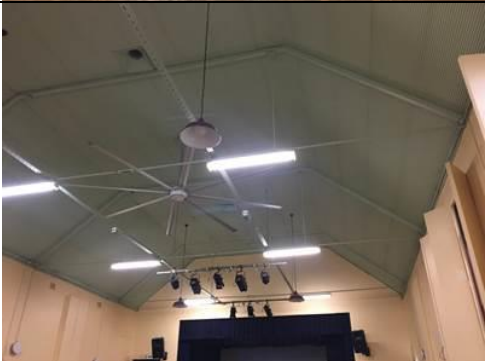
| ASBESTOS MATERIALS REGISTER | | ASSET: Lawson Mechanics Institute, 284 Great Western Highway, Lawson, NSW, 2783 | | | |
|---|---|---|--|---|---|
| 21 st March 2018 | | Main Hall. Corrugated Iron Ceiling. 84 | No Sample Taken No Asbestos Containing Materials Sighted | A5 | N/A |

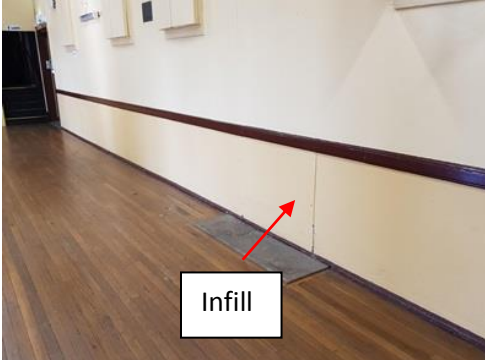
| ASBESTOS MATERIALS REGISTER | | ASSET: Lawson Mechanics Institute, 284 Great Western Highway, Lawson, NSW, 2783 | | | |
|---|---|--|---|---|--|
| 21 st March 2018 | | Main Hall. Masonite Infill Western Wall. | No Sample Taken No Asbestos Containing Material Sighted 93 | A5 | N/A |

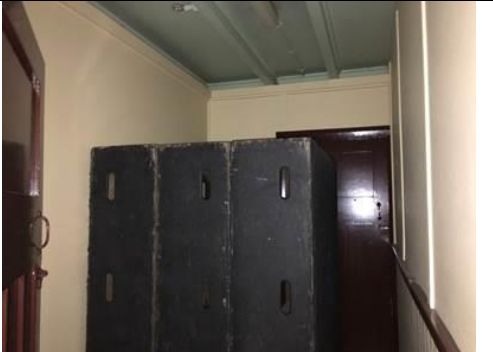
| ASBESTOS MATERIALS REGISTER | | ASSET: Lawson Mechanics Institute, 284 Great Western Highway, Lawson, NSW, 2783 | | | |
|---|--|---|--|---|---|
| 21 st March 2018 | | AV Room – Lower Level. Infill Panel Above East and West Doors Fibre Cement Sheet Approximately 2m ² | No Asbestos Detected 96 | A5 | Clearance Certificate JMB 4/1/2020 HPE# 20/1887 |

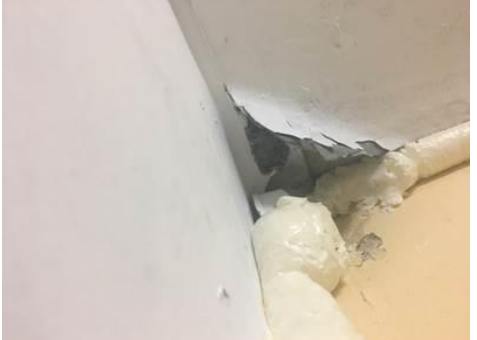
| ASBESTOS MATERIALS REGISTER | | ASSET: Lawson Mechanics Institute, 284 Great Western Highway, Lawson, NSW, 2783 | | | |
|---|---|---|--|---|---|
| 5 th April 2018 | | AV Room – Upper Level. Fibre Cement Sheet Behind Aluminium Ceiling Lining. Approximately 6m ² | No Asbestos Detected 99 | A5 | Clearance Certificate JMB 4/1/2020 HPE# 20/1887 |

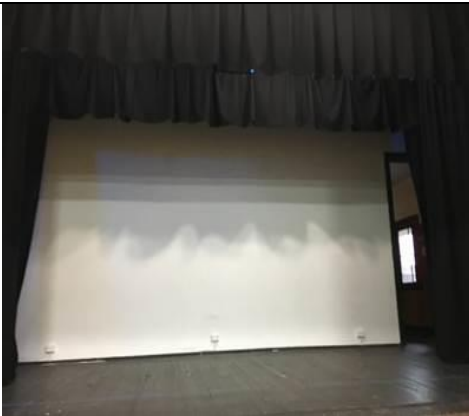
| ASBESTOS MATERIALS REGISTER | | ASSET: Lawson Mechanics Institute, 284 Great Western Highway, Lawson, NSW, 2783 | | | |
|---|---|---|--|---|---|
| 21 st March 2018 | | Stage Area. Timber & Chipboard Floor, North Decorative Timber Wall, Rendered Cement Eastern, Southern & Western Walls, Timber Skirting, Architraves & Doors, Stage Curtains and Corrugated Iron Roof | No Sample Taken No Asbestos Containing Material Sighted 102 | A5 | N/A |

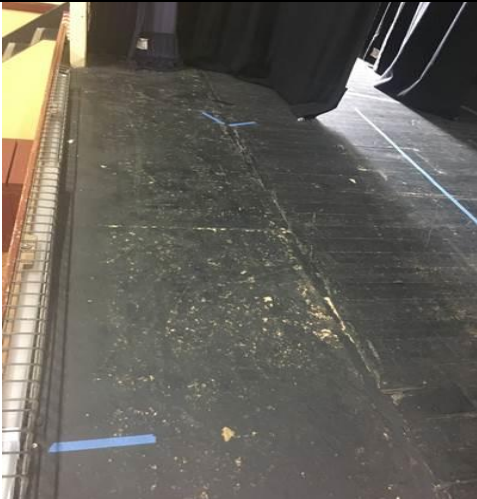
| ASBESTOS MATERIALS REGISTER | | ASSET: Lawson Mechanics Institute, 284 Great Western Highway, Lawson, NSW, 2783 | | | |
|---|---|---|--|---|---|
| 5 th April 2018 | | Stage Area. Black Stage Floor. | Sample #B18109S25 No Asbestos Detected. 105 | A5 | N/A |

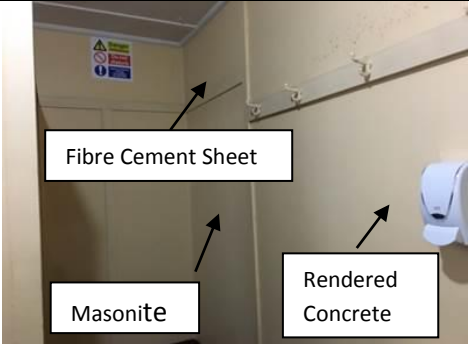
| ASBESTOS MATERIALS REGISTER | | ASSET: Lawson Mechanics Institute, 284 Great Western Highway, Lawson, NSW, 2783 | | | |
|---|--|---|--|---|--|
| 21 st March 2018 | <p>Fibre Cement Sheet</p> <p>Masonite</p> <p>Rendered Concrete</p> | Male Toilets. Western Wall Linings are Rendered Concrete, Masonite & Fibre Cement Sheet. | No Asbestos Detected 230 | A5 | Clearance Certificate JMB 4/1/2020 HPE# 20/1887 |

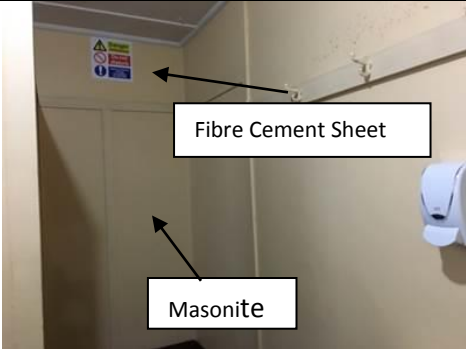
| ASBESTOS MATERIALS REGISTER | | ASSET: Lawson Mechanics Institute, 284 Great Western Highway, Lawson, NSW, 2783 | | | |
|---|---|---|---|---|---|
| 21 st March 2018 | | Male Toilets. Southern Wall Linings are Masonite & Fibre Cement Sheet. 231 | No Asbestos Detected | A5 | Clearance Certificate JMB 4/1/2020 HPE# 20/1887 |

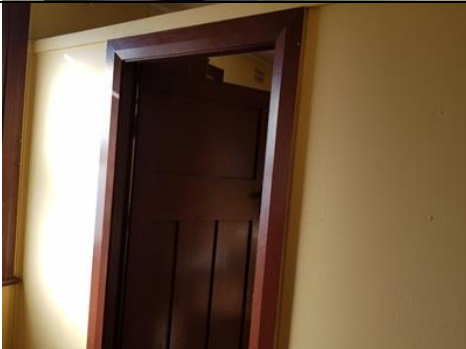
| ASBESTOS MATERIALS REGISTER | | ASSET: Lawson Mechanics Institute, 284 Great Western Highway, Lawson, NSW, 2783 | | | |
|---|---|---|---|---|---|
| 21 st March 2018 | | Male Toilets. North Side of Entry Partition Wall Fibre Cement Sheet 232 | No Asbestos Detected | A5 | Clearance Certificate JMB 4/1/2020 HPE# 20/1887 |

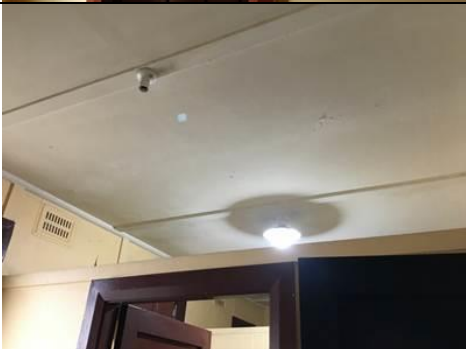
| ASBESTOS MATERIALS REGISTER | | ASSET: Lawson Mechanics Institute, 284 Great Western Highway, Lawson, NSW, 2783 | | | |
|---|---|---|---|---|---|
| 21 st March 2018 | | Male Toilets. Ceiling Lining Fibre Cement Sheet 233 | No Asbestos Detected | A5 | Clearance Certificate JMB 4/1/2020 HPE# 20/1887 |

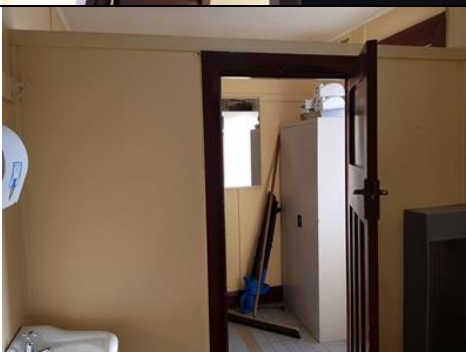
| ASBESTOS MATERIALS REGISTER | | ASSET: Lawson Mechanics Institute, 284 Great Western Highway, Lawson, NSW, 2783 | | | |
|---|---|---|---|---|---|
| 21 st March 2018 | | Male Toilets. South Side of Entry Partition Wall Fibre Cement Sheet Approximately 3m ² 234 | Sample #B18109S07 No Asbestos Detected | A5 | N/A |

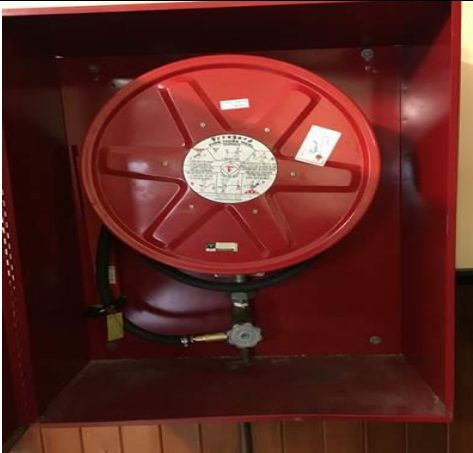
| ASBESTOS MATERIALS REGISTER | | ASSET: Lawson Mechanics Institute, 284 Great Western Highway, Lawson, NSW, 2783 | | | |
|---|---|--|--|---|--|
| 21 st March 2018 | | Supper Room. Fire Hydrant Cabinet. 806 | No Sample Taken. No Asbestos Containing Material Sighted. | A5 | N/A |

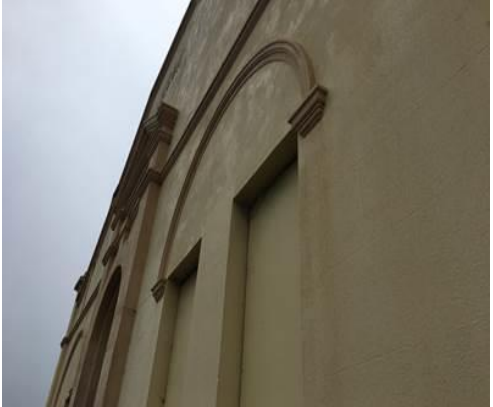
| ASBESTOS MATERIALS REGISTER | | ASSET: Lawson Mechanics Institute, 284 Great Western Highway, Lawson, NSW, 2783 | | | |
|---|---|--|--|---|---|
| 21 st March 2018 | | Northern Aspect. Corrugated Iron Roof, Rendered & Brick Walls, Timber Doors, Timber Infills Above Windows, Aluminium on Timber Board Infill Above Door. | No Sample Taken. No Asbestos Containing Material Sighted. 817 | A5 | N/A |

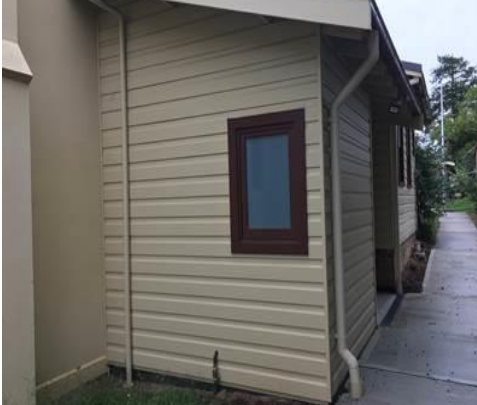
| ASBESTOS MATERIALS REGISTER | | ASSET: Lawson Mechanics Institute, 284 Great Western Highway, Lawson, NSW, 2783 | | | |
|---|---|---|--|---|---|
| 21 st March 2018 | | Western Aspect. Corrugated Iron Roof, Steel Guttering, PVC Downpipes, Timber Weatherboards, Trims, Corner Moulds & Window Frames, Exposed Timber Trusses & Foil Sparking | No Sample Taken. No Asbestos Containing Material Sighted 820 | A5 | N/A |

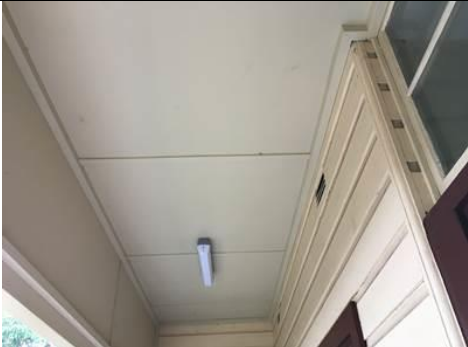
| ASBESTOS MATERIALS REGISTER | | ASSET: Lawson Mechanics Institute, 284 Great Western Highway, Lawson, NSW, 2783 | | | |
|---|---|---|---|---|---|
| 21 st March 2018 | | Western Aspect. Verandah Soffit Lining Fibre Cement Approximately 10m ² | Sample #B18109S15 No Asbestos Detected 823 | A5 | N/A |

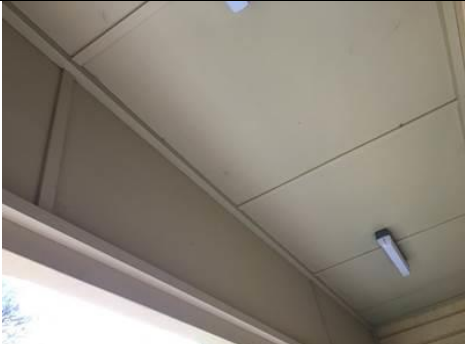
| ASBESTOS MATERIALS REGISTER | | ASSET: Lawson Mechanics Institute, 284 Great Western Highway, Lawson, NSW, 2783 | | | |
|---|---|--|--|---|---|
| 21 st March 2018 | | Western Aspect. Verandah Upper Wall Lining Fibre Cement Sheet Approximately 3m ² | Similar to Sample #B18109S15 No Asbestos Detected 824 | A5 | N/A |

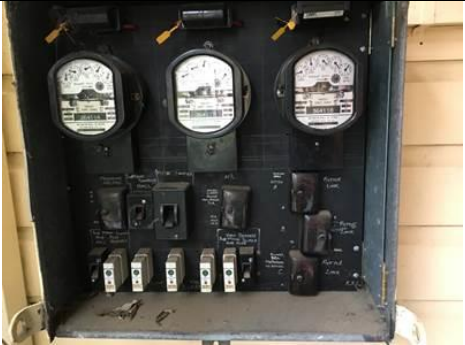
| ASBESTOS MATERIALS REGISTER | | ASSET: Lawson Mechanics Institute, 284 Great Western Highway, Lawson, NSW, 2783 | | | |
|---|---|--|--|---|---|
| 21 st March 2018 | | Western Aspect. Verandah Meter Boards Electrical Bakelite Backing Board Approximately 0.5m ² | No Sample Taken. Assume Contains Asbestos. Non-Friable 825 | A4 | Good Condition Accessible to Tradespeople Refer to Asbestos Management Plan |

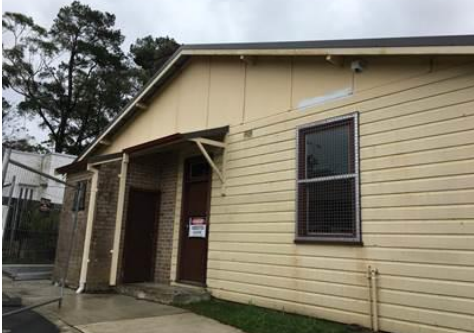
| ASBESTOS MATERIALS REGISTER | | ASSET: Lawson Mechanics Institute, 284 Great Western Highway, Lawson, NSW, 2783 | | | |
|---|---|--|--|---|---|
| 21 st March 2018 | | Southern Aspect. Window Mastic. | Similar to Sample #B18109S13 No Asbestos Detected 829 | A5 | N/A |

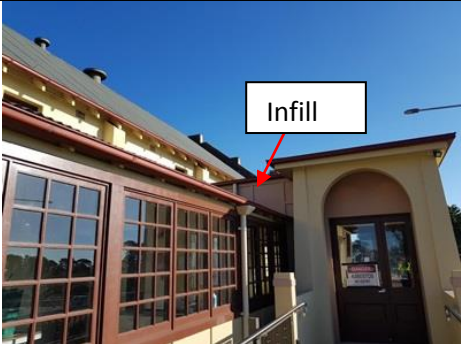
| ASBESTOS MATERIALS REGISTER | | ASSET: Lawson Mechanics Institute, 284 Great Western Highway, Lawson, NSW, 2783 | | | |
|---|---|--|--|---|---|
| 21 st March 2018 | | Eastern Aspect. South-East Gable Fibre Cement Sheet Approximately 2m ² | Similar to Sample #B18109S18 No Asbestos Detected 833 | A5 | N/A |

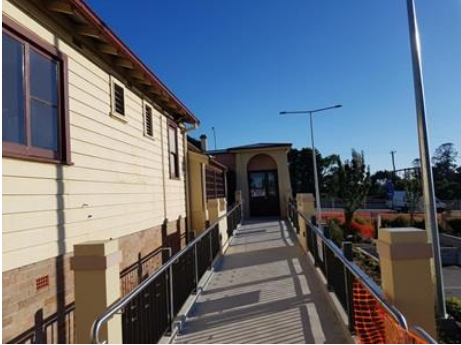
| ASBESTOS MATERIALS REGISTER | | ASSET: Lawson Mechanics Institute, 284 Great Western Highway, Lawson, NSW, 2783 | | | |
|---|---|--|--|---|---|
| 21 st March 2018 | | Eastern Aspect East Entrance. Corrugated Iron Roof, Rendered Brick Walls, Cement Ramp, Timber Door, Cover Trips & Cornices | No Sample Taken. No Asbestos Containing Material Sighted. 834 | A5 | N/A |

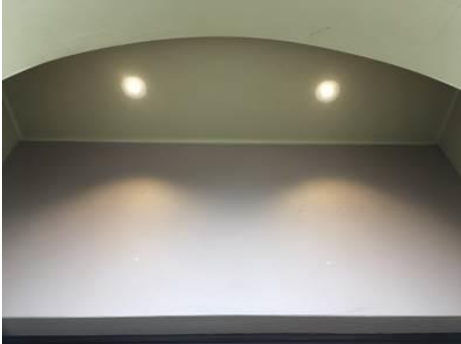
| ASBESTOS MATERIALS REGISTER | | ASSET: Lawson Mechanics Institute, 284 Great Western Highway, Lawson, NSW, 2783 | | | |
|---|---|--|--|---|---|
| 21 st March 2018 | | Eastern Aspect. South-East Entrance Soffit Lining Fibre Cement Sheet Approximately 2m ² | Sample #B18109S20 No Asbestos Detected 835 | A5 | N/A |

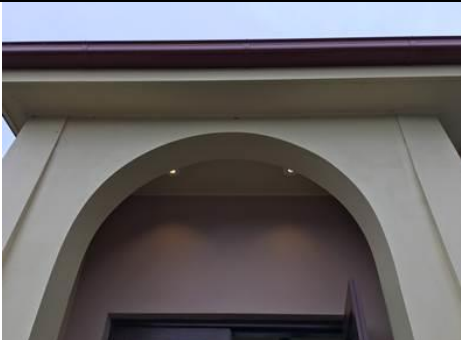
| ASBESTOS MATERIALS REGISTER | | ASSET: Lawson Mechanics Institute, 284 Great Western Highway, Lawson, NSW, 2783 | | | |
|---|---|--|--|---|---|
| 21 st March 2018 | | Northern Aspect. North-East Entrance Soffit Lining Fibre Cement Sheet Approximately 2m ² | Similar to Sample #B18109S20 No Asbestos Detected 1023 | A5 | N/A |

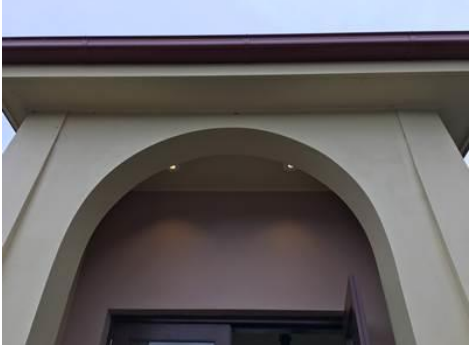
| ASBESTOS MATERIALS REGISTER | | ASSET: Lawson Mechanics Institute, 284 Great Western Highway, Lawson, NSW, 2783 | | | |
|---|---|--|---|---|---|
| 21 st March 2018 | | Northern Aspect. Eave Linings to North-Eastern Entrance Fibre Cement Sheet Approximately 6m ² | Similar to Sample #B18109S20 No Asbestos Detected 1024 | A5 | N/A |

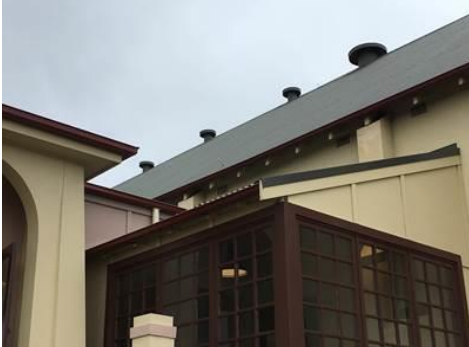
| ASBESTOS MATERIALS REGISTER | | ASSET: Lawson Mechanics Institute, 284 Great Western Highway, Lawson, NSW, 2783 | | | |
|---|---|--|---|---|---|
| 21 st March 2018 | | Northern Aspect New Section. Upper & Lower North Facing Infill, Fibre Cement Sheet. Approximately 8m ² | Similar to Sample #B18109S18 No Asbestos Detected 1026 | A5 | N/A |

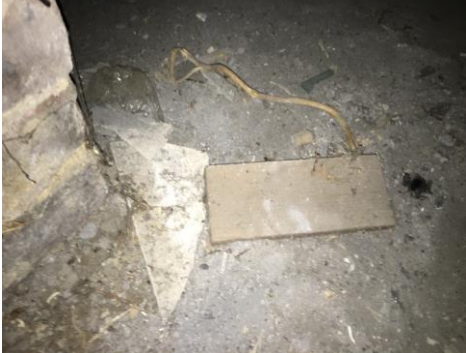
| ASBESTOS MATERIALS REGISTER | | ASSET: Lawson Mechanics Institute, 284 Great Western Highway, Lawson, NSW, 2783 | | | |
|---|---|--|--|---|--|
| 21 st March 2018 | | Entire Subfloor Space Scattered Fibre Cement Sheet Debris. 1028 | No Asbestos Detected | A5 | Asbestos Removed Empire Contracting |

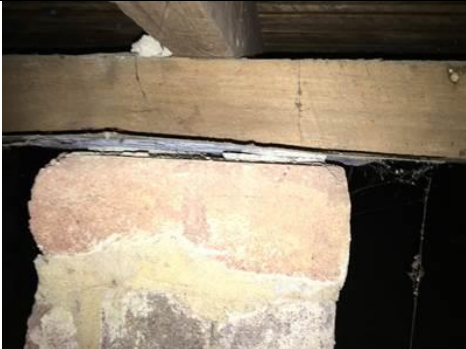
| ASBESTOS MATERIALS REGISTER | | ASSET: Lawson Mechanics Institute, 284 Great Western Highway, Lawson, NSW, 2783 | | | |
|---|---|--|--|---|--|
| 21 st March 2018 | | Subfloor Space. Fibre Cement Sheet Packers to Some Brick Piers | No Asbestos Detected 1029 | A5 | Asbestos Removed by Empire Contracting |

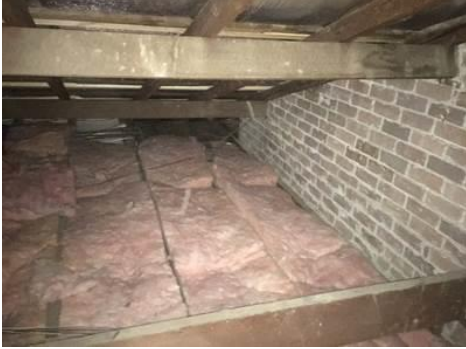
| ASBESTOS MATERIALS REGISTER | | ASSET: Lawson Mechanics Institute, 284 Great Western Highway, Lawson, NSW, 2783 | | | |
|---|---|--|--|---|--|
| 21 st March 2018 | | Roof Space. Corrugated Iron Roof, Timber Trusses, Northern Brick Wall, Southern Bonded Board Gable & Pink Insulation Batts. | No Sample Taken. No Asbestos Containing Material Sighted 1030 | A5 | N/A |

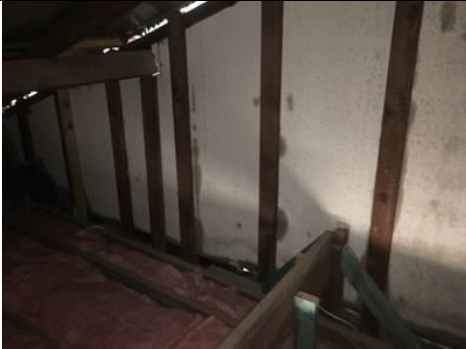
| ASBESTOS MATERIALS REGISTER | | ASSET: Lawson Mechanics Institute, 284 Great Western Highway, Lawson, NSW, 2783 | | | |
|---|---|--|--|---|--|
| 21 st March 2018 | | Roof Space. Corrugated Iron Roof, Timber Trusses, Northern Brick Wall, Southern Fibre Cement Sheet Gable & Pink Insulation Batts. | No Sample Taken. No Asbestos Containing Material Sighted 1031 | A5 | N/A |

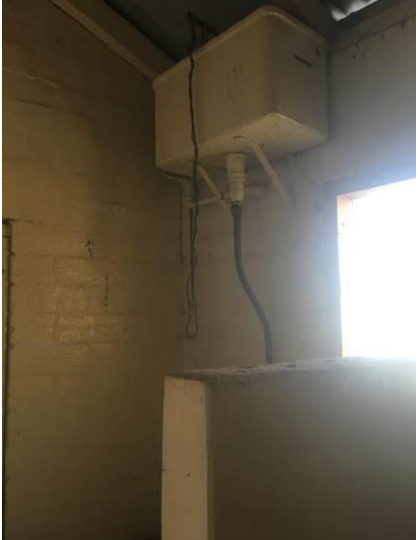
| ASBESTOS MATERIALS REGISTER | | ASSET: Lawson Mechanics Institute, 284 Great Western Highway, Lawson, NSW, 2783 | | | |
|---|---|--|---|---|---|
| 21 st March 2018 | | External Toilet. Toilet Water Cistern. | Sample #B18109S22 No Asbestos Detected. 1034 | A5 | N/A |

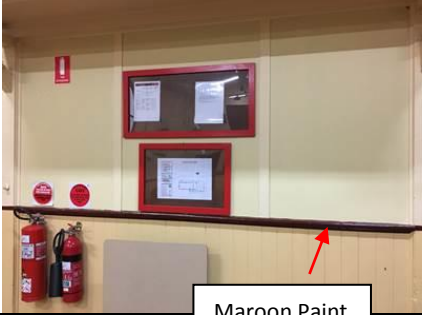
| LEAD BASED PAINTS REGISTER Date Sampled 21 st March 2018 | | ASSET: Lawson Mechanics Institute, 284 Great Western Highway, Lawson, NSW, 2783 | | | |
|--|---|---|--|---|--|
| 18109- S01 (188223-1) | | Maroon Architrave and Window Paint | 3.7% w/w | A4 | Paint is classified as lead based as greater than 0.1% w/w |

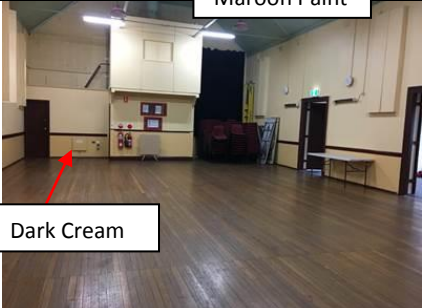
| LEAD BASED PAINTS REGISTER Date Sampled 21 st March 2018 | | ASSET: Lawson Mechanics Institute, 284 Great Western Highway, Lawson, NSW, 2783 | | | |
|--|---|---|--|---|--|
| 18109- S02 (188223-2) | | Dark Cream Wall Paint | 1.2% w/w | A4 | Paint is classified as lead based as greater than 0.1% w/w |

Remediation is required for those areas. However, good practice would dictate that existing paint, even though is below the recognised standard, should not be sanded and that dust minimisation techniques should be adopted, when undertaking renovation / repair works particularly in heritage period buildings. It would be good practice to wear a P1 dust mask during any paint removal even though it does not contain lead but small particles of paint can still be inhaled or ingested.

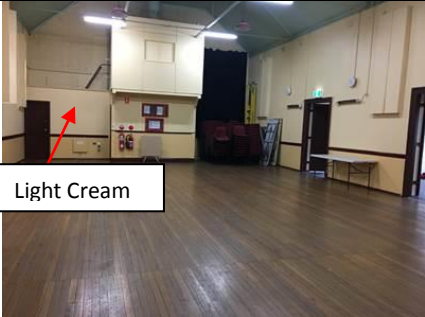
| LEAD BASED PAINTS REGISTER Date Sampled 21 st March 2018 | | ASSET: Lawson Mechanics Institute, 284 Great Western Highway, Lawson, NSW, 2783 | | | |
|--|---|---|---|---|--|
| 18109- S03 (188223-3) | | Light Cream Wall Paint | 0.1% w/w | A5 | Paint not classified as lead based as less than or equal to 0.1% w/w |

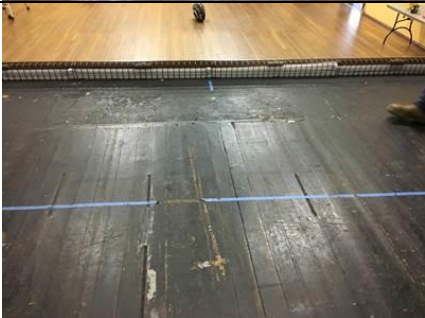
| LEAD BASED PAINTS REGISTER Date Sampled 21 st March 2018 | | ASSET: Lawson Mechanics Institute, 284 Great Western Highway, Lawson, NSW, 2783 | | | |
|--|---|---|---|---|--|
| 18109- S04 (188223-4) | | Black Stage Paint | 0.07% w/w | A5 | Paint not classified as lead based as less than or equal to 0.1% w/w |

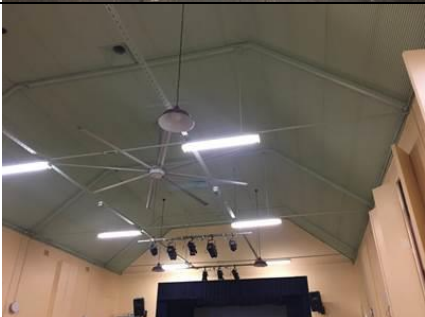
| LEAD BASED PAINTS REGISTER Date Sampled 21 st March 2018 | | ASSET: Lawson Mechanics Institute, 284 Great Western Highway, Lawson, NSW, 2783 | | | |
|--|---|---|---|---|--|
| 18109- S05 (188223-5) | | Green Hall Ceiling Paint | <0.05% w/w | A5 | Paint not classified as lead based as less than or equal to 0.1% w/w |

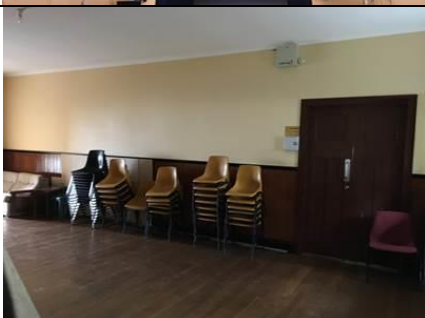
| LEAD BASED PAINTS REGISTER Date Sampled 21 st March 2018 | | ASSET: Lawson Mechanics Institute, 284 Great Western Highway, Lawson, NSW, 2783 | | | |
|--|---|---|---|---|--|
| 18109- S06 (188223-6) | | Supper Room Black Architrave Paint | 0.4% w/w | A4 | Paint is classified as lead based as greater than 0.1% w/w |

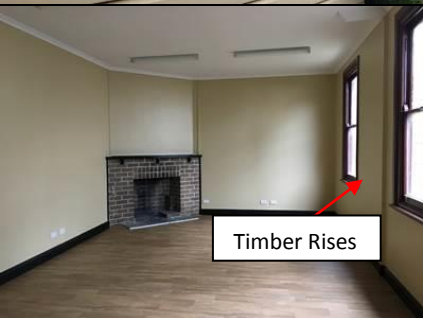
| LEAD BASED PAINTS REGISTER Date Sampled 21 st March 2018 | | ASSET: Lawson Mechanics Institute, 284 Great Western Highway, Lawson, NSW, 2783 | | | |
|--|---|---|---|---|--|
| 18109- S10 (188223-10) | | Paint to Timber Rises in Library | 0.52% w/w | A4 | Paint is classified as lead based as greater than 0.1% w/w |

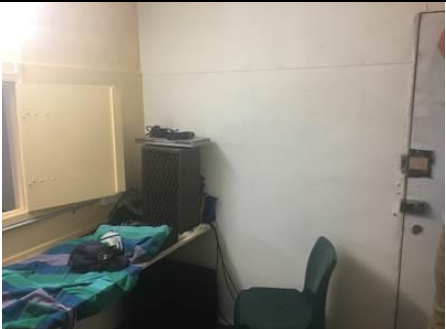
| LEAD BASED PAINTS REGISTER Date Sampled 21 st March 2018 | | ASSET: Lawson Mechanics Institute, 284 Great Western Highway, Lawson, NSW, 2783 | | | |
|--|---|---|---|---|--|
| 18109-S11 (189152-11) | | White Paint to Upper Level of AV Room | 0.2% w/w | A4 | Paint is classified as lead based as greater than 0.1% w/w |

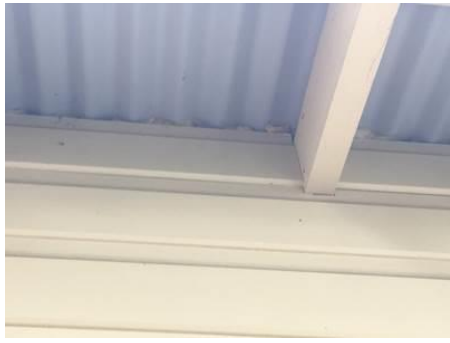
| SYNTHETIC MINERAL FIBRE REGISTER | | ASSET: Lawson Mechanics Institute, 284 Great Western Highway, Lawson, NSW, 2783 | | | |
|---|---|--|---|---|--|
| 21 st March 2018 | | Western Aspect New West Entrance. Synthetic Mineral Fibre Products Were Sighted | Visual Inspection | A4 | Bonded, Good Condition Refer to Management Plan |

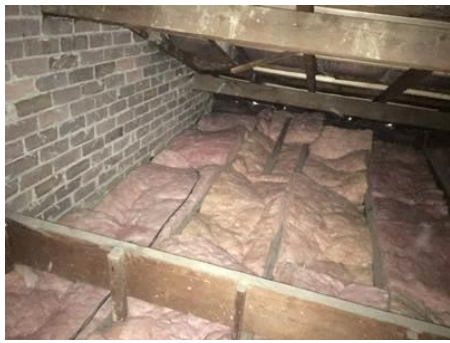
| SYNTHETIC MINERAL FIBRE REGISTER | | ASSET: Lawson Mechanics Institute, 284 Great Western Highway, Lawson, NSW, 2783 | | | |
|---|---|--|---|---|--|
| 21 st March 2018 | | Roof Space Above Supper, Billiard & Library Rooms. Synthetic Mineral Fibre Products Were Sighted | Visual Inspection | A4 | Bonded, Good Condition Refer to Management Plan |

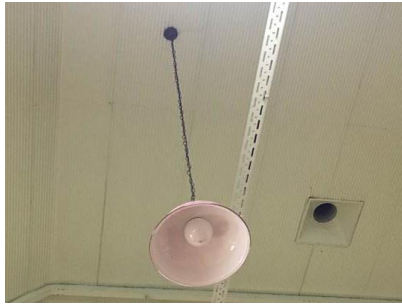
| POLYCHLORINATED BIPHENYLS REGISTER | | ASSET: Lawson Mechanics Institute, 284 Great Western Highway, Lawson, NSW, 2783 | | | |
|---|---|---|--|---|--|
| 21 st March 2018 | | Main Hall Six (6) Incandescent Lights No PCB's Present | Visual Observation | A5 | N/A |

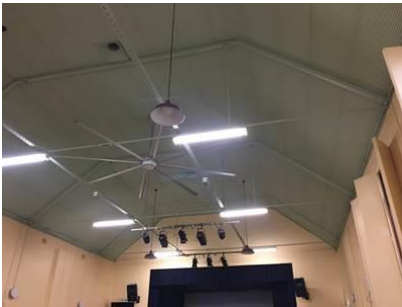
| POLYCHLORINATED BIPHENYLS REGISTER | | ASSET: Lawson Mechanics Institute, 284 Great Western Highway, Lawson, NSW, 2783 | | | |
|---|---|---|--|---|--|
| 21 st March 2018 | | Main Hall Eight (8) Fluorescent Lights Potential PCB's Present | No Visual Inspection Completed No Access Height Restriction | A4 | Unknown Condition Inaccessible Due to Height of Lights |

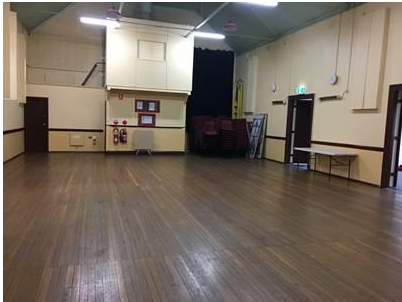
| POLYCHLORINATED BIPHENYLS REGISTER | | ASSET: Lawson Mechanics Institute, 284 Great Western Highway, Lawson, NSW, 2783 | | | |
|---|---|---|--|---|--|
| 21 st March 2018 | | Main Hall Eight (8) Wall Lights Fluorescent Lights No PCB's Present | Visual Observation | A5 | N/A |

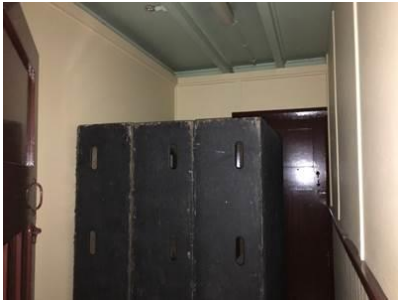
| POLYCHLORINATED BIPHENYLS REGISTER | | ASSET: Lawson Mechanics Institute, 284 Great Western Highway, Lawson, NSW, 2783 | | | |
|---|---|---|---|---|---|
| 21 st March 2018 | | Audio Visual Room – Lower Level Fluorescent Lights No PCB's Present | Visual Observation | A5 | N/A |

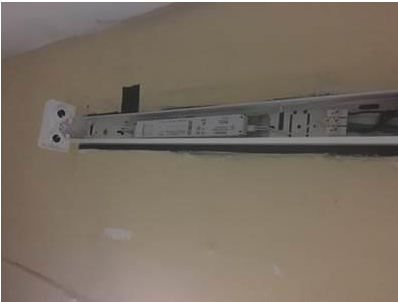
| POLYCHLORINATED BIPHENYLS REGISTER | | ASSET: Lawson Mechanics Institute, 284 Great Western Highway, Lawson, NSW, 2783 | | | |
|---|---|---|---|---|---|
| 5 th April 2018 | | Audio Visual Room – Upper Level Fluorescent Level No PCB's Present | Visual Observation | A5 | N/A |

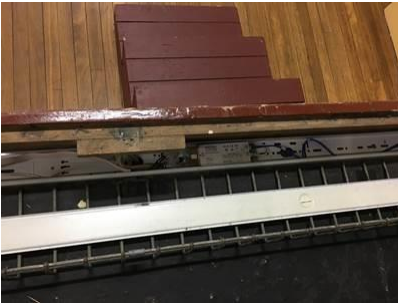
| POLYCHLORINATED BIPHENYLS REGISTER | | ASSET: Lawson Mechanics Institute, 284 Great Western Highway, Lawson, NSW, 2783 | | | |
|---|---|---|---|---|---|
| 21 st March 2018 | | Stage Floor Fluorescent Lights No PCB's Present | Visual Observation | A5 | N/A |

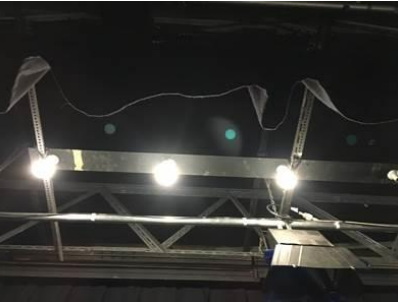
| POLYCHLORINATED BIPHENYLS REGISTER | | ASSET: Lawson Mechanics Institute, 284 Great Western Highway, Lawson, NSW, 2783 | | | |
|---|---|---|---|---|---|
| 21 st March 2018 | | Stage Lights Fluorescent Light No PCB's Present | Visual Observation | A5 | N/A |

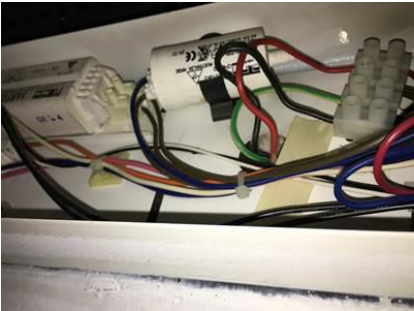
| POLYCHLORINATED BIPHENYLS REGISTER | | ASSET: Lawson Mechanics Institute, 284 Great Western Highway, Lawson, NSW, 2783 | | | |
|---|---|---|---|---|---|
| 21 st March 2018 | | East and West Stage Wall Lights Fluorescent Lights No PCB's Present | Visual Observation | A5 | N/A |

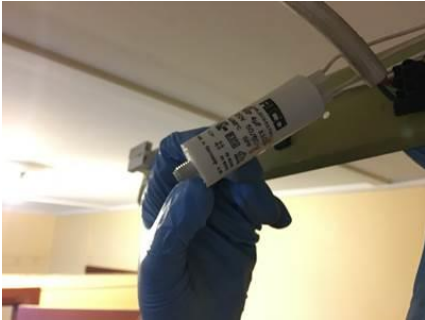
| POLYCHLORINATED BIPHENYLS REGISTER | | ASSET: Lawson Mechanics Institute, 284 Great Western Highway, Lawson, NSW, 2783 | | | |
|---|---|---|---|---|---|
| 21 st March 2018 | | Female Toilet Lights Fluorescent Lights No PCB's Present | Visual Observation | A5 | N/A |

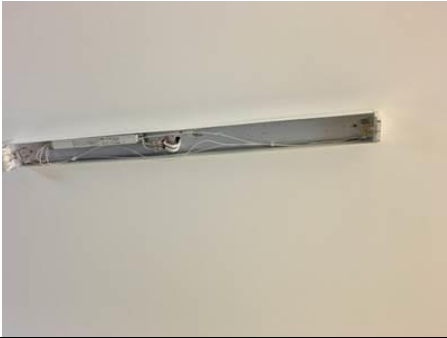
| POLYCHLORINATED BIPHENYLS REGISTER | | ASSET: Lawson Mechanics Institute, 284 Great Western Highway, Lawson, NSW, 2783 | | | |
|---|---|---|---|---|---|
| 21 st March 2018 | | Supper Room Fluorescent Lights No PCB's Present | Visual Observation | A5 | N/A |

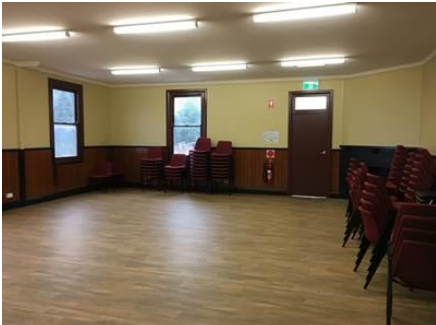
| POLYCHLORINATED BIPHENYLS REGISTER | | ASSET: Lawson Mechanics Institute, 284 Great Western Highway, Lawson, NSW, 2783 | | | |
|---|---|---|---|---|---|
| 21 st March 2018 | | Billiard Room Six (6) Lights Fluorescent Lights No PCB's Present | Visual Observation | A5 | N/A |

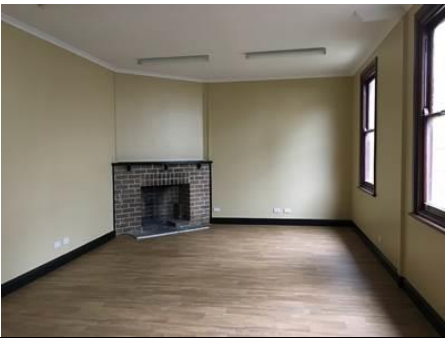
| POLYCHLORINATED BIPHENYLS REGISTER | | ASSET: Lawson Mechanics Institute, 284 Great Western Highway, Lawson, NSW, 2783 | | | |
|---|---|---|---|---|---|
| 21 st March 2018 | | Library Four (4) Lights Fluorescent Lights No PCB's Present | Visual Observation | A5 | N/A |

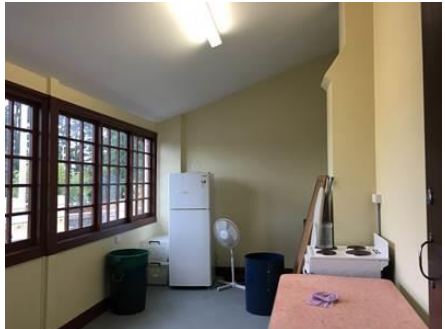
| POLYCHLORINATED BIPHENYLS REGISTER | | ASSET: Lawson Mechanics Institute, 284 Great Western Highway, Lawson, NSW, 2783 | | | |
|---|---|---|---|---|---|
| 21 st March 2018 | | Store Room Lights Fluorescent Lights No PCB's Present | Visual Observation | A5 | N/A |

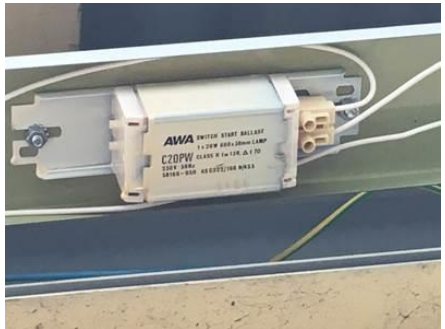
| POLYCHLORINATED BIPHENYLS REGISTER | | ASSET: Lawson Mechanics Institute, 284 Great Western Highway, Lawson, NSW, 2783 | | | |
|---|---|---|---|---|---|
| 21 st March 2018 | | West Verandah Light Fluorescent Lights No PCB's Present | Visual Observation | A5 | N/A |

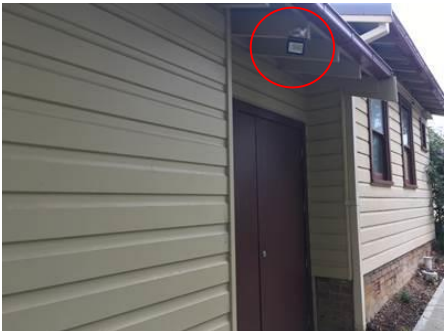
| POLYCHLORINATED BIPHENYLS REGISTER | | ASSET: Lawson Mechanics Institute, 284 Great Western Highway, Lawson, NSW, 2783 | | | |
|---|---|---|---|---|---|
| 21 st March 2018 | | Western Entrance Flood Light Fluorescent Light No PCB's Present | Visual Observation | A5 | N/A |

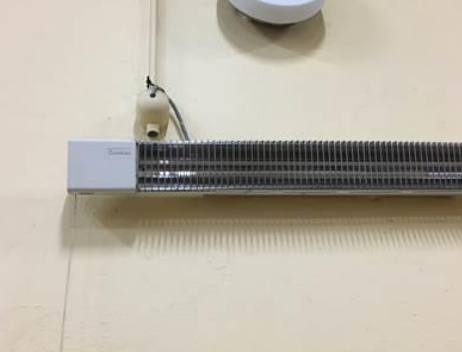
| PHENOLS REGISTER | | ASSET: Lawson Mechanics Institute, 284 Great Western Highway, Lawson, NSW, 2783 | | | |
|---|---|---|---|---|--|
| 21 st March 2018 | | Main Hall. Six Potential Bakelite Fittings on Eastern and Western Walls. | Visual Inspection Assume Phenol Positive | A4 | Good Condition Accessible to Tradespeople Refer to Management Plan |
