## HAZARDOUS BUILDING MATERIALS SURVEY REPORT

Katoomba Solitary Restaurant  
90 Cliff Drive, Katoomba NSW 2780

Report Number 610.17816.00000.0240-R01-ASR

19 March 2018

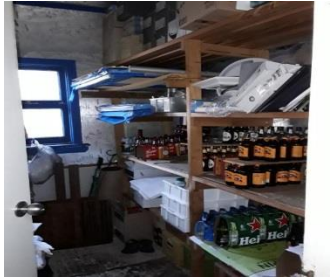
Katoomba Solitary Restaurant Ground Floor - Staff only area adjacent male toilets	Walls throughout , Fibrous Cement	22m <sup>2</sup>	NAD
17 1651
