Asbestos Register

Management Plan

Woodford RFS, 2 Park Road, Woodford

Asbestos Register and Management Plan

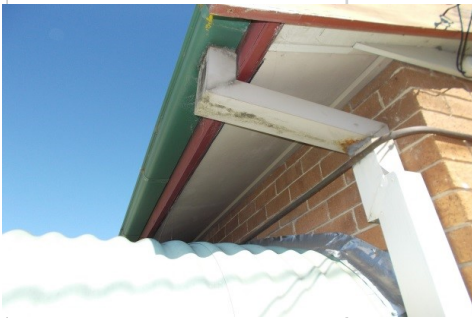
Ref No.	Date Identified	Clearance Cert Date	Onsite Register	Last Inspection Date	Next Inspection Date
966	19/12/2014		Yes	18-Apr-2019	18-Apr-2024
Accessibility		Material		Extent	
Inaccessible		Fibreboard		6m2	
Friability		Sealed / Surface Treatment		Risk Assessment	
Non Friable		Sealed		RA04 - Very Low	
				Control Actions	
				No Remedial Action - Reinspect Periodically	
				Labels Affixed	
				No	
Specific Location					
Woodford RFS - External - Eave linings					
Additional Comments					GPS Lat,Long
Sample: 25132-40-1

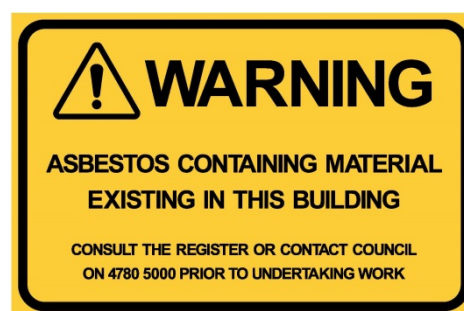
NSW Work Health and Safety Regulation 2017 R422, R424, R427 and R429 requires that the person with the management control of the workplace to identify asbestos containing materials and the asbestos material that has been identified to date must be labelled and ensure that it complies with the Australian Standard 1319: Safety Signs for the Occupational Environment; signage should be similar to the label detailed below.
