# BLUE MOUNTAINS CITY COUNCIL

## ASBESTOS REGISTER

### BLACKHEATH SHED-NEAR CROSSING

**3.1.3 Blackheath Shelter Shed**

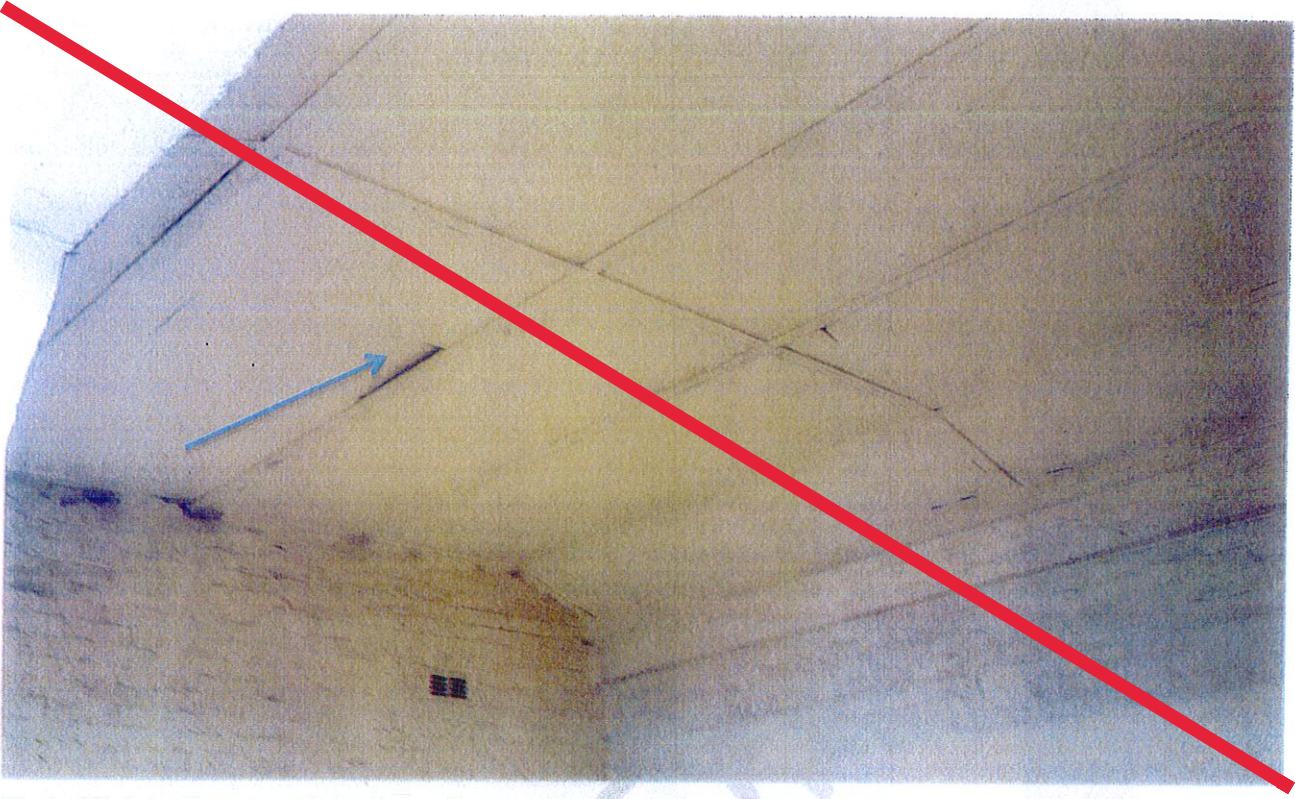
**Photo 13:** Asbestos cement sheeting, with a small crack, on the ceiling lining of Blackheath Shelter Shed (near crossing).

Location	Material	Sample ID	Sample Status	Photo No.	Asbestos Classification	Condition	Accessibility	Re-inspect	Current Label	Control Measure	Record of Works Undertaken
<b>Blackheath Shelter Shed (Near Crossing)</b>											
External – Roof shingles <b>3121</b>	Fibrous cement sheeting	21880-8	Positive	12	Bonded	Stable	Low	March 2019	Not Labeled	4	Airsafe CC #37393 - 17/226753 - 27/06/2017
External – ceiling lining <b>3122</b>	Fibrous cement sheeting	21880-9	Positive	13	Bonded	Stable	Low	March 2019	Not Labeled	4	Airsafe CC #37393 - 17/226753 - 27/06/2017

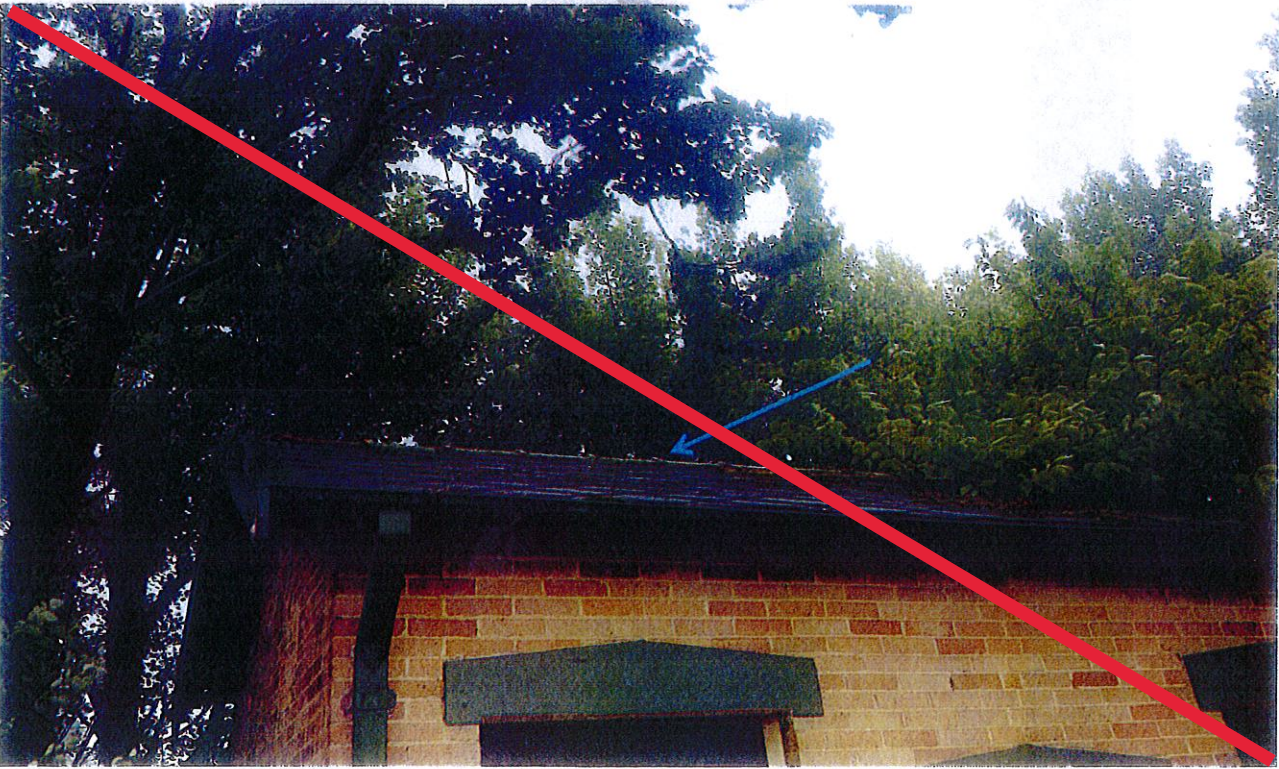
**Photo 12:** Asbestos cement roof shingles on the roof of Blackheath Shelter Shed (near crossing).
