# Asbestos Register

Regional EnviroScience Pty Ltd was requested by Mr. Rick Harris of Blue Mountain City Council to undertake a Hazardous Building Materials Register and to prepare an Asbestos Materials Management Plan of the property known as Katoomba Falls Reserve Oval Amenities, located at Lot 101 Cliff Drive, Katoomba, NSW, 2780. The purpose of the audit was to locate and identify asbestos based building materials and product within the building in accordance with the *NSW Work Health and Safety Act and Regulation 2017* and the *Code of Practice; How to Manage and Control Asbestos in the Workplace* [Safe Work Australia: 2016] and the *Code of Practice; How to Safely Remove Asbestos* [Safe Work Australia: 2016].

| ASBESTOS MATERIALS REGISTER | | ASSET: Katoomba Falls Reserve, Oval Amenities,<br>Lot 101 Cliff Drive, Katoomba, NSW, 2780 | | | |

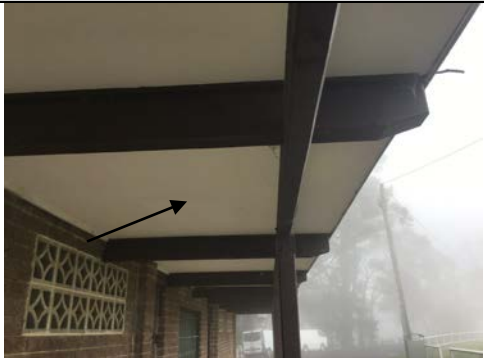
| ASBESTOS MATERIALS REGISTER | | ASSET: Katoomba Falls Reserve, Oval Amenities,<br>Lot 101 Cliff Drive, Katoomba, NSW, 2780 | | | |
|---|---|---|---|---|---|
| 4 <sup>th</sup> December 2017 | | South Soffit<br>Fibre Cement | Sample<br>#B17356S01<br><br>No Asbestos Detected<br><br><b>568</b> | A5 | N/A |

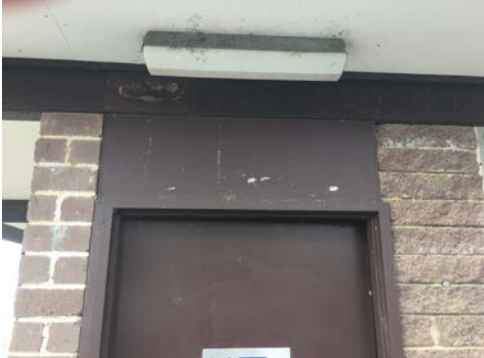
| ASBESTOS MATERIALS REGISTER | | ASSET: Katoomba Falls Reserve, Oval Amenities,<br>Lot 101 Cliff Drive, Katoomba, NSW, 2780 | | | |
|---|---|---|---|---|---|
| 4 <sup>th</sup> December 2017 | | Infill Above<br>Unisex Disabled<br>Door<br>Fibre Cement | Sample<br>#B17356S02<br><br>No Asbestos Detected<br><br><b>569</b> | A5 | N/A |

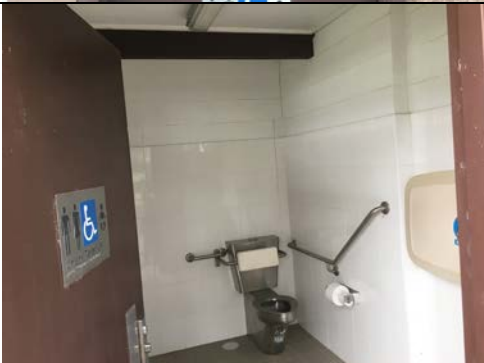
| ASBESTOS MATERIALS REGISTER | | ASSET: Katoomba Falls Reserve, Oval Amenities,<br>Lot 101 Cliff Drive, Katoomba, NSW, 2780 | | | |
|---|---|---|---|---|---|
| 4 <sup>th</sup> December 2017 | | Disabled/Unisex<br>Toilets Ceiling<br>Fibre Cement | Sample<br>#B17356S03<br><br>No Asbestos Detected<br><br><b>570</b> | A5 | N/A |

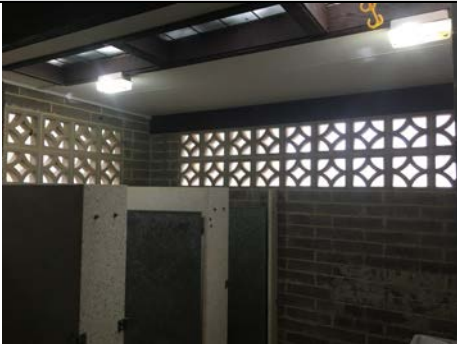
| ASBESTOS MATERIALS REGISTER | | ASSET: Katoomba Falls Reserve, Oval Amenities,<br>Lot 101 Cliff Drive, Katoomba, NSW, 2780 | | | |
|---|---|---|---|---|---|
| 4 <sup>th</sup> December 2017 | | Ladies and Male Toilets Ceilings<br>Fibre Cement<br>Approximately 18m <sup>2</sup> | Sample #B17356S04<br>Chrysotile Asbestos Detected<br>Non-Friable<br><b>571</b> | A4 | Good Condition<br>Accessible to Tradespeople<br>Refer to Asbestos Management Plan |

The materials identified in this report were in good or fair condition and can be managed effectively according to the Asbestos Management Plan.

- Provided the ACM remains in good condition and is not disturbed they pose minimal risk if left in situ.
- If the ACM is in fair condition it should be removed under controlled conditions and replaced, during routine maintenance works.
- If the ACM is in poor condition it should be removed under controlled conditions as soon as practicable.
- If renovation or demolition works are to occur the asbestos based materials which are likely to be disturbed should be removed prior to works commencing.

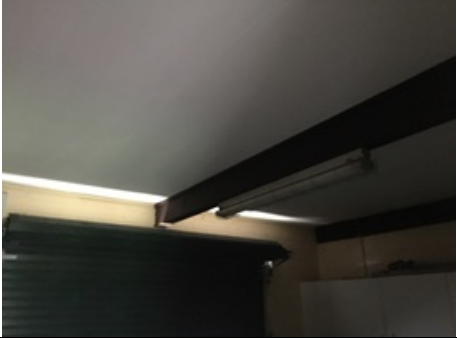
| ASBESTOS MATERIALS REGISTER | | ASSET: Katoomba Falls Reserve, Oval Amenities,<br>Lot 101 Cliff Drive, Katoomba, NSW, 2780 | | | |
|---|---|---|---|---|---|
| 4 <sup>th</sup> December 2017 | | Storeroom Ceiling<br>Fibre Cement<br>Approximately 6m <sup>2</sup> | Similar to Sample #B17356S04<br>Chrysotile Asbestos Detected<br>Non-Friable<br><b>572</b> | A4 | Good Condition<br>Accessible to Tradespeople<br>Refer to Asbestos Management Plan |

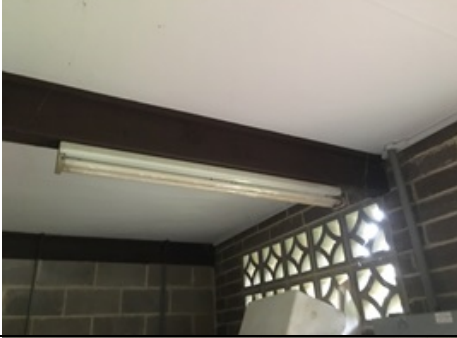
| ASBESTOS MATERIALS REGISTER | | ASSET: Katoomba Falls Reserve, Oval Amenities,<br>Lot 101 Cliff Drive, Katoomba, NSW, 2780 | | | |
|---|---|---|---|---|---|
| 4 <sup>th</sup> December 2017 | | Kitchen Ceiling<br>Fibre Cement<br>Approximately 8m <sup>2</sup> | Similar to Sample #B17356S04<br>Chrysotile Asbestos Detected<br>Non-Friable<br><b>573</b> | A4 | Good Condition<br>Accessible to Tradespeople<br>Refer to Asbestos Management Plan |

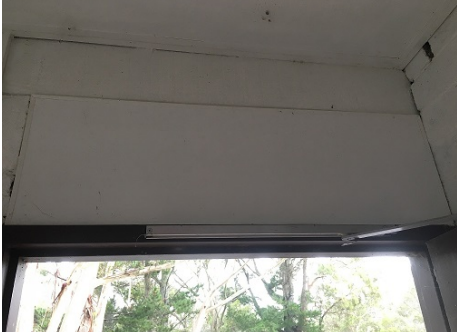
| ASBESTOS MATERIALS REGISTER | | ASSET: Katoomba Falls Reserve, Oval Amenities,<br>Lot 101 Cliff Drive, Katoomba, NSW, 2780 | | | |
|---|---|---|---|---|---|
| 4 <sup>th</sup> December 2017 | | Unisex Disabled Toilet Infill Fibre Cement<br>Approximately 1m <sup>2</sup> | Similar to Sample #B17356S02<br>No Asbestos Detected<br><b>574</b> | A5 | N/A |

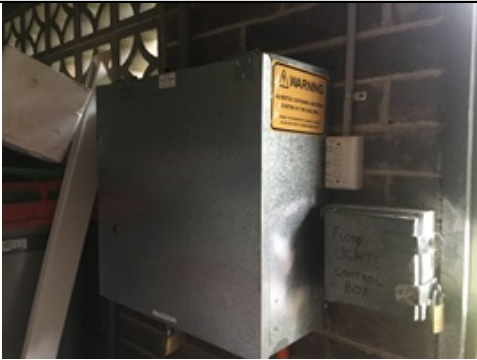
| ASBESTOS MATERIALS REGISTER | | ASSET: Katoomba Falls Reserve, Oval Amenities,<br>Lot 101 Cliff Drive, Katoomba, NSW, 2780 | | | |
|---|---|---|---|---|---|
| 4 <sup>th</sup> December 2017 | | Internal Electrical Meter Board. Nil Access.<br><br>Note: Asbestos Warning Label Attached to the Cabinet. | No Sample Taken.<br>Assume Contains Asbestos Materials<br><b>575</b> | A4 | Presume to be in Good Condition.<br>Accessible to Tradespeople<br>Refer to Asbestos Management Plan |

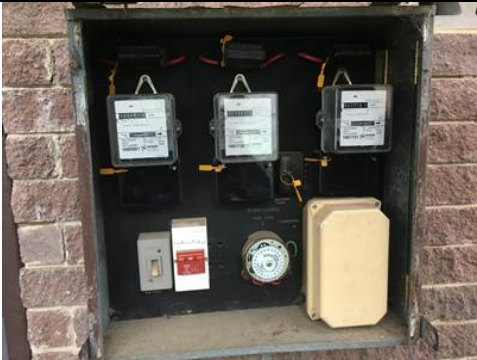
| ASBESTOS MATERIALS REGISTER | | ASSET: Katoomba Falls Reserve, Oval Amenities,<br>Lot 101 Cliff Drive, Katoomba, NSW, 2780 | | | |
|---|---|---|---|---|---|
| 4 <sup>th</sup> December 2017 | | External Switchboard Electrical Backing Board. | No Sample Taken.<br>Assume Contains Asbestos Materials<br><b>576</b> | A4 | Good Condition<br>Accessible to Tradespeople<br>Refer to Asbestos Management Plan |

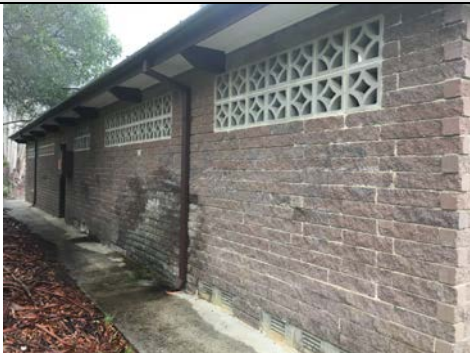
| LEAD BASED PAINTS REGISTER<br>Date Sampled: 4 <sup>th</sup> December 2017 | | ASSET: Katoomba Falls Reserve, Oval Amenities, Lot 101 Cliff Drive, Katoomba, NSW, 2780 | | | |
|---|---|---|---|---|---|
| 17356- S01<br>(181769-1) | | Support<br>Beams<br>and Facia<br>Brown<br>Paint for<br>Lead | <0.05% w/w | A5 | Paint is not<br>classified as lead<br>based. Less than<br>0.1% w/w |

No Lead based paints were detected at Katoomba Falls Reserve Oval Amenities, however good practice would dictate that existing paint, even though is below the recognised standard, should not be sanded and that dust minimisation techniques should be adopted, when undertaking renovation / repair works particularly in heritage period buildings. It would be good practice to wear a P1 dust mask during any paint removal even though it does not contain lead but small particles of paint can still be inhaled or ingested.

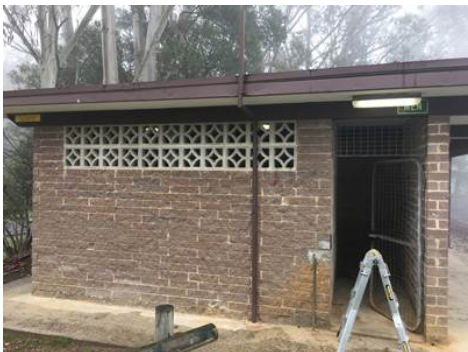
| POLYCHLORINATED BIPHENYLS REGISTER | | ASSET: Katoomba Falls Reserve, Oval Amenities, Lot 101 Cliff Drive, Katoomba, NSW, 2780 | | | |
|---|---|---|---|---|---|
| 4 <sup>th</sup> December 2017 | | Western External Fluorescent Light<br>No PCB's Present | Visual Observation | A5 | N/A |

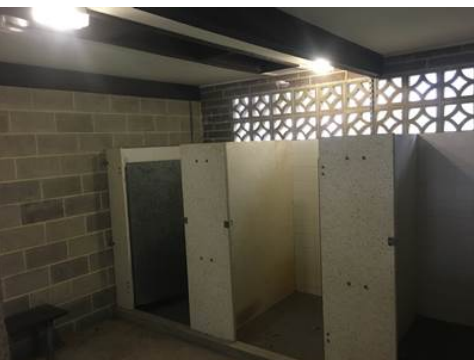
| POLYCHLORINATED BIPHENYLS REGISTER | | ASSET: Katoomba Falls Reserve, Oval Amenities, Lot 101 Cliff Drive, Katoomba, NSW, 2780 | | | |
|---|---|---|---|---|---|
| 4 <sup>th</sup> December 2017 | | Women's & Men's Changeroom<br>Fluorescent Lights<br>No PCB's Present | Visual Observation | A5 | N/A |

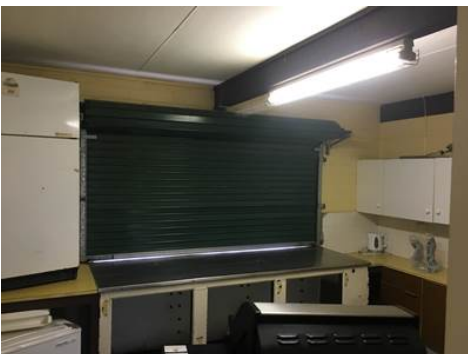
| POLYCHLORINATED BIPHENYLS REGISTER | | ASSET: Katoomba Falls Reserve, Oval Amenities, Lot 101 Cliff Drive, Katoomba, NSW, 2780 | | | |
|---|---|---|---|---|---|
| 4 <sup>th</sup> December 2017 | | Kitchen Light Fluorescent Light<br>No PCB's Present | Visual Observation | A5 | N/A |

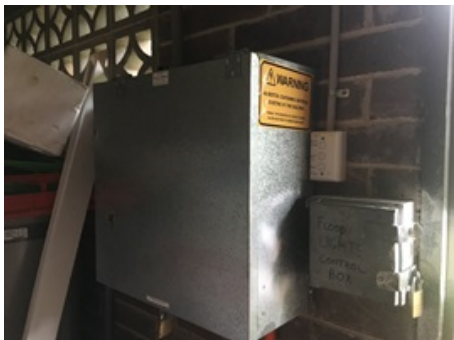
| PHENOLS REGISTER | | ASSET: Katoomba Falls Reserve, Oval Amenities, Lot 101 Cliff Drive, Katoomba, NSW, 2780 | | | |
|---|---|---|---|---|---|
| 4 <sup>th</sup> December 2017 | | Internal Switchboard<br>Electrical Backing Board Bakelite.<br><br>Note: Locked<br>Lighting Box<br>Adjacent Meter Box<br>May Contain Phenol Switch Assemblies.<br><br>Nil Access. | Visual Inspection<br><br>Assume Phenol Materials Present | A4 | Good Condition<br>Accessible to Tradespeople<br>Refer to Management Plan |

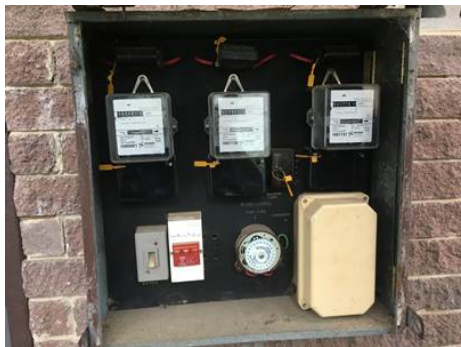
| PHENOLS REGISTER | | ASSET: Katoomba Falls Reserve, Oval Amenities, Lot 101 Cliff Drive, Katoomba, NSW, 2780 | | | |
|---|---|---|---|---|---|
| 4 <sup>th</sup> December 2017 | | External Switchboard<br>Electrical Backing Board Bakelite | Visual Inspection<br><br>Assume Phenol Materials Present | A4 | Good Condition<br>Accessible to Tradespeople<br>Refer to Management Plan |

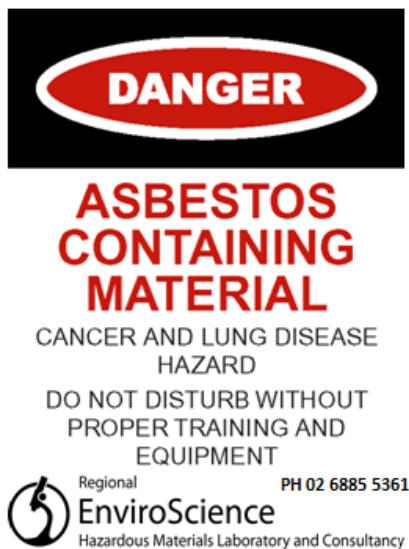
Work Health and Safety Regulation 2017 R422, R424, R427 and R429 requires that the person with the management control of the workplace to identify asbestos containing materials and the asbestos material that has been identified to date should be labelled and ensured that it complies with the *Australian Standard 1319: Safety Signs for the Occupational Environment*; signage should be similar to the label detailed below.

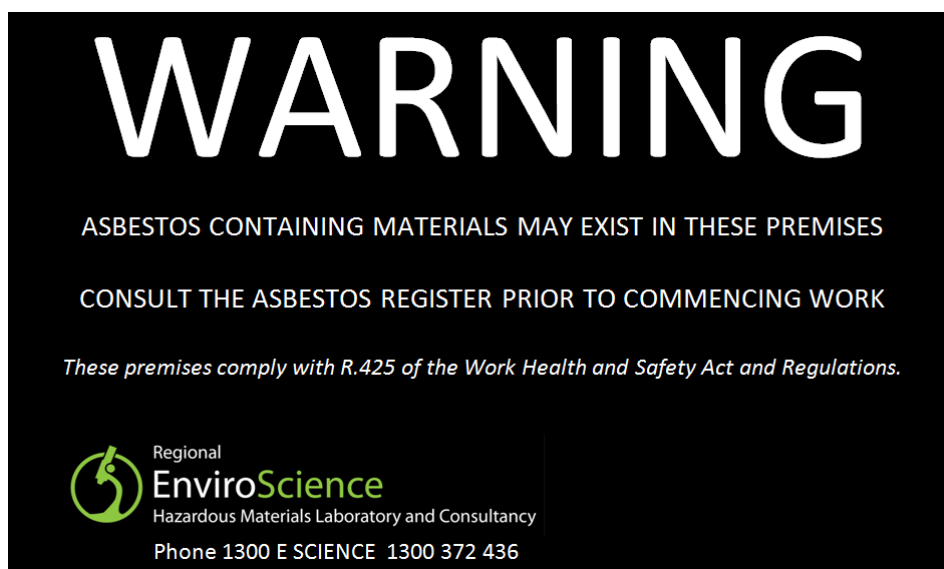
Signage should also be placed at the entry points to the building/plant similar to the one detailed below

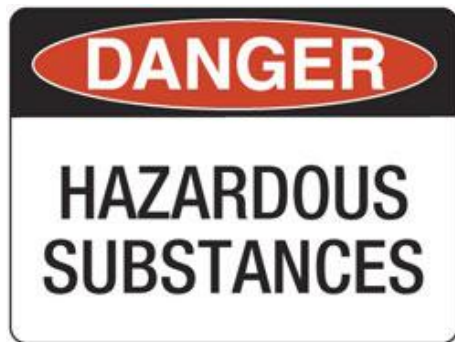
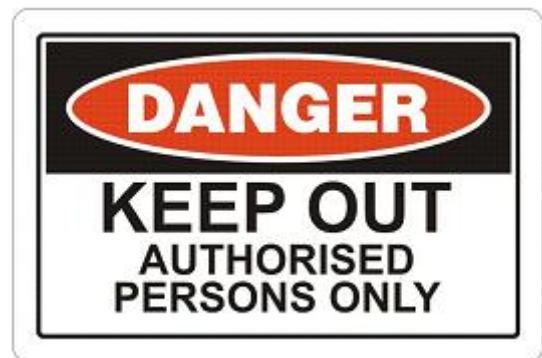
It is recommended that signage be placed around the perimeter of the site, together with barriers constructed of barrier tape and or trestles. Signage should be similar to the ones detailed below.
